Pino Fire Restoration Project 14-16

Pre-treatment Monitoring Report

2015

Prepared by Kathryn R Mahan, Ecological Monitoring Specialist, New Mexico Forest and Watershed Restoration Institute for the Greater Rio Grande Watershed Alliance

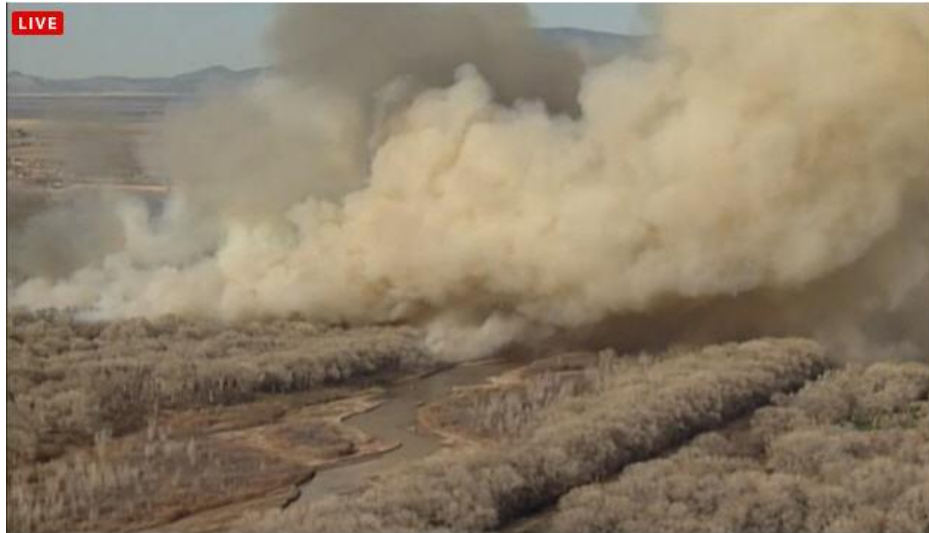
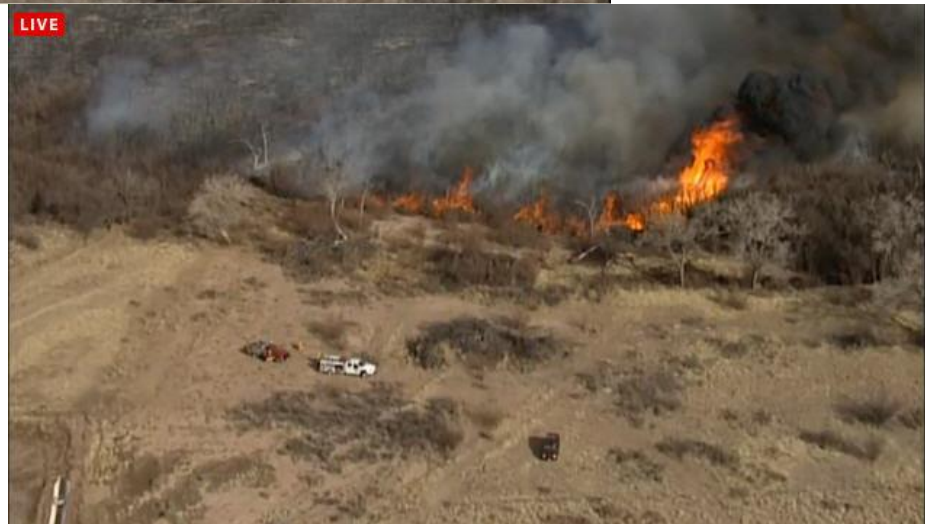
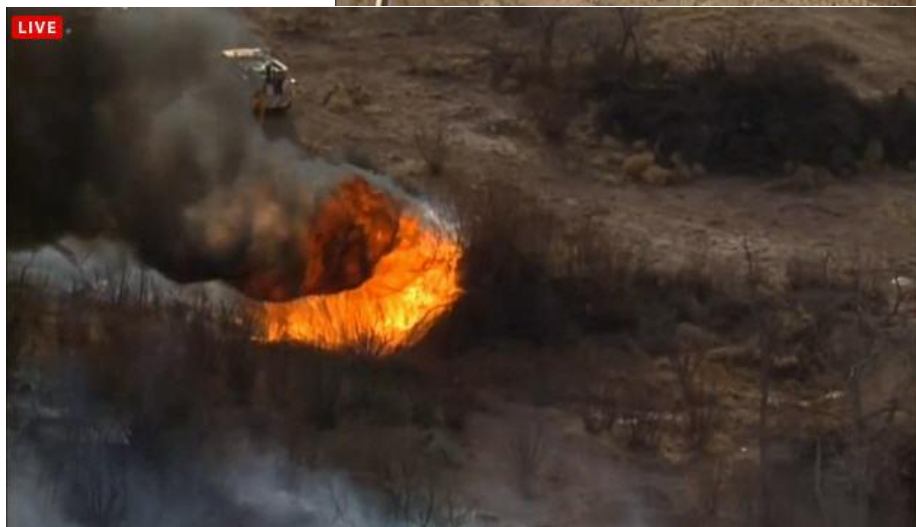
Figure 2. KRQE News 13 SkyNews photos of the Pino Fire.
(Chelo Rivera, KRQE News 13, 2014)

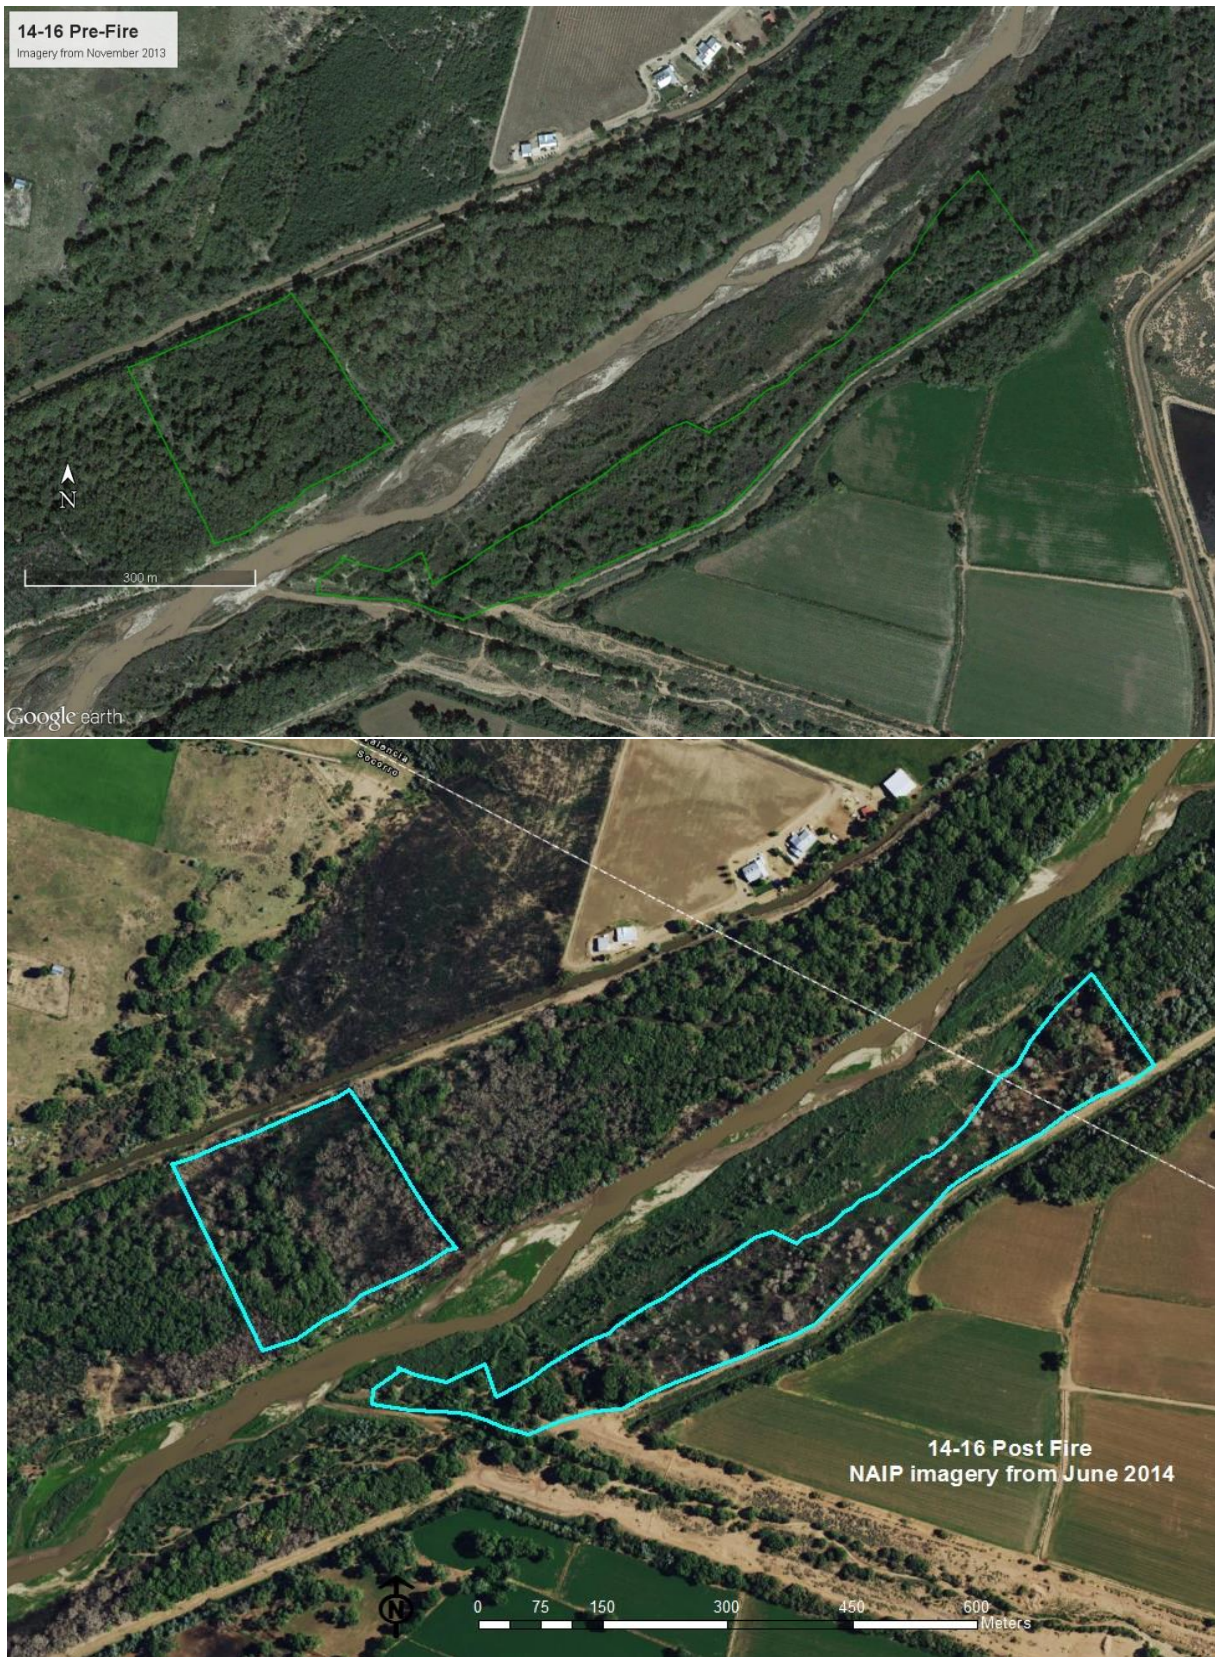
Local news reported the fire's primary fuel source was the dense salt cedar stands along the river (Chelo Rivera, KRQE News 13, 2014). GRGWA's 2014 RFP noted the presence of dead sapling- and pole-sized salt cedar and Russian olives in the project area but suggested that much of the damaged vegetation was beginning to re-sprout, with heights at 2 to 4 feet by August 2014, just 5 months post-fire (Claunch-Pinto Soil and Water Conservation District on behalf of The Greater Rio Grande Watershed Alliance, 2014). Our contractor's photographs and notes from February 2016 (11 months post-fire; see Appendix II) suggest a patchy burn pattern where some areas experienced significant mortality in all canopy strata.

Figure 3. 14-16 Pre- and post-fire imagery (Google and NAIP).

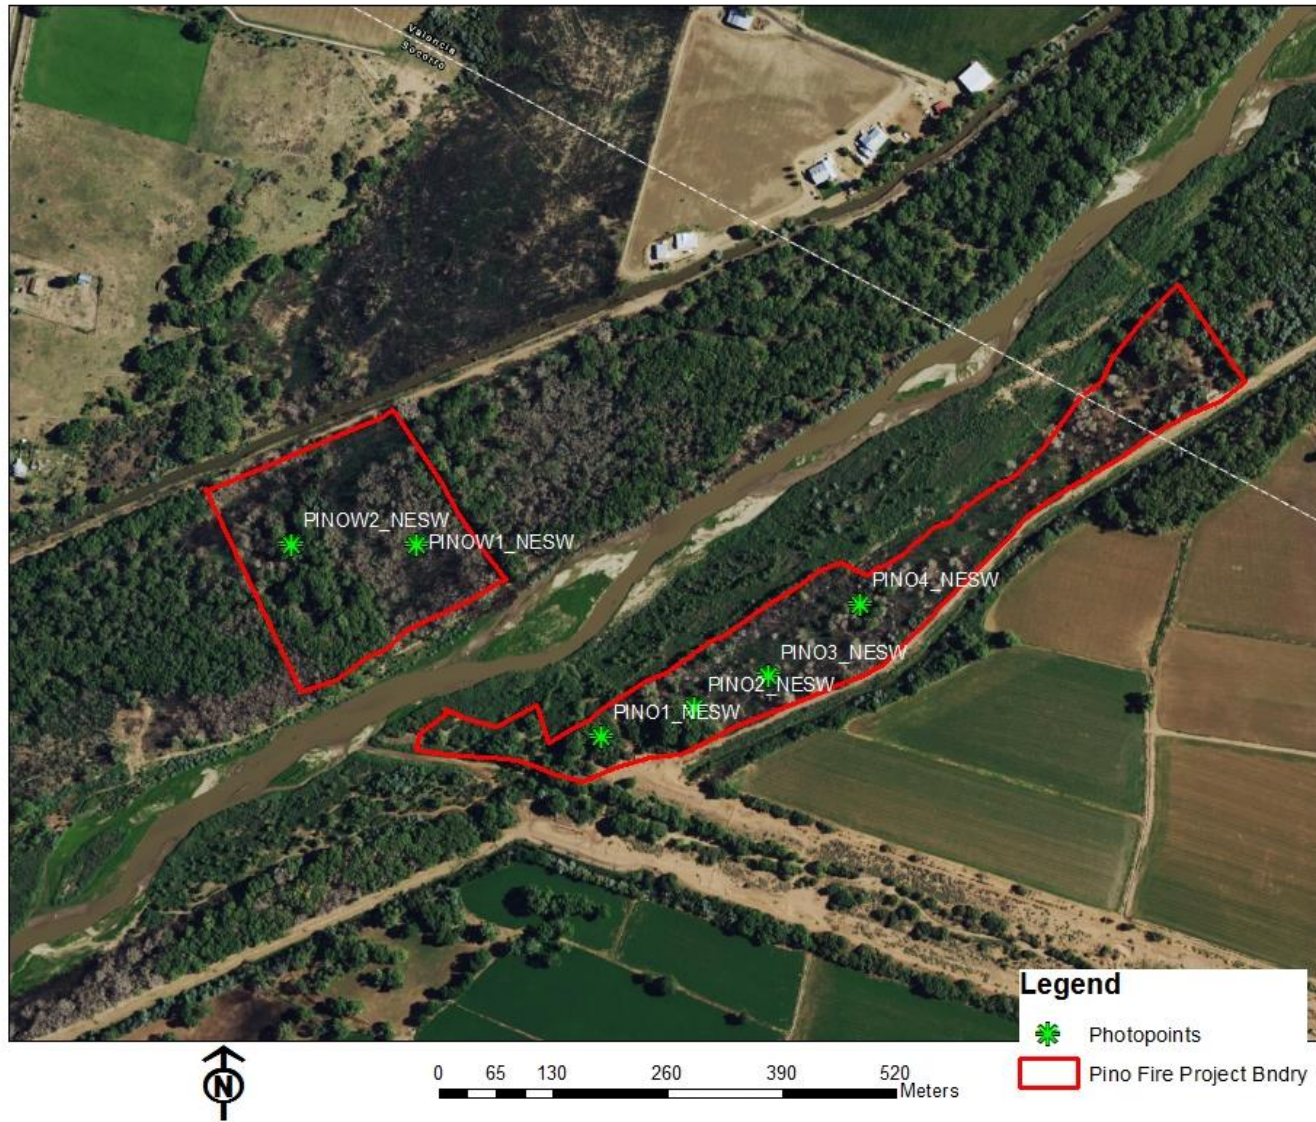
Figure 4. 14-16 Pino Fire monitoring photopoints

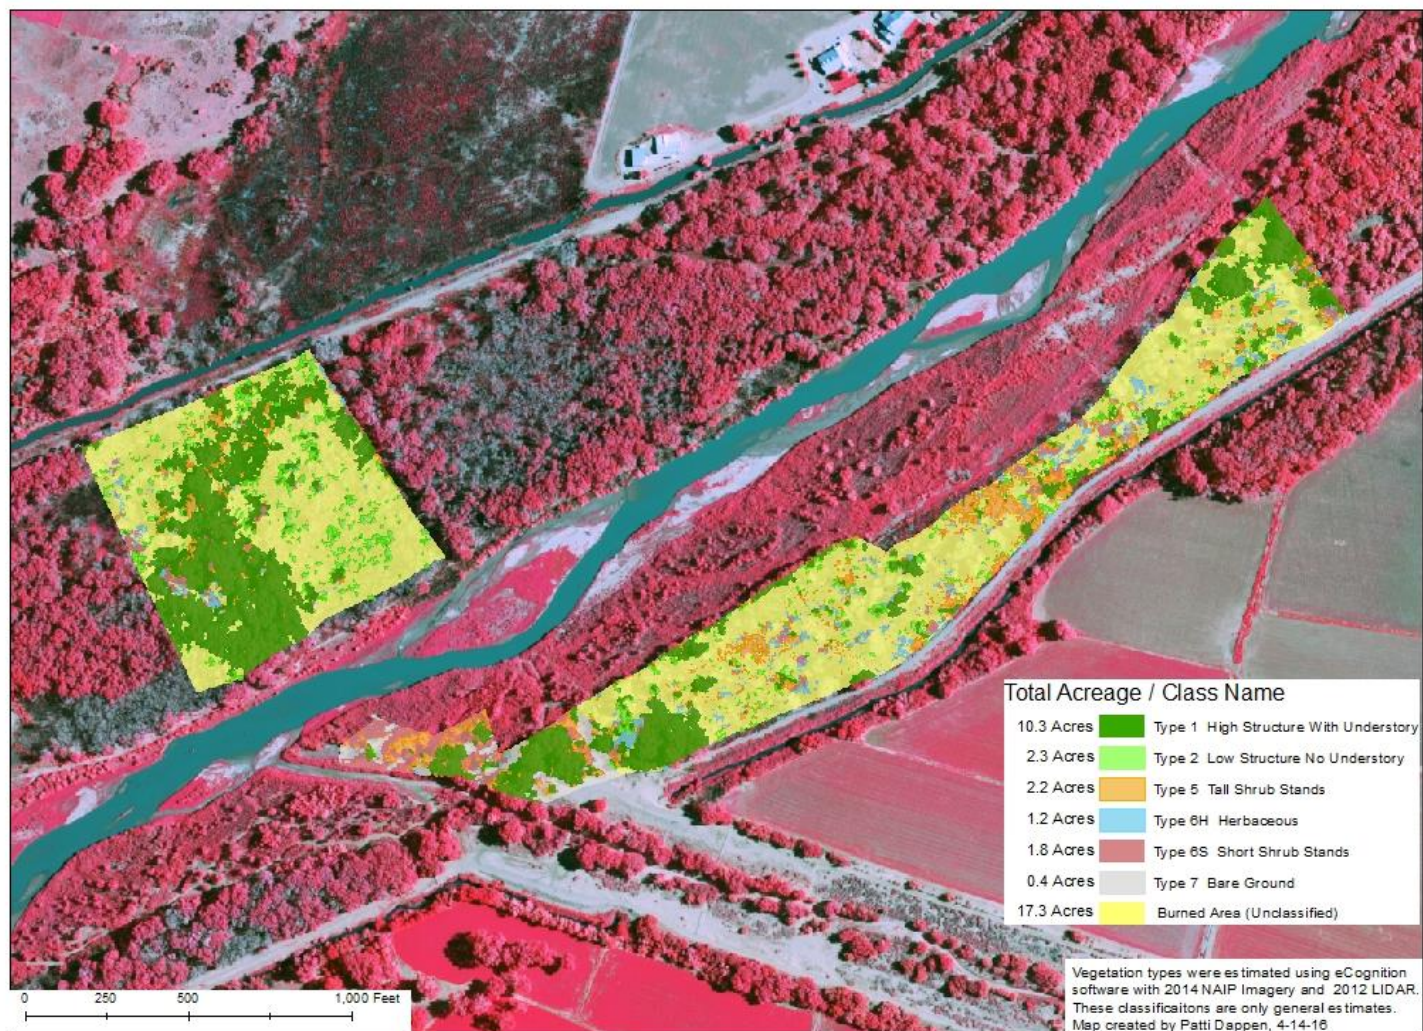
14.16 Pino Fire Vertical Structure Classification

Based on the GIS classification (see Figure 5), 10 acres of this site was burned enough to kill overstory (49%). The remaining 51% fell into the following vertical structural classes: 23% was Type 1 High Structure with Understory (on this site, cottonwood and salt cedar with understory including coyote willow); 5.1% Type 2 (cottonwood or salt cedar without understory), 9.4% Type 5 Tall Shrub Stands (salt cedar or coyote willow), 7.1% Type 6S Short Shrub Stands (coyote willow), 4.9% Type 6H Herbaceous (kochia, yerba mansa, grasses), and 1.8% Type 7 Bare Ground.

Based on the GIS classification (see Figure 5), 7 acres of this site was burned enough to kill overstory (48%). The remaining 52% fell into the following vertical structural classes: 38% was Type 1 High Structure with Understory (cottonwood and Russian olive with understory); 8.8% Type 2 Low Structure (cottonwood and Russian olive without understory), 2.2% Type 5 Tall Shrub Stands (salt cedar, Russian olive or coyote willow), 1.8% Type 6S Short Shrub Stands (coyote willow), and 1.4% Type 6H Herbaceous (kochia, yerba mansa, grasses).

Based on the GIS LIDAR and NAIP analysis, approximately 48% of the project area was burned and therefore not structurally classified. Of the remaining 52%, the majority was a Type 1 structure of cottonwood and salt cedar overstory with salt cedar, Russian olive, and coyote willow understory.

Figure 5. 14-16 Pino Fire Restoration LIDAR and NAIP classification. The map was produced with false-color NAIP imagery to allow the viewer to more easily distinguish between the vegetation and the green color of the Type 1 and Type 2 classifications.
