Pino Fire Restoration Project 14-16

Pre-treatment Monitoring Report

2015

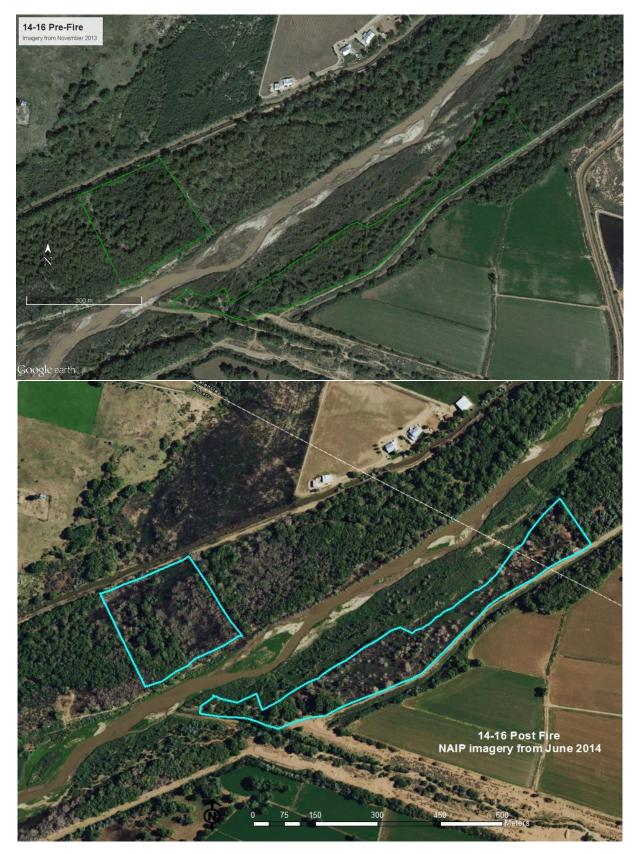
Figure 3. 14-16 Pre- and post-fire imagery (Google and NAIP).

Local news reported the fire's primary fuel source was the dense salt cedar stands along the river (Chelo Rivera, KRQE News 13, 2014). GRGWA's 2014 RFP noted the presence of dead sapling- and pole-sized salt cedar and Russian olives in the project area but suggested that much of the damaged vegetation was beginning to re-sprout, with heights at 2 to 4 feet by August 2014, just 5 months post-fire (Claunch-Pinto Soil and Water Conservation District on behalf of The Greater Rio Grande Watershed Alliance, 2014). Our contractor's photographs and notes from February 2016 (11 months post-fire; see Appendix II) suggest a patchy burn pattern where some areas experienced significant mortality in all canopy strata.

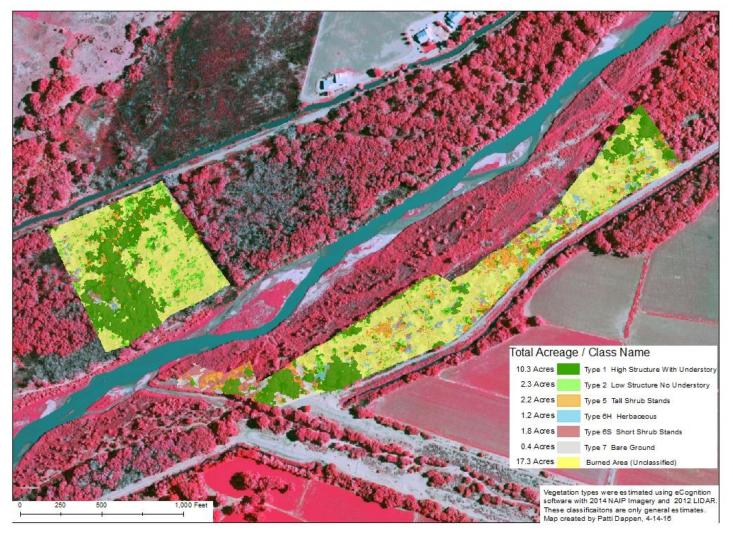
Figure 5. 14-16 Pino Fire Restoration LIDAR and NAIP classification. The map was produced with false-color NAIP imagery to allow the viewer to more easily distinguish between the vegetation and the green color of the Type 1 and Type 2 classifications.

Based on the GIS classification (see Figure 5), 10 acres of this site was burned enough to kill overstory (49%). The remaining 51% fell into the following vertical structural classes: 23% was Type 1 High Structure with Understory (on this site, cottonwood and salt cedar with understory including coyote willow); 5.1% Type 2 (cottonwood or salt cedar without understory), 9.4% Type 5 Tall Shrub Stands (salt cedar or coyote willow), 7.1% Type 6S Short Shrub Stands (coyote willow), 4.9% Type 6H Herbaceous (kochia, yerba mansa, grasses), and 1.8% Type 7 Bare Ground.

Based on the GIS classification (see Figure 5), 7 acres of this site was burned enough to kill overstory (48%). The remaining 52% fell into the following vertical structural classes: 38% was Type 1 High Structure with Understory (cottonwood and Russian olive with understory); 8.8% Type 2 Low Structure (cottonwood and Russian olive without understory), 2.2% Type 5 Tall Shrub Stands (salt cedar, Russian olive or coyote willow), 1.8% Type 6S Short Shrub Stands (coyote willow), and 1.4% Type 6H Herbaceous (kochia, yerba mansa, grasses).

Based on the GIS LIDAR and NAIP analysis, approximately 48% of the project area was burned and therefore not structurally classified. Of the remaining 52%, the majority was a Type 1 structure of cottonwood and salt cedar overstory with salt cedar, Russian olive, and coyote willow understory.
