Pueblo of Sandia Projects 15-01, 15-02, 15-03, 15-04, 15-05

Pre-treatment Monitoring Report

2015

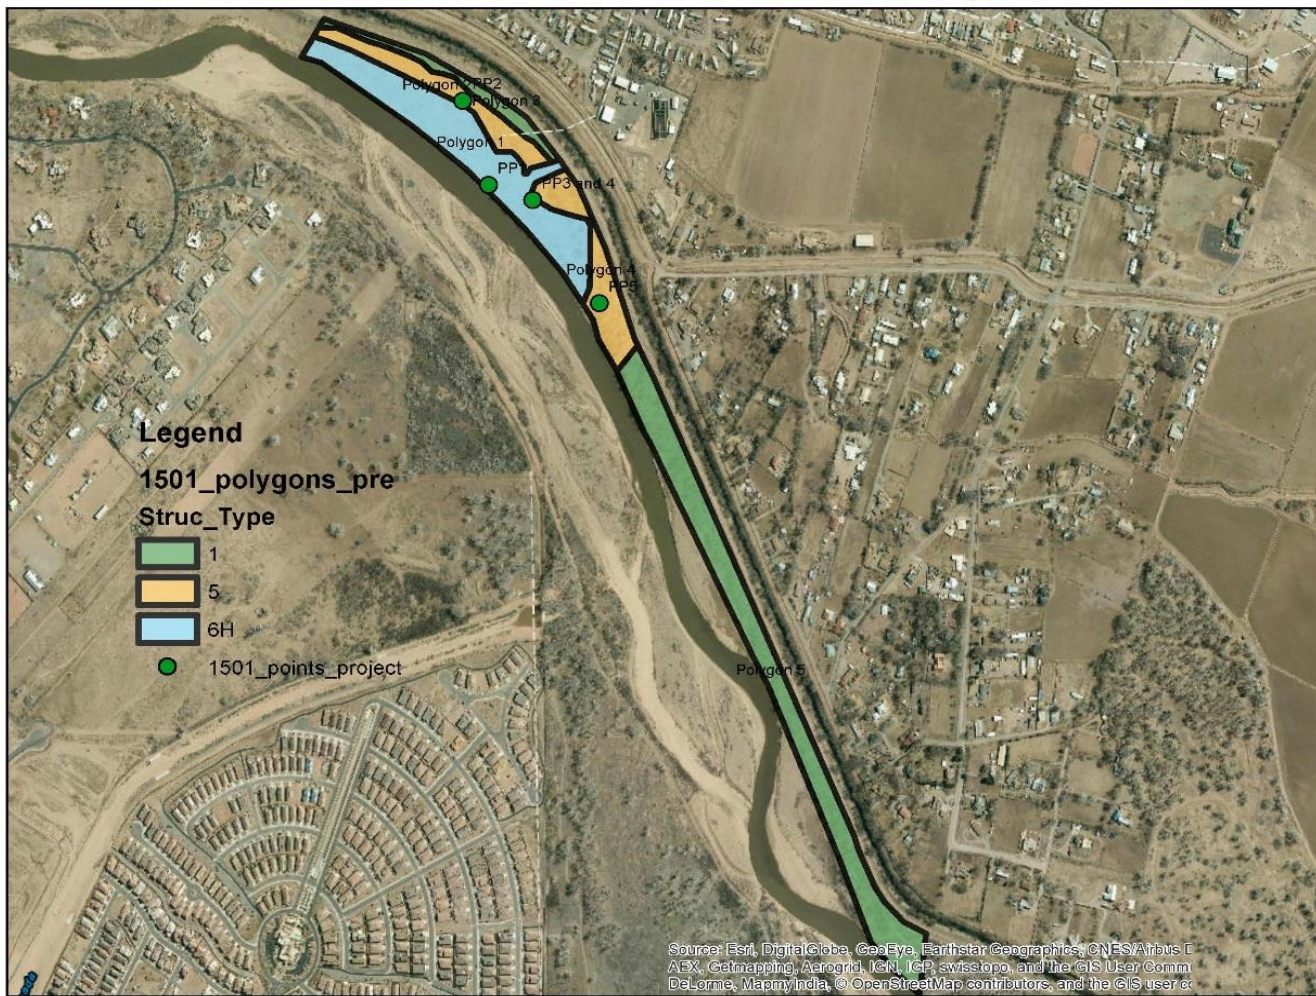
Figure 2. 15-01 Vegetation polygons and photopoints.

There are also jetty jacks present at this site, which present obstacles for access but are intended to remain in place to protect the levee. The north end of the 15-01 project was burned in 2001 by a fire reportedly started by a firework from Bernalillo. Replanting efforts in this area have been unsuccessful and at the time of the site visit there was an abundance of Russian thistle. Other treatment in the northern and central portion of the project has included mastication, which has left some disturbed soil as well as woody material on the ground. There is some New Mexico olive (*Forestiera neomexicana*) understory in the central portion of the project. Other native species observed in abundance included cottonwood, curlycup gumweed and false indigo-bush (*Amorpha fruticosa*). Lambsquarters were also prevalent, although their status as native or exotic is uncertain. Exotic species observed included tamarisk, Russian olive, Russian thistle, kochia, and a patch of Tree-of-Heaven. Many of the tamarisk were re-sprouts.

Lowest scores for this project came in the Relative Native Plant Community Composition and the Exotic Invasive Plant Species Cover, due to the high percentage of invasive plants. The amount of surface fuels is due largely to residual mastication material and cottonwood duff. The project scored best in the two structural metrics, indicating the presence of diversity both vertically and horizontally. This is reflected in the vegetation polygon map (Figure 2). This site scored a 1.9 out of 4 overall, which is a "C" or "Fair" biotic rating. Most metrics were above average in comparison to the other 2015 Pueblo of Sandia sites. Note that polygon 5 was not walked in its entirety due to time constraints and its assessment by the Bosque Project Manager as largely homogenous.

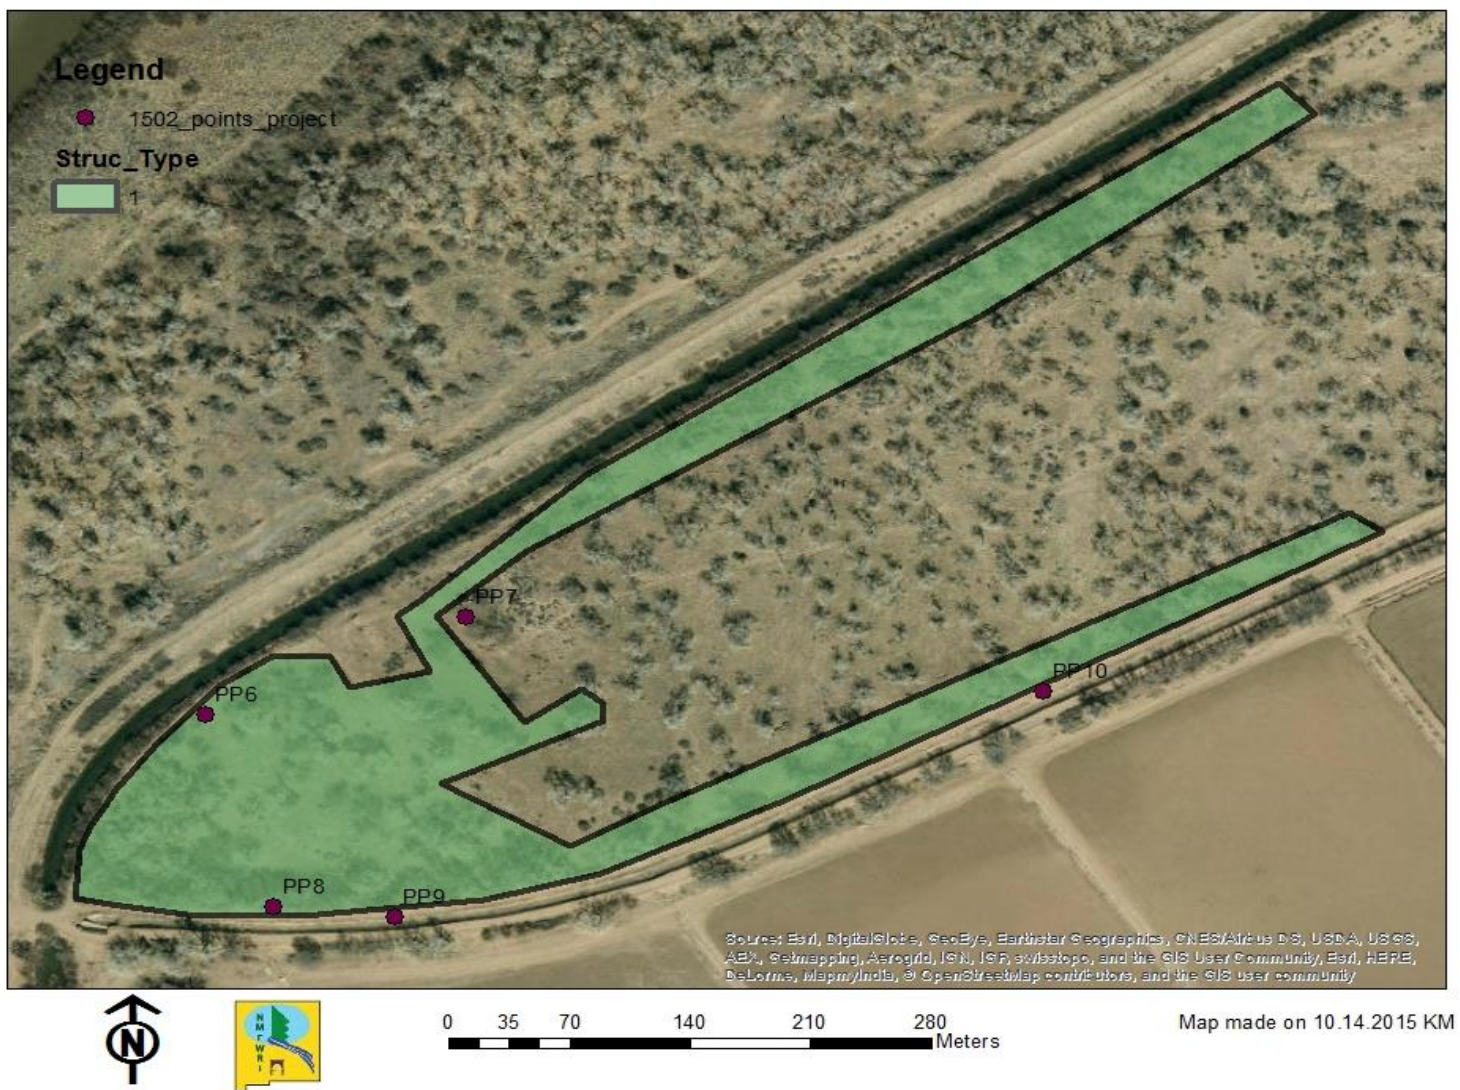
Figure 4. 15-02 Vegetation polygon and photopoints.

The project at this time is planned to be 13 acres. The delineation of this project was based on the distribution of Siberian elms and Russian olives, which explains its unusual shape. Other exotics observed included tamarisk and Russian thistle. Native species noticed in abundance included cottonwood, juniper, silverleaf nightshade, globemallow and sage. This site supported more xeric plant communities than did project 15-01.

Low scores for this project came from the high percentage of invasive plants, the lack of new native tree growth, and because the project boundaries so very closely followed invasive trees, which, combined with the small size, essentially meant the entire project was one vegetation community. This issue with the assessment methods, as well as other concerns, are discussed in the conclusion and recommendations section. The amount of surface fuels is due largely to the presence of weedy species like Russian thistle. The project scored best in the vertical structure metric, because the structure type was a high-structure forest. This is reflected in the vegetation polygon map (Figure 4). This site scored a 1.1 out of 4 overall, which is a “D” or “Poor” biotic rating. Most metrics were average or below average in comparison to the other 2015 Pueblo of Sandia sites.

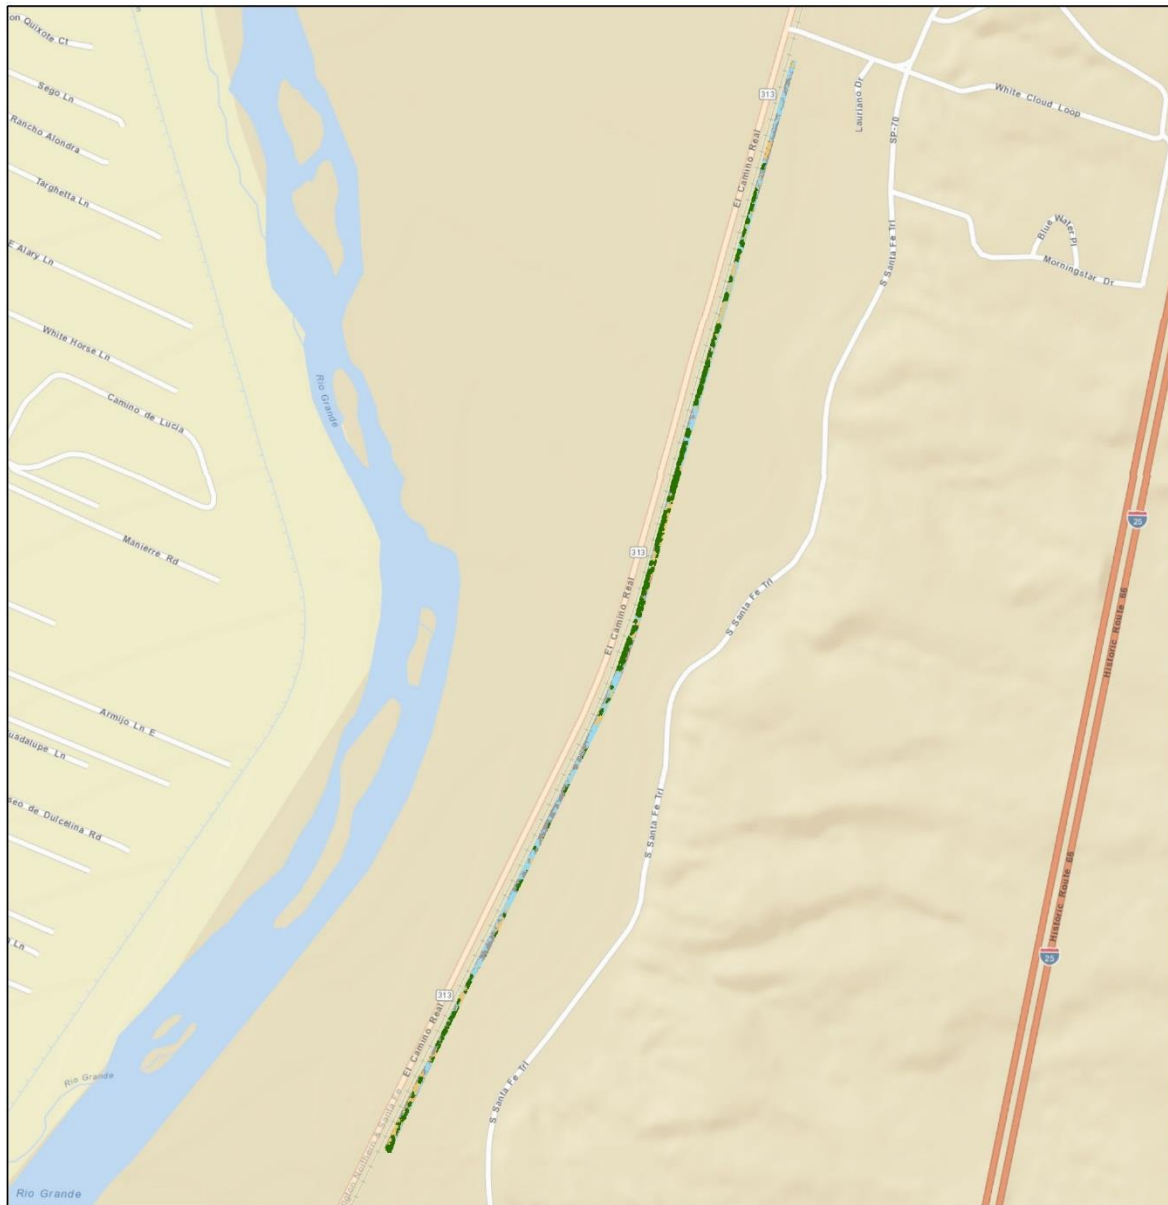
Figure 7. LiDAR and NAIP classification for 15-03.

The LIDAR classification of this project allowed us to create a vegetation classification map using the methods explained above. This shows that 3.6 acres of the project within the boundary were Type 1, High Structure Forest, which is likely Siberian elm and Russian olive, as well as some salt cedar. 1.3 acres of the project was Type 5, Tall Shrub stands, which could include some salt cedar. The remainder of the project, 4.56 acres, was classified as 6S Short Shrub, 6H Herbaceous, and 7 Bare Ground in which the presence of target nonnative phreatophytes is unlikely.

Because of the narrow, elongated shape of the project, classification is difficult to see, particularly when the entire project is shown in a single map (Figure 7). Maps showing the northern and southern portions of project separately are found in Figure 8. False color is used on the NAIP imagery to allow the viewer to distinguish the green Type 1 classification from the surrounding vegetation. Note that the acreage totals are for the entire project, not for the separate portions.

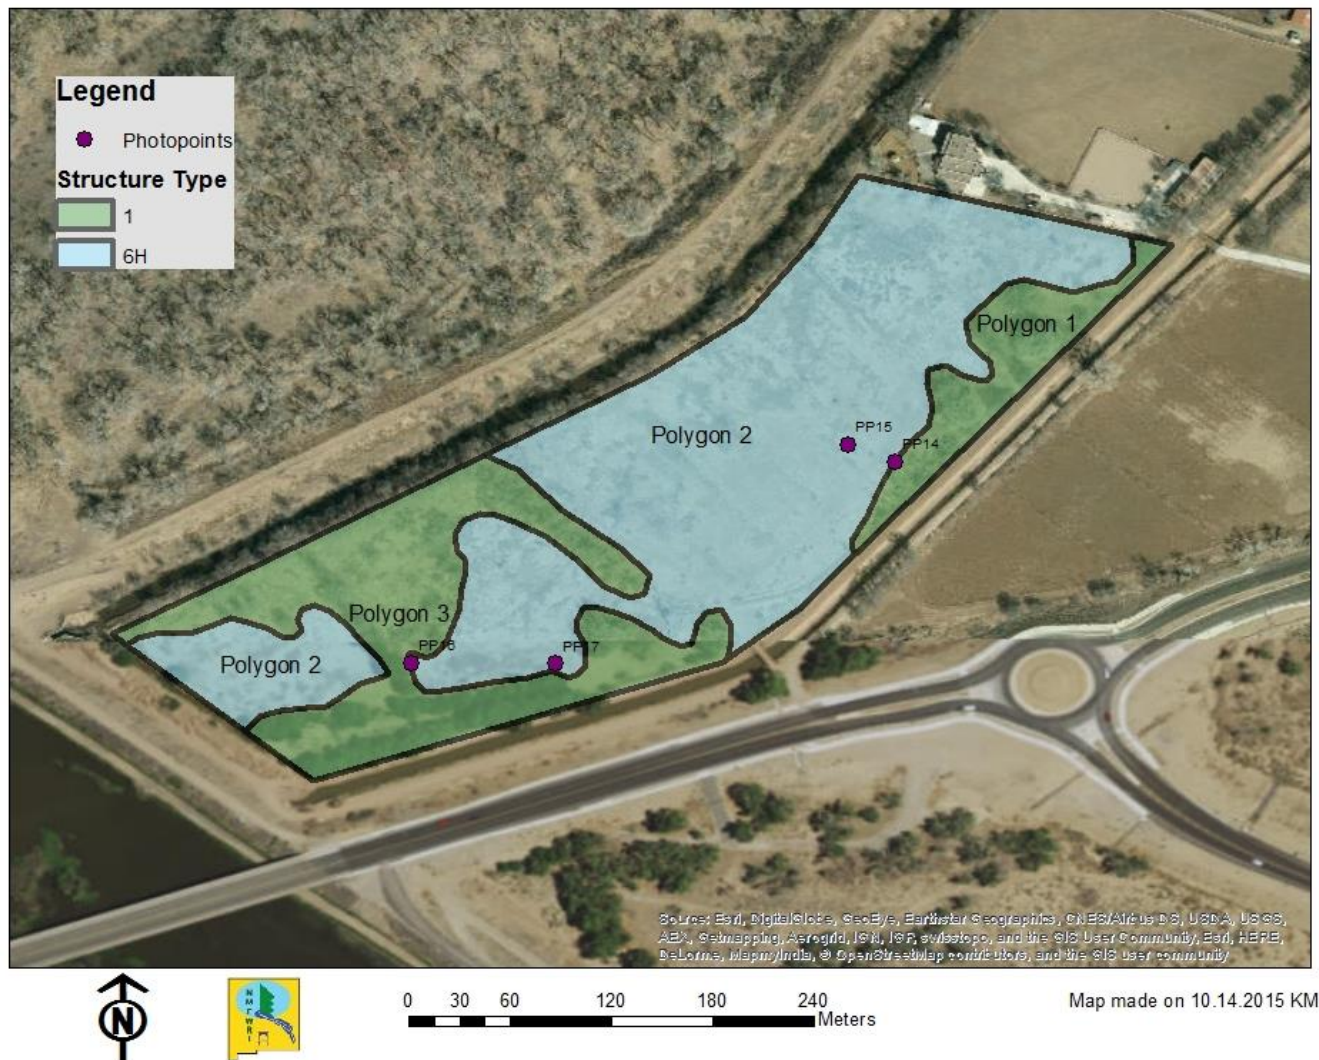
Figure 10. 15-04 Vegetation polygons and photopoints.

This site is an abandoned farm field where many Siberian elms have grown up along old irrigation ditches. Some salt cedar is present as well as one patch of tree-of-heaven. Alternative methods were discussed for treating tree-of-heaven, including extraction, but at this time they have not been explored. Other exotic species observed include Russian thistle, kochia, and Siberian elm. Native species observed in abundance include cottonwood, cota, sunflower, silverleaf nightshade, amaranth, and winterfat.

Low scores for this project came from the high percentage of invasive plants and the lack of new native tree growth. The amount of surface fuels is due largely to the presence of weedy species like Russian thistle. The project scored best in the vertical structure metric, because there were multiple structure types present including a high-structure forest. This is reflected in the vegetation polygon map, Figure 10. This site scored a 1.6 out of 4 overall, which is a “D” or “Poor” biotic rating. Most metrics were average in comparison to the other 2015 Pueblo of Sandia sites.

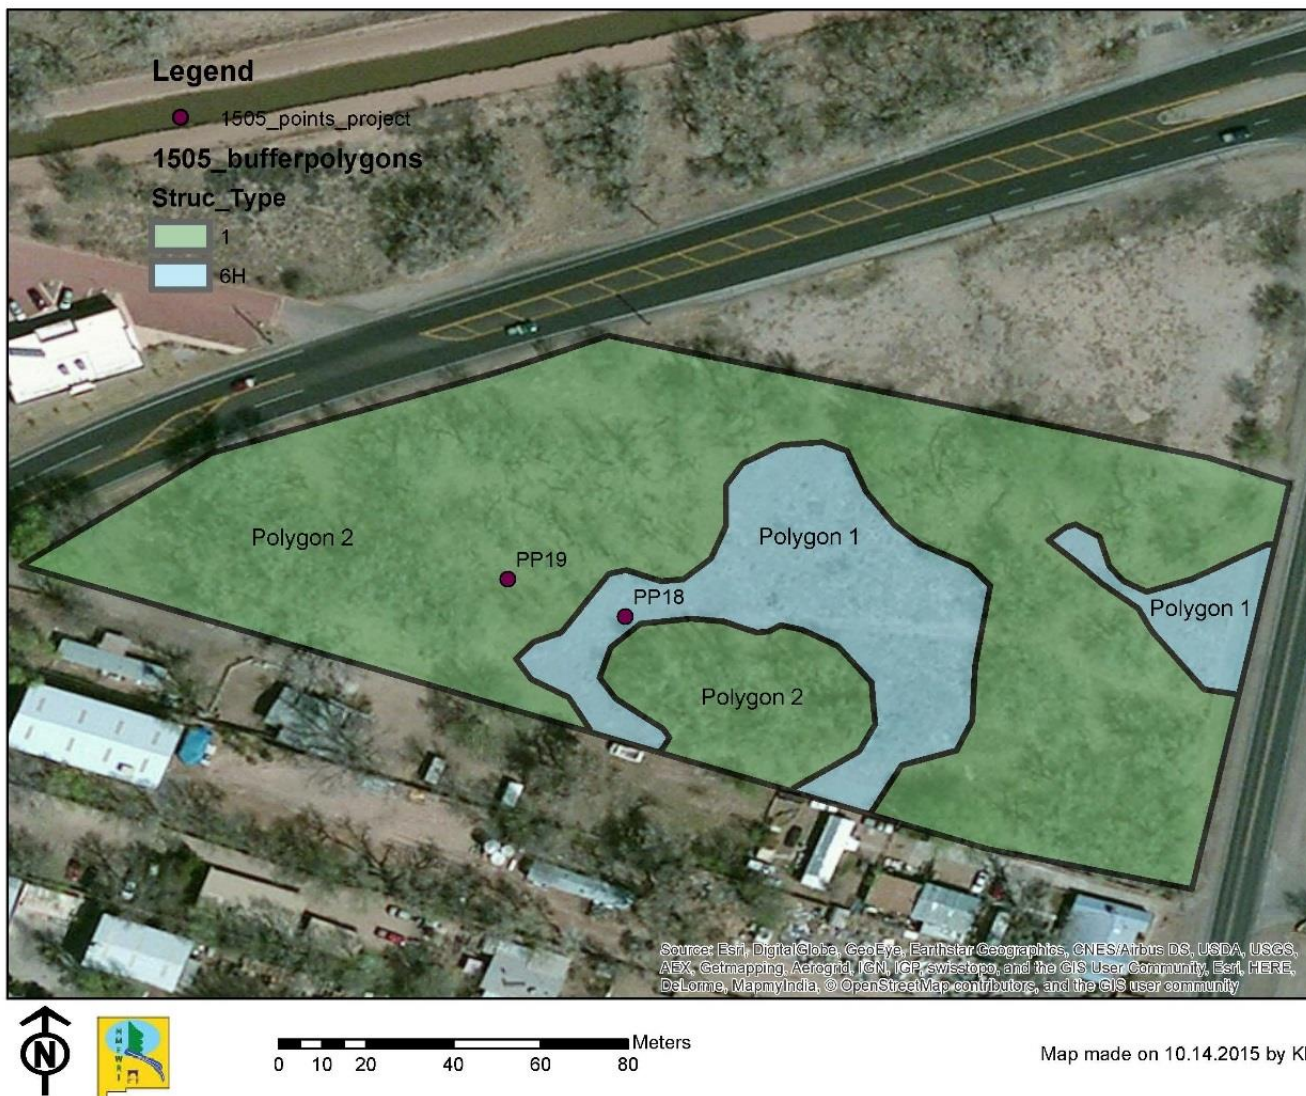
Figure 12. 15-05 Vegetation polygons and photopoints.

This site was recently purchased by the Pueblo. The property is bordered by a fence, though it is incomplete on the northeast side. There is no known development on the property, although there is a two-track road and concrete debris present. There are small to medium Siberian elms present, as well as some Russian thistle. This project has good ground cover, due largely to cottonwood leaves. It also has good canopy cover and shade. Native species observed in abundance included Canada lettuce, Canada wild rye, bursage, cota, and dropseed grass.

Low scores for this project came from the high percentage of invasive plants and the lack of new native tree growth; the above-average score in the Relative Native Plant Community Composition metric came in large part from the native cottonwood and native grass presence. The amount of surface fuels is due largely to the presence of cottonwood leaves as ground cover. The project scored best in the vertical structure metric, because there were multiple structure types present including a high-structure forest. This is reflected in the vegetation polygon map, Figure 12. This site scored a 1.9 out of 4 overall, which is a “C” or “Fair” biotic rating. Most metrics were average or above average in comparison to the other 2015 Pueblo of Sandia sites.
