Pueblo of Sandia Projects 16.01, 16.02a, 16.02b, 16.03, 16.04, 16.05

Post-treatment Monitoring Report

2021

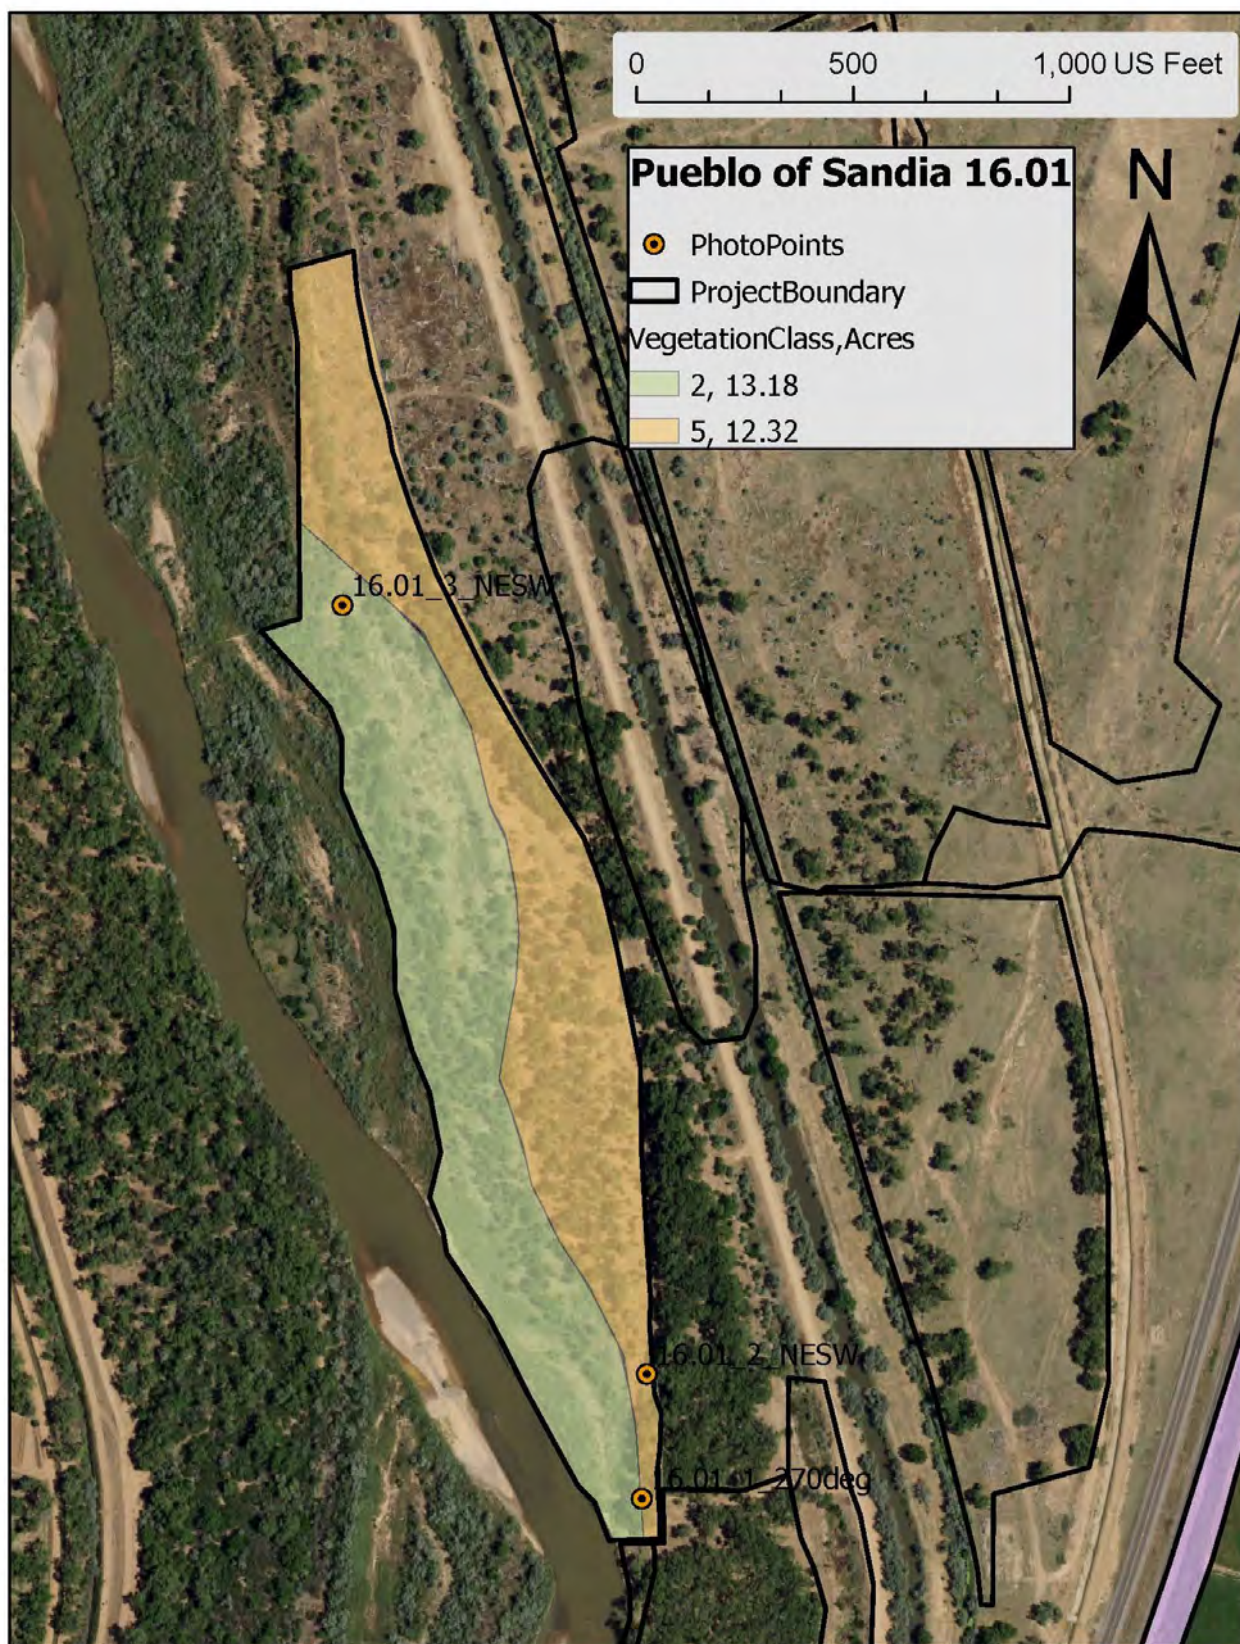
Figure 3. 16.01 Vegetation polygons and photopoints.

This site was observed to have beaver sign and cottonwood seedlings. Native vegetation including Rio Grande cottonwood, black willow, seep willow, and coyote willow was noted in abundance; some cottonwoods appeared to have been burned in the Romero Fire and a patch of high mortality among willows, cottonwoods and salt cedar was observed near the Bureau of Reclamation fence line. The

reason for this mortality was unclear at the time of the site visit. An old channel was present on site with wetland characteristics; the western edges of the project had the most hydrophilic vegetation. Sunflowers were abundant in the burned areas. In general, overstory was somewhat sparse, resulting in patchy shade. Other native species observed included New Mexico olive, dropseed grass, rough cocklebur and silverleaf nightshade. Exotic species observed on the site included Russian thistle (tumbleweed), Russian olive, salt cedar, tree-of-heaven, and sacred datura.

In 2021, the only metric which dropped in rating was Native Riparian Tree Regeneration. No young riparian trees were observed in 2021. In 2016 more than 5% of the sample area had riparian tree saplings on site, in 2021 high cottonwood mortality was noted in the sample area. Invasive species cover dropped from 70% to 25%, due to the vegetation treatment, though patches of dense invasive species were noted where cottonwood mortality had created light gaps. From 2016 to 2021 there was a loss of high structure forests, and this can be attributed to cottonwood mortality which was represented by down woody debris scattered across the site. Tall shrub vegetation was the dominant vegetation type for both years the site was monitored. Overall, the site score went down from 2016, from a “C” or “Fair” to a “D” “Poor”.

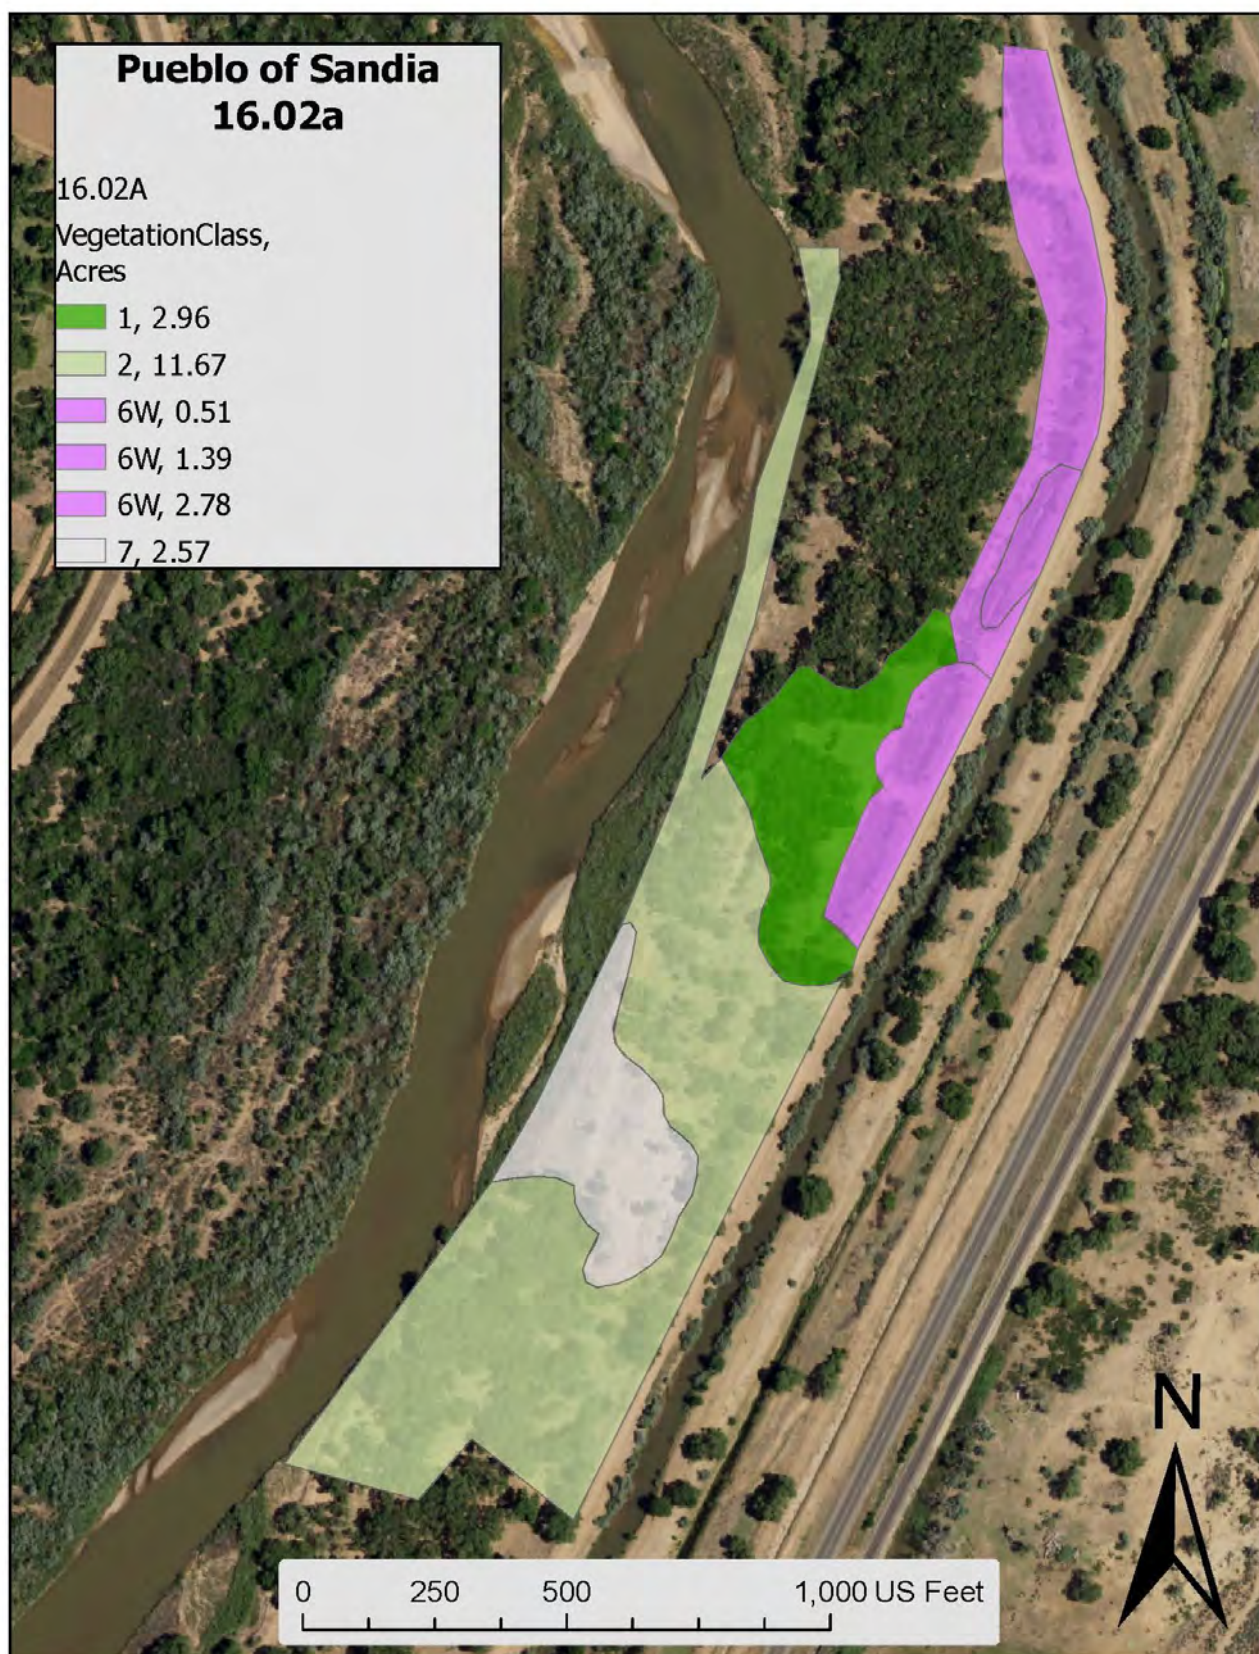
Figure 5. 16.02a Vegetation polygon and photopoints.

Field crew observations on this site included the presence of salt cedar and Russian olive trees, mostly under 8 feet tall. Native vegetation including Rio Grande cottonwood, dropseed grass, scratchgrass, and buffalo bur. Cattail was observed at some of the ponds. Exotic species observed included salt cedar, Russian olive, Siberian elm, and Russian thistle.

The site score remained the same as observed in 2016, though there were small changes in significant areas of the monitoring. These significant areas of change were native riparian tree regeneration and Relative Native Plant Community Composition. In 2016, a small amount of native tree saplings were found in the sample area; this observation was not made in 2021. This means the area lacks the next generation of native trees required to maintain a healthy ecosystem and ensure the survival of the species in the area. Native species, such as New Mexico Olive and Seep Willow were observed in areas that previously contained Tamarisk and Russian Olive. This could be correlated with the dominance of low structure forest vegetation type within the sample area that was once dominated by high-structure forest. Overall. The site has improved in quality due to the reduction in invasive species cover (70% from 2016 to 40% in 2021).

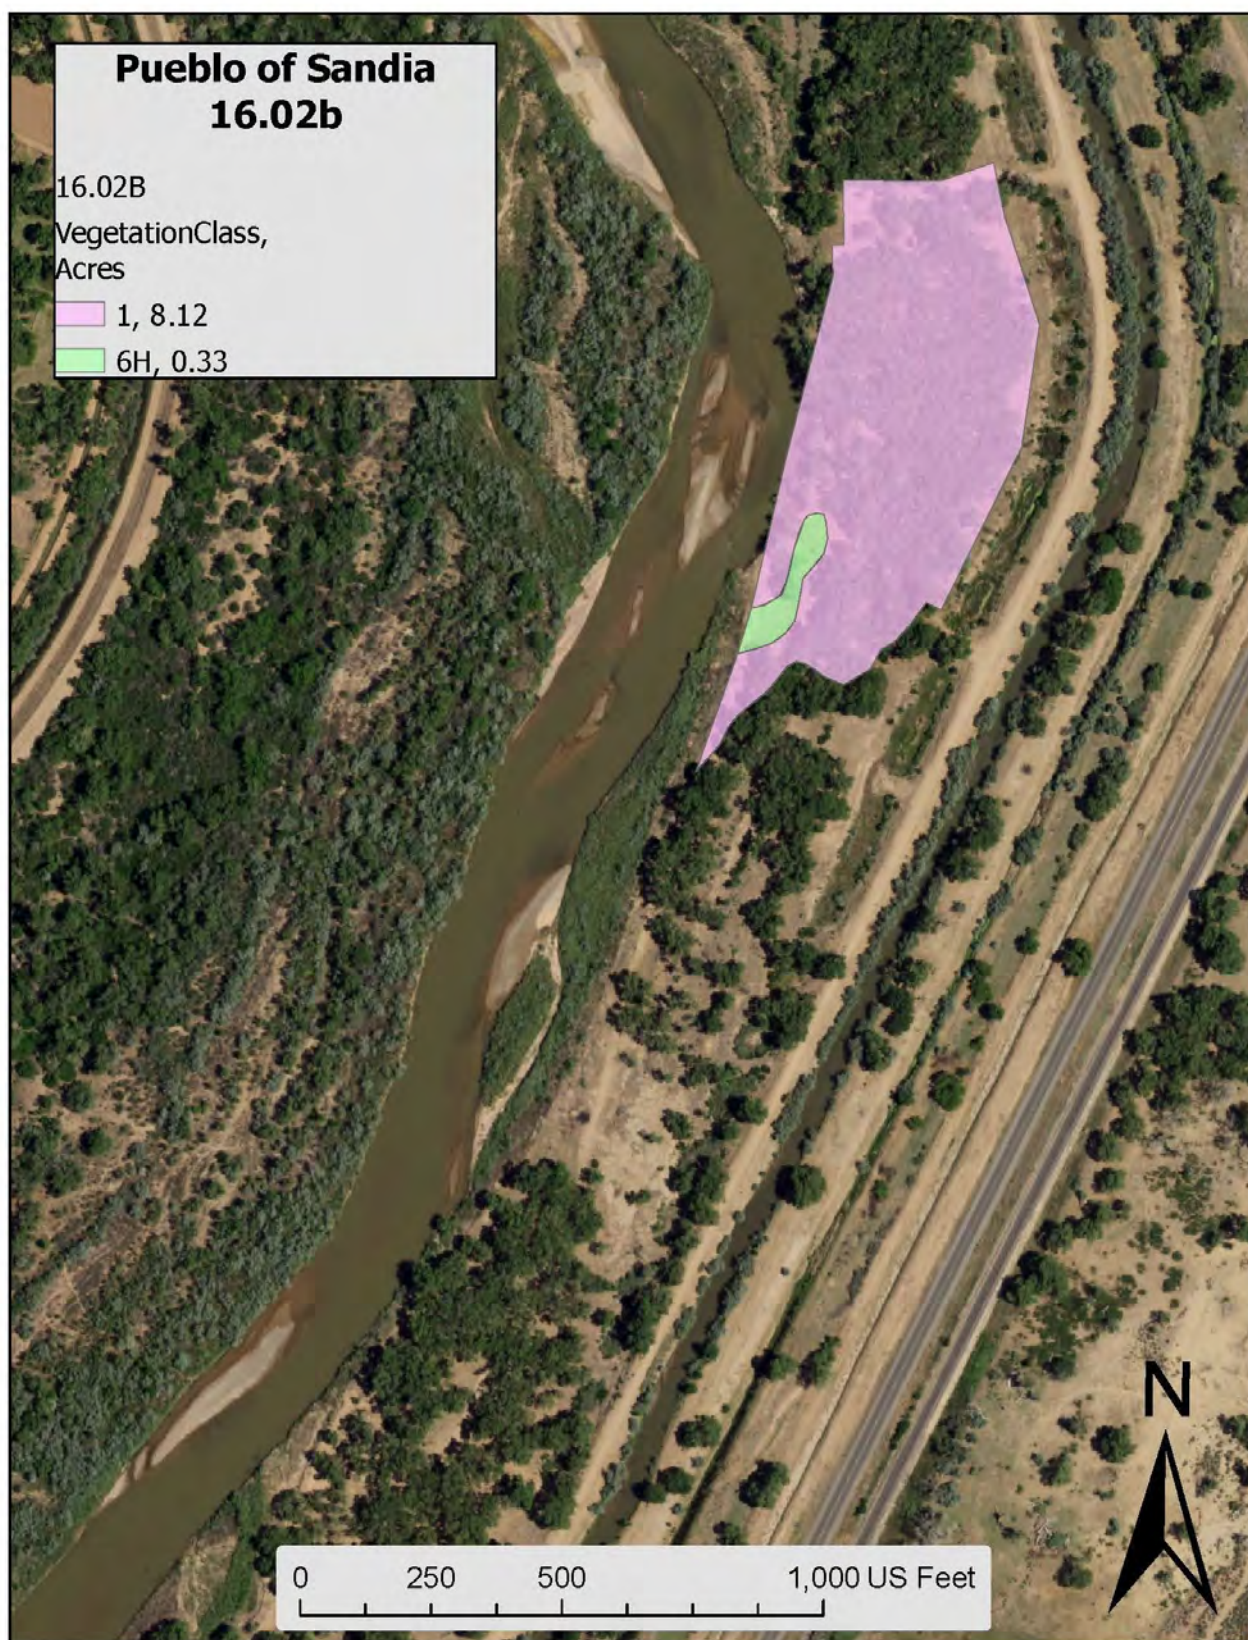
Figure 7. 16.02b Vegetation polygons.

Field crew observations on this site included the presence of Rio Grande cottonwood, New Mexico olive, juniper, dropseed and scratchgrass. Exotic species included salt cedar, Russian olive and a few Siberian elm, primarily as seedlings and saplings.

Scores for the sample area remained similar to those observed in 2016, with changes occurring in the invasive exotic plant species cover and native plant community composition. Invasive exotic plant species cover score improved from 2016 to 2021; coverage went from 40% in 2016 to 10% in 2021. Low scores for native plant community composition in 2016 can be attributed to Tamarisk occupying significant portions of their vegetation community. In 2021, more native species such as New Mexican Olive and Desert Saltgrass were observed which contributed to a higher scoring. An increase in native shrubs and grass could be due to reduced competition from plants such as Tamarisk and Russian Olive which were removed during treatment. The amount of surface fuels observed in 2021 was also lower than in 2016 and this could be a result of less Tamarisk present to produce flammable leaf litter.

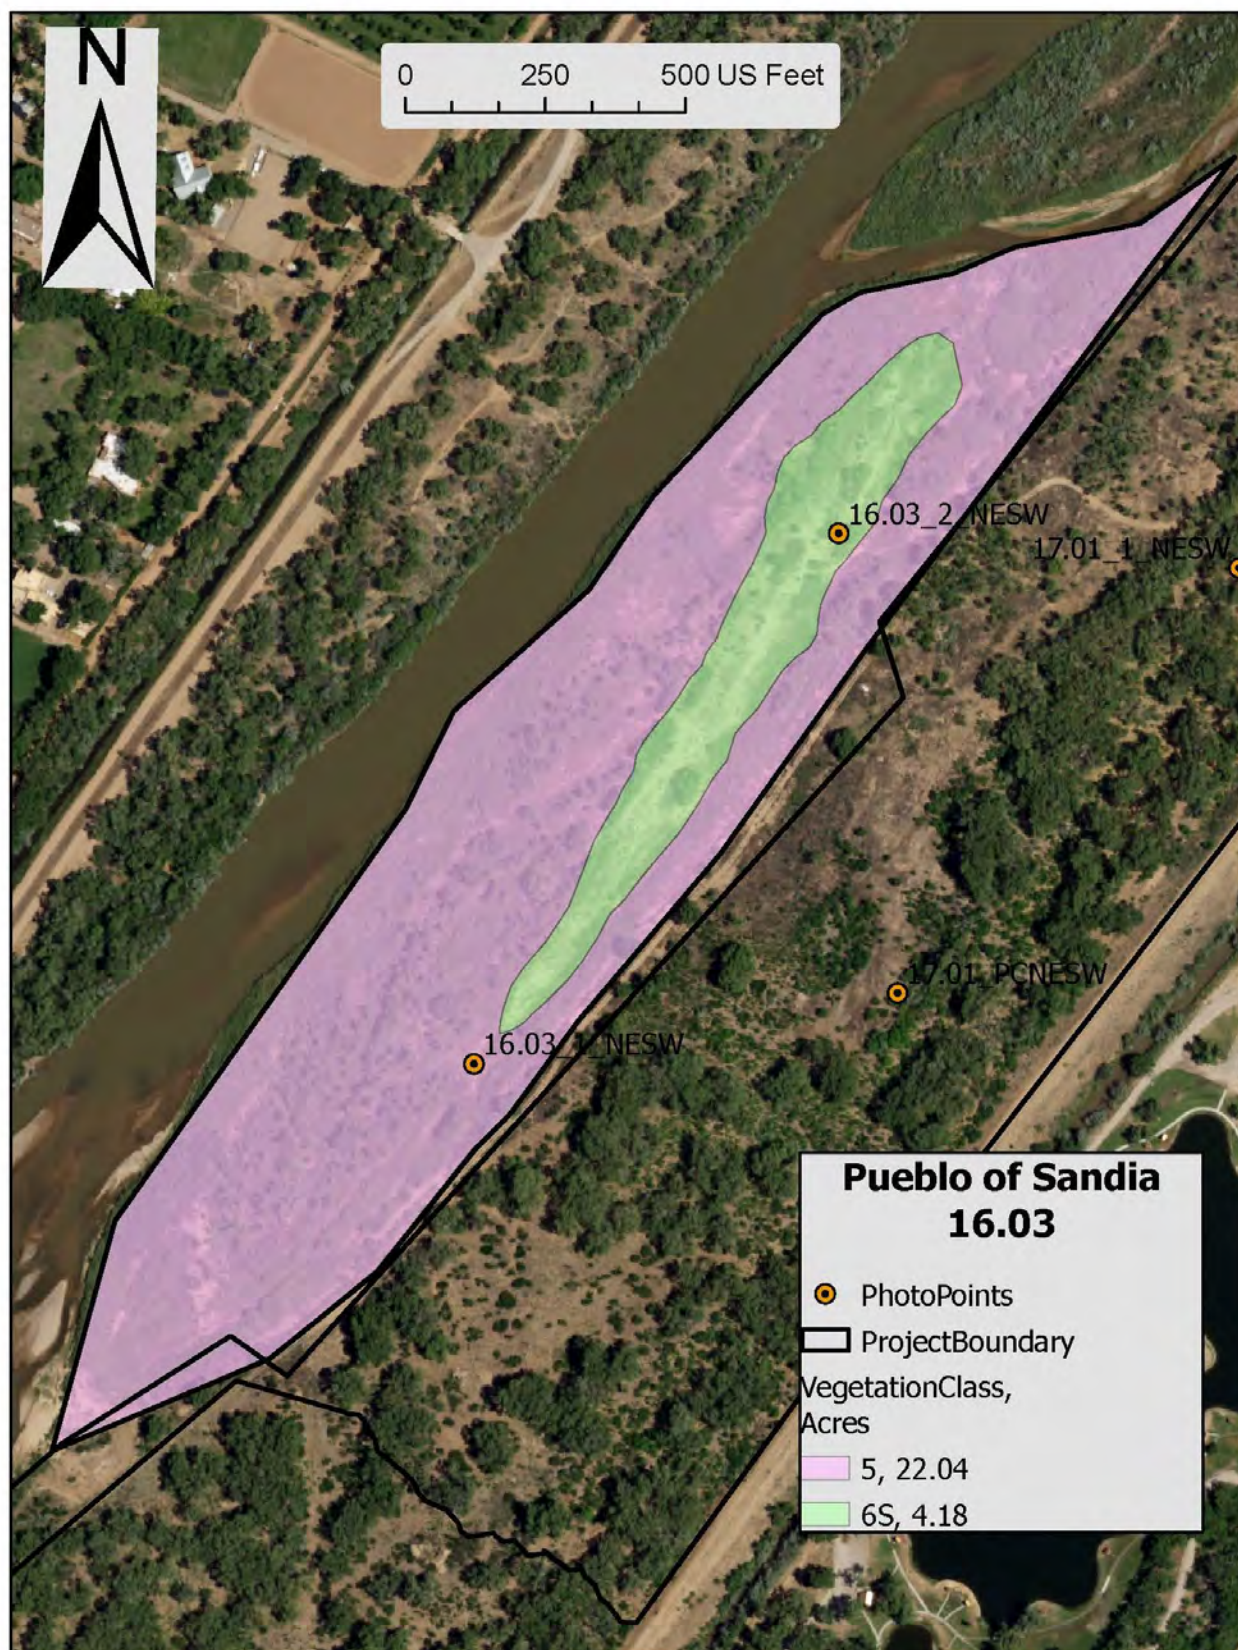
Figure 9. 16.03 Vegetation polygons and photopoints.

Native species observed by the field crew included Rio Grande cottonwood, coyote willow, horseweed, horsetail, as well as other forbs and grasses. Exotic species included Siberian elm, Russian olive, salt cedar, and Russian thistle.

The lowest score came in Native Riparian Tree Regeneration while the Relative Native Plant Community Composition score increased. In 2016 it was noted that native riparian tree saplings were 'well represented, displayed obvious regeneration, and covered more than 5% of the sample area'. In 2021 none of this was observed. Cottonwoods were observed within the sample area during 2021 monitoring but were not the dominant vegetation and therefore were not recorded as a significant species present. Instead, coyote and black willows, both native species, were present and dominant enough to positively affect the native plant community composition rating.

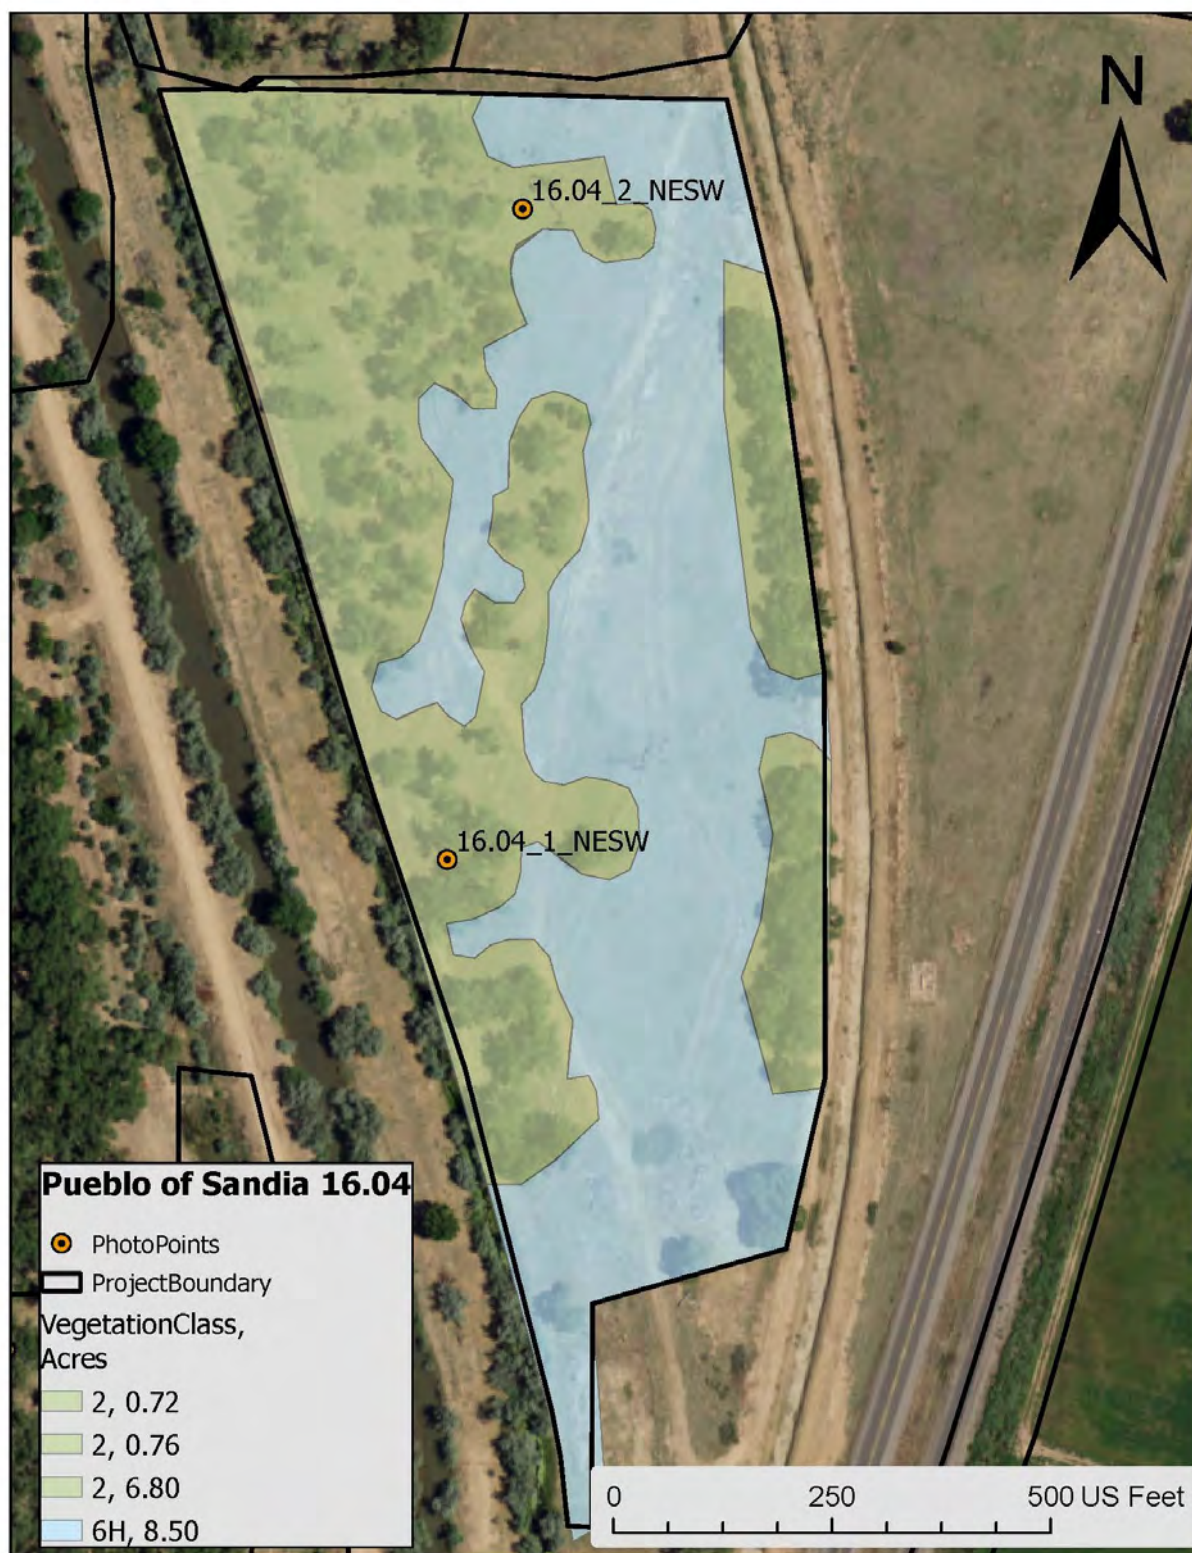
Figure 11. 16.04 Vegetation polygons and photopoints.

At the time of the site visit, large cottonwood pieces from the Sandia Lakes clearing were near the project boundaries. Target species on the project are mostly Russian olive. The Pueblo of Sandia had already begun extracting some Russian olive trees and piling them for the contractor to masticate. Cows were on-site during the pre-treatment monitoring site visit. Native species observed by the field crew

included Rio Grande cottonwood, dropseed grass and scratchgrass. Exotic species included Russian olive and Siberian elm.

Low scores for this project were the same as in 2016's. Five-year post monitoring observed only two vegetation structure types, the same number observed in 2016, though there was a change in which vegetation structure types. As in 2016, Low Structure Forest remained the dominant vegetation structure type, but in 2021 no tall structure forest was observed, instead there was short herbaceous vegetation. This observation makes sense because the sample area was seeded with grass mix after the removal of invasive exotic woody plants. The short herbaceous vegetation type occupied 40% of the sample area; in 2016 Tall Structure Forest occupied 46% of the sample area. Overall, the site scored a "D" or "Poor".

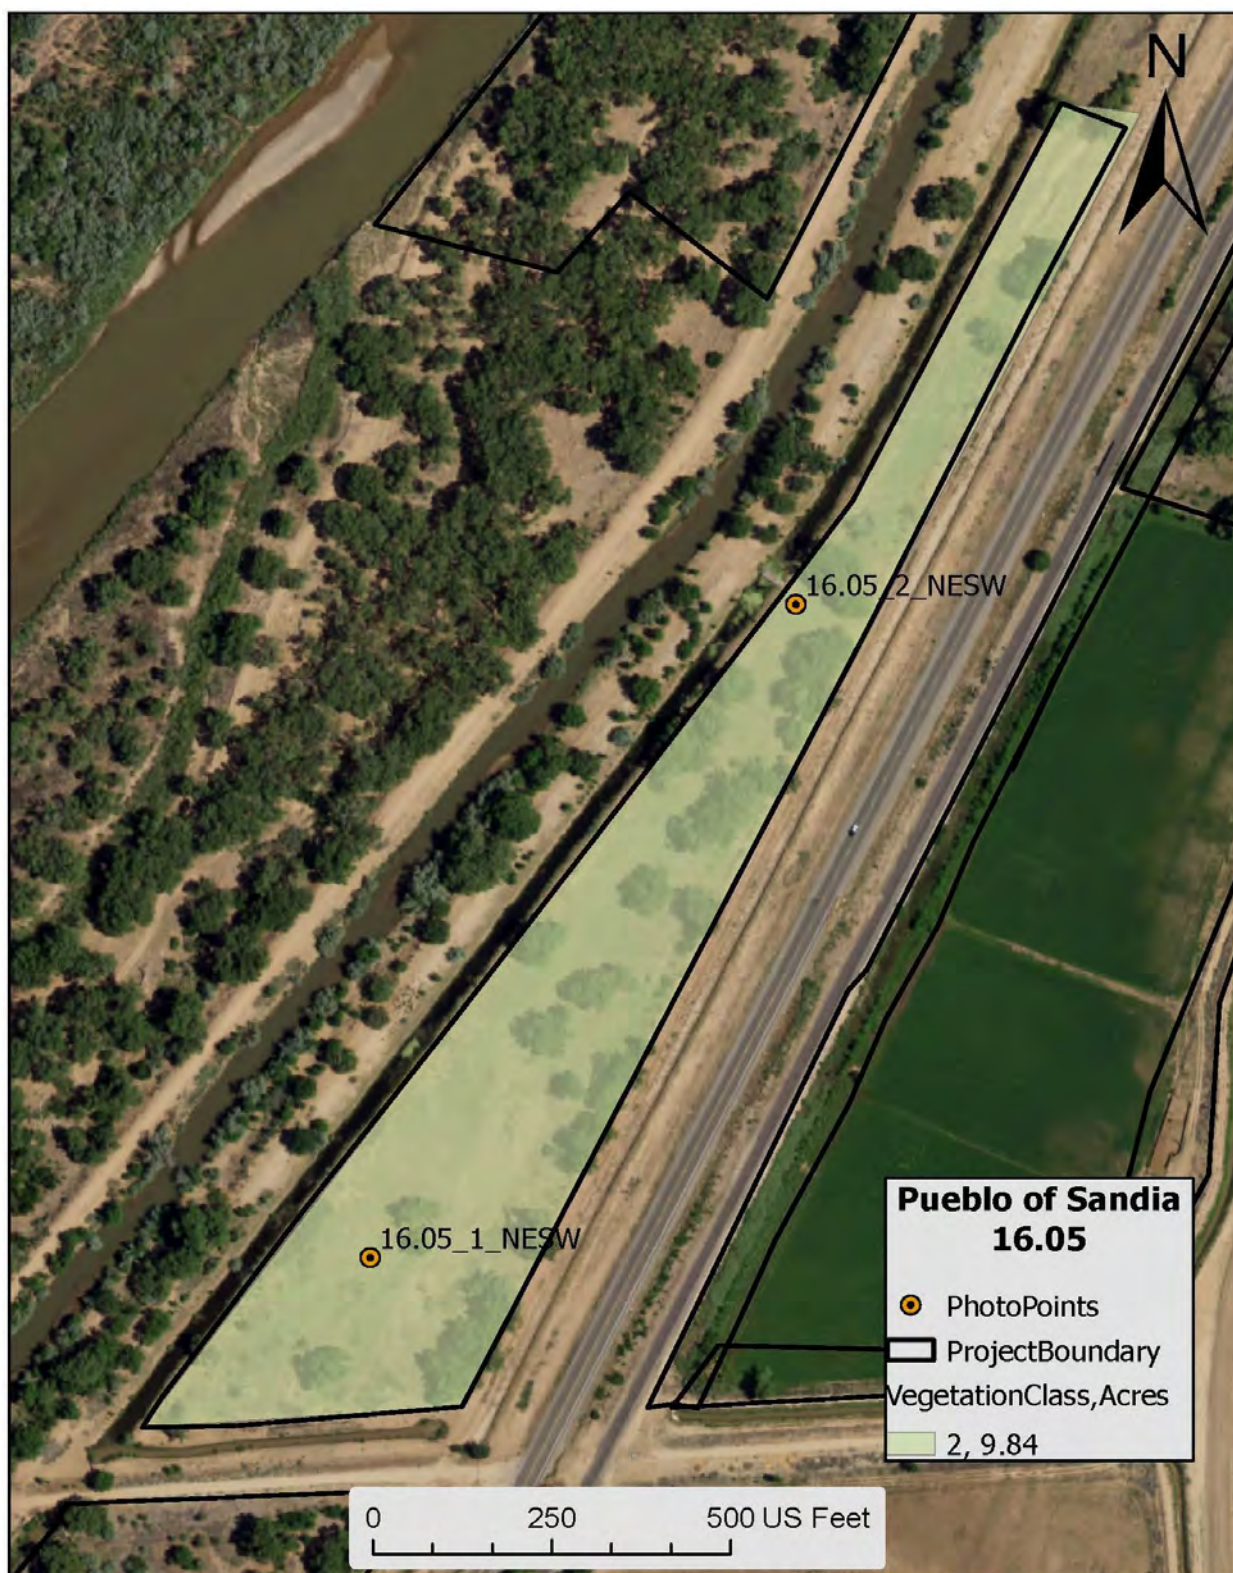
Figure 13. 16.05 Vegetation polygons and photopoints.

Field crew observations included several Siberian elm seedlings and resprouts as well as trees in banks that were left from a previous treatment. At the time of the site visit, there were signs of recent livestock grazing and a beaver dam was present above the wooden bridge at the north end of the project.

Low scores for this project came in Vegetation Horizontal Patch Structure and Invasive Exotic Plant Species Cover. In 2016 two different types of vegetation structure were observed: Tall Shrub structure and herbaceous vegetation. In 2021, only Low Structure Forest vegetation was observed, this could be due to maturing trees in the area shading out smaller plants and keeping the understory clear of growth. Invasive exotic vegetation cover was reduced by 8% from 2016 to 2021 and can be attributed to the removal of these plants during treatment. More surface fuels were observed in 2021 possibly a result of mastication.
