**Pueblo of Sandia Projects 16-01, 16-02a, 16-02b, 16-03, 16-04, 16-05**

**Pre-treatment Monitoring Report**

2016

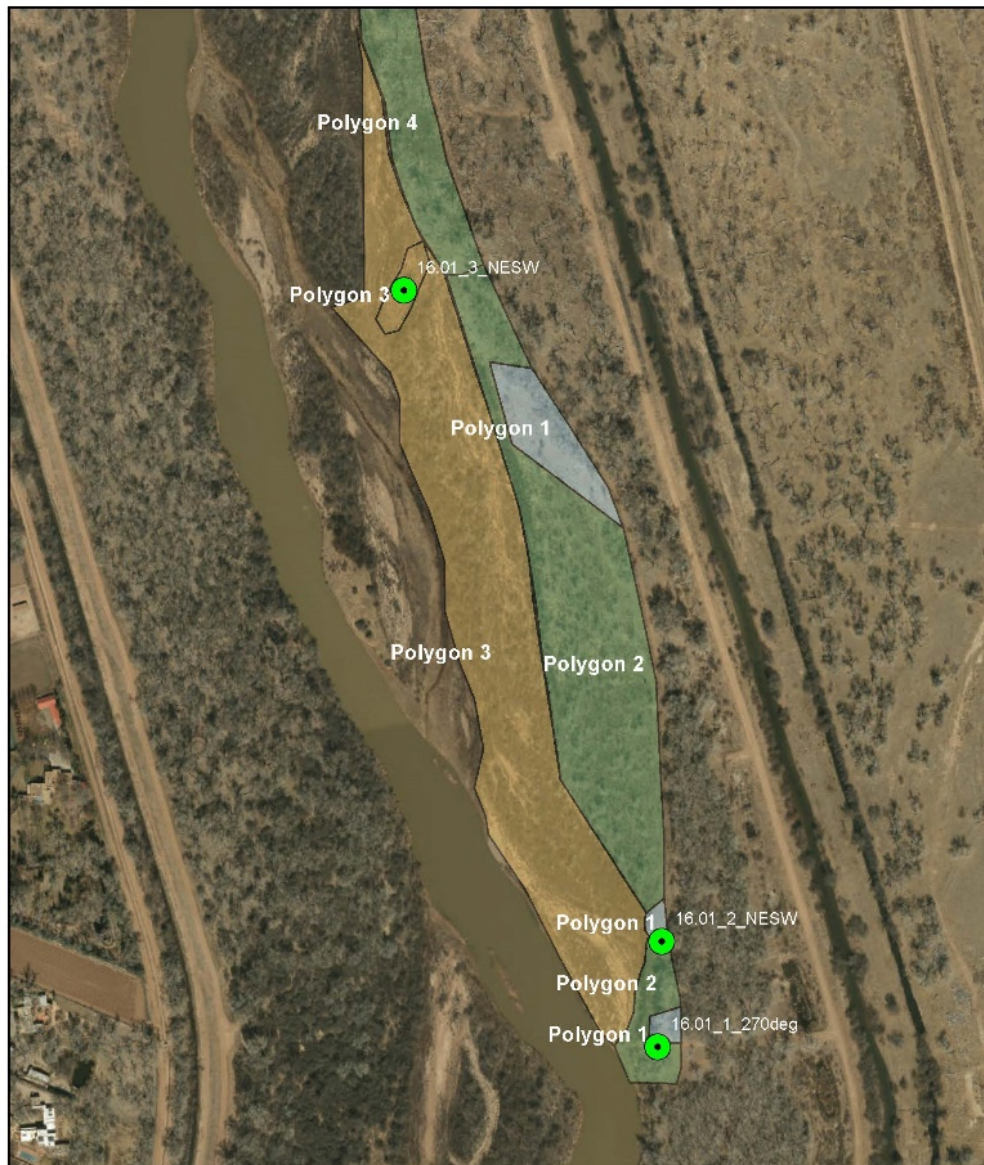
Figure 3. 16-01 Vegetation polygons and photopoints.

This site was observed to have beaver sign and cottonwood seedlings. Native vegetation including Rio Grande cottonwood, black willow, seepwillow, and coyote willow was noted in abundance; some cottonwoods appeared to have been burned in the Romero Fire and a patch of high mortality among willows, cottonwoods and salt cedar was observed near the Bureau of Reclamation fenceline. The

reason for this mortality was unclear at the time of the site visit. An old channel was present on site with wetland characteristics; the western edges of the project had the most hydrophilic vegetation. Sunflowers were abundant in the burned areas. In general, overstory was somewhat sparse, resulting in patchy shade. Other native species observed included New Mexico olive, dropseed grass, rough cocklebur and silverleaf nightshade. Exotic species observed on the site included Russian thistle (tumbleweed), Russian olive, salt cedar, tree-of-heaven, and sacred datura.

The lowest score for this project came in the Exotic Invasive Plant Species Cover metric, due to the high percentage of invasive plants (estimated over 50% of the site). The amount of surface fuels is due largely to residual mastication material and cottonwood duff. The project scored best in the Native Riparian Tree Regeneration metric, due to the abundance of cottonwood seedlings. This site scored a 2.2 out of 4 overall, which is a “C” or “Fair” biotic rating. Most metrics were average in comparison to the other 2016 Pueblo of Sandia sites.

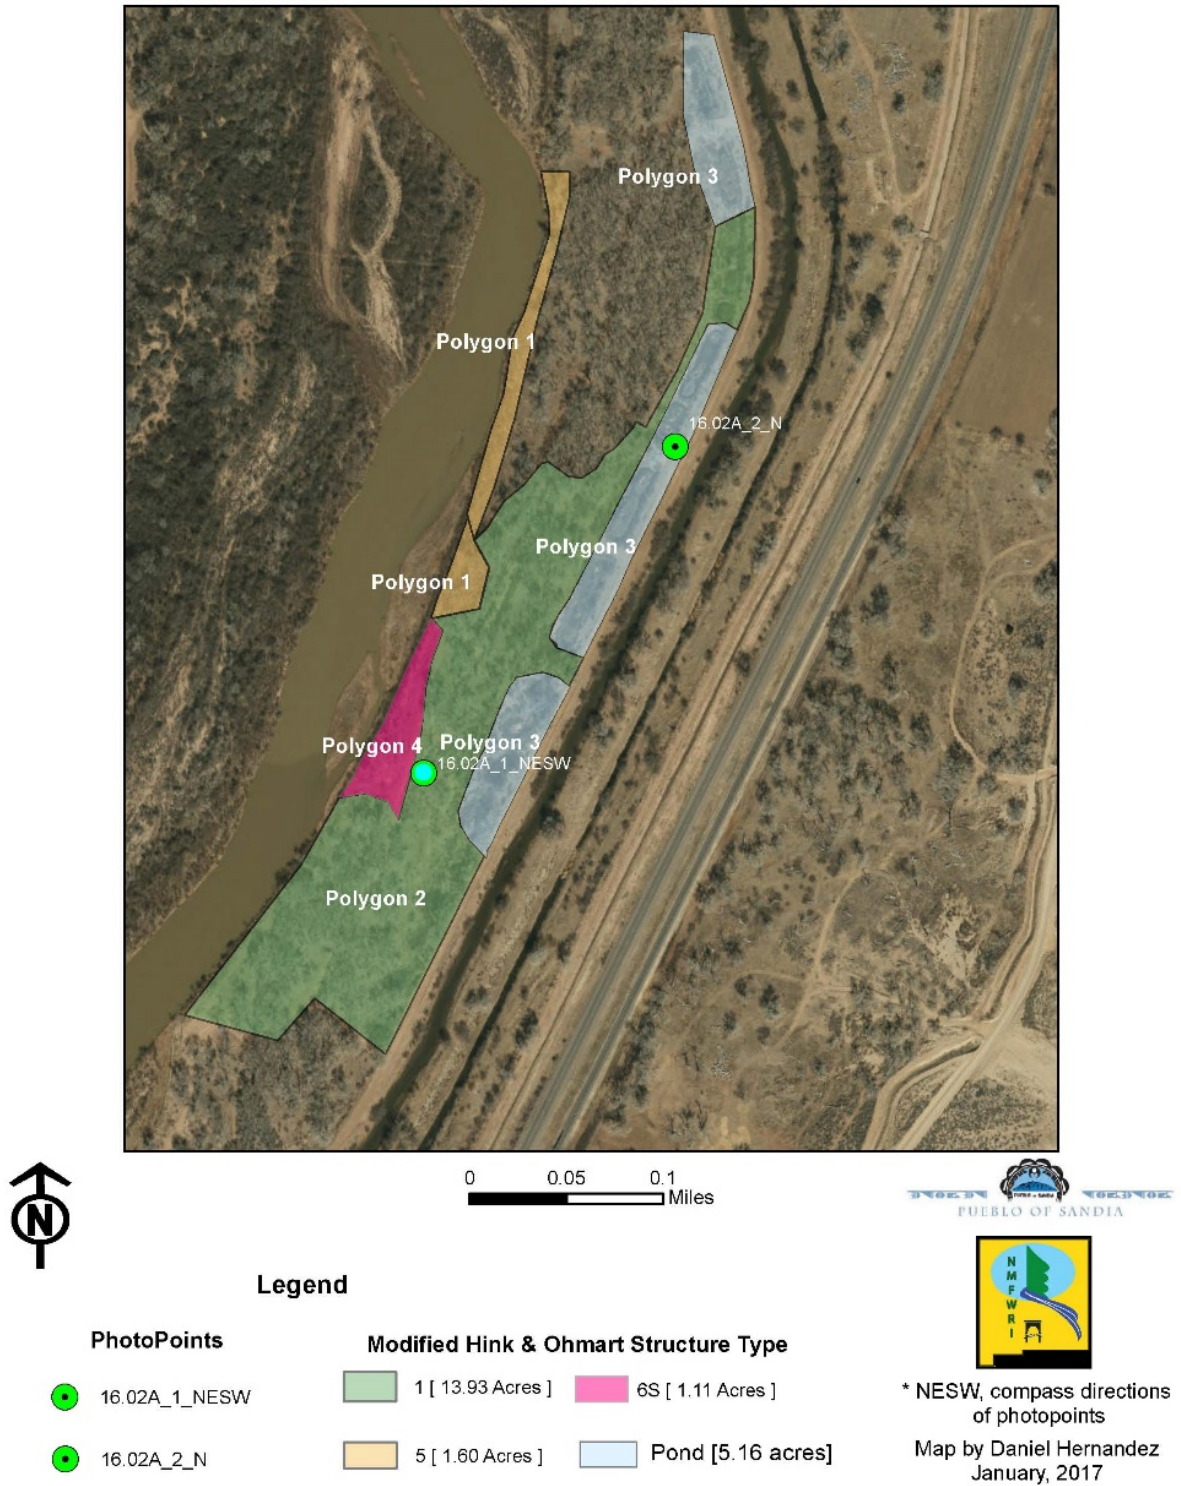
Figure 5. 16-02a Vegetation polygon and photopoints.

Field crew observations on this site included the presence of salt cedar and Russian olive trees, mostly under 8 feet tall. Native vegetation including Rio Grande cottonwood, dropseed grass, scratchgrass, and buffalo bur. Cattail was observed at some of the ponds. Exotic species observed included salt cedar, Russian olive, Siberian elm, and Russian thistle.

Lowest scores for this project came in the Relative Native Plant Community Composition and Exotic Invasive Plant Species Cover metrics, due to the high percentage of invasive plants (estimated at over 50% of the site). The amount of surface fuels is due largely to the presence of weedy species like Russian thistle. The project scored best in the vertical and horizontal structure metrics, because of the variety of communities and the dominance of high-structure forest. This is reflected in the vegetation polygon map (Figure 5). This site scored a 1.9 out of 4 overall, which is a “C” or “Fair” biotic rating. Most metrics were average or above average in comparison to the other 2016 Pueblo of Sandia sites.

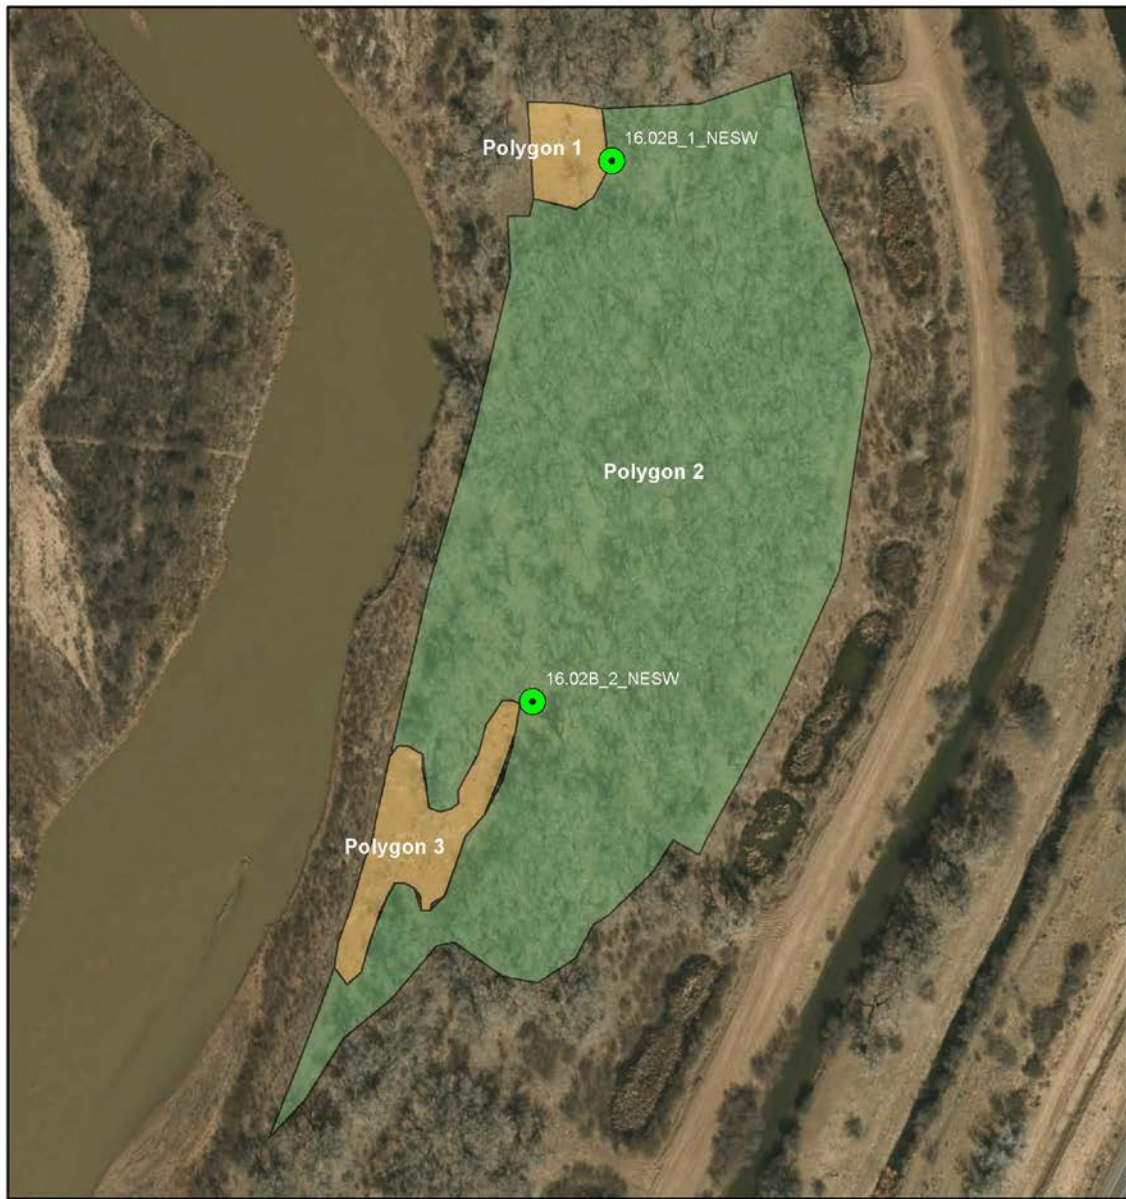
Figure 7. 16-02b Photopoints & Vegetation polygons.

Field crew observations on this site included the presence of Rio Grande cottonwood, New Mexico olive, juniper, dropseed and scratchgrass. Exotic species included salt cedar, Russian olive and a few Siberian elm, primarily as seedlings and saplings.

Lowest scores for this project came in the Relative Native Plant Community Composition and Exotic Invasive Plant Species Cover metrics, due to the high percentage of invasive plants (estimated at over 50% of the site). Low scores were also recorded in the Vegetation Horizontal Patch Structure and Native Riparian Tree Regeneration metrics, due to the low diversity of plant communities within the project area and the lack of native riparian regeneration. The amount of surface fuels is due largely to the presence of weedy species, mastication material and down woody debris, and cottonwood duff. The project scored best in the vertical structure metrics, because of the dominance of high-structure forest. This is reflected in the vegetation polygon map (Figure 7). This site scored a 1.5 out of 4 overall, which is a “D” or “Poor” biotic rating. Most metrics were below average in comparison to the other 2016 Pueblo of Sandia sites.

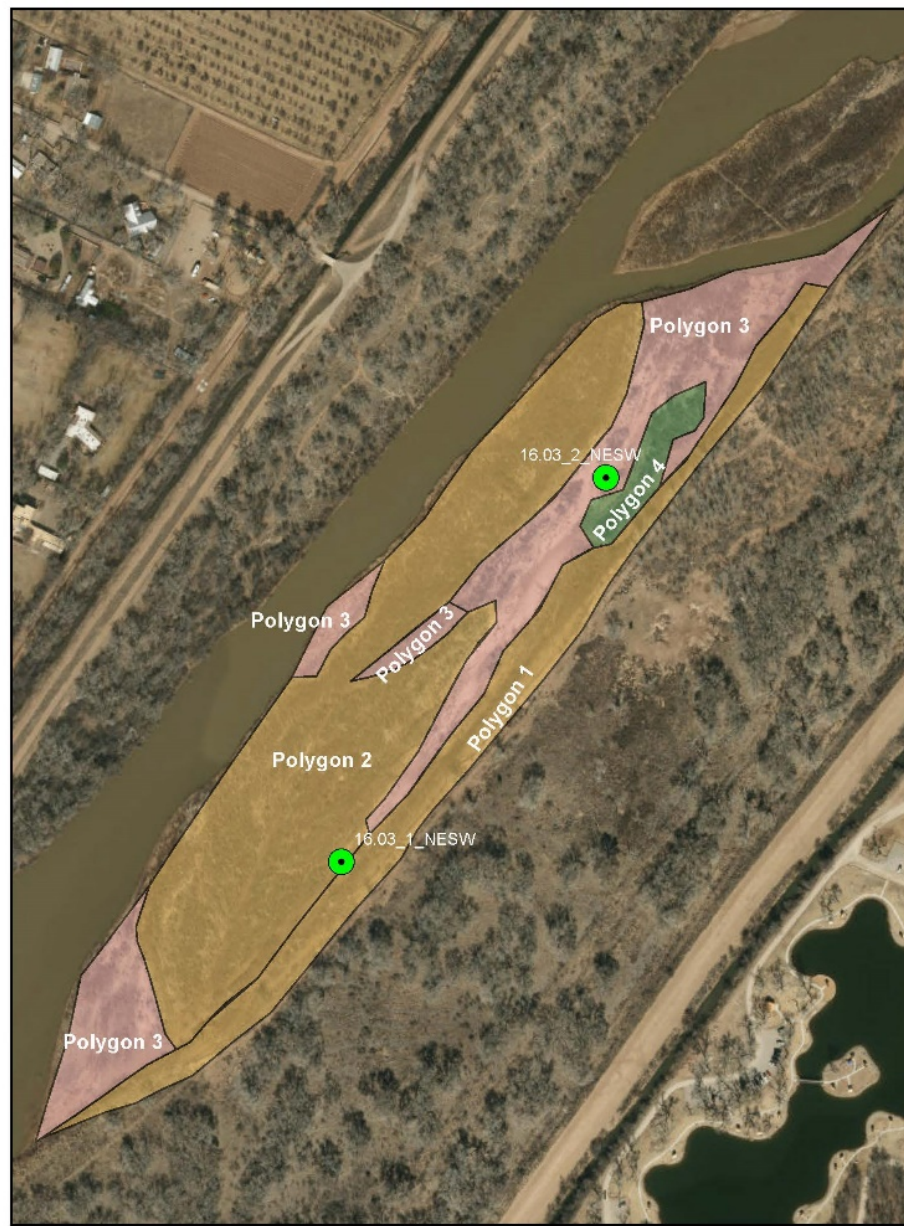
Figure 9. 16-03 Vegetation polygons and photopoints.

Native species observed by the field crew included Rio Grande cottonwood, coyote willow, horseweed, horsetail, as well as other forbs and grasses. Exotic species included Siberian elm, Russian olive, salt cedar, and Russian thistle.

The lowest scores for this project came in the Relative Native Plant Community and Exotic Invasive Plant Species Cover metrics due to the high percentage of invasive plants. The project scored best in the Native Riparian Tree Regeneration metric because of the presence of cottonwood regeneration. This site scored a 1.7 out of 4 overall, which is a “D” or “Poor” biotic rating. Most metrics were average in comparison to the other 2016 Pueblo of Sandia sites.

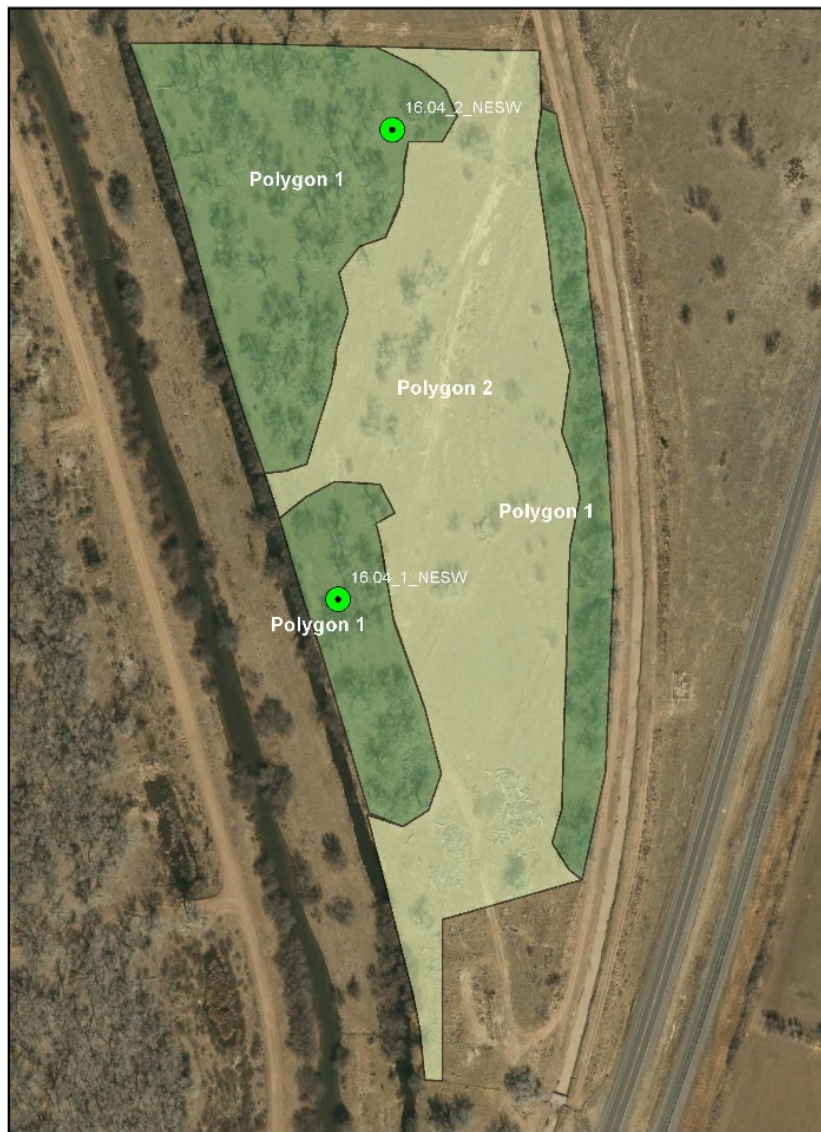
Figure 11. 16-04 Vegetation polygons and photopoints.

At the time of the site visit, large cottonwood pieces from the Sandia Lakes clearing were near the project boundaries. Target species on the project are mostly Russian olive. The Pueblo of Sandia had already begun extracting some Russian olive trees and piling them for the contractor to masticate. Cows were on-site during the pre-treatment monitoring site visit. Native species observed by the field crew

included Rio Grande cottonwood, dropseed grass and scratchgrass. Exotic species included Russian olive and Siberian elm.

Low scores for this project came in the Native Riparian Tree Regeneration and Exotic Invasive Plant Species Cover metrics because of the high percentage of invasive plants. The highest score came in the Soil Surface Condition metric. Other vegetation and structural metrics were also low because there were only two vegetation communities with two structure types. This is reflected in the vegetation polygon map, Figure 11. This site scored a 1.9 out of 4 overall, which is a “C” or “Fair” biotic rating. Most metrics were average in comparison to the other 2016 Pueblo of Sandia sites.

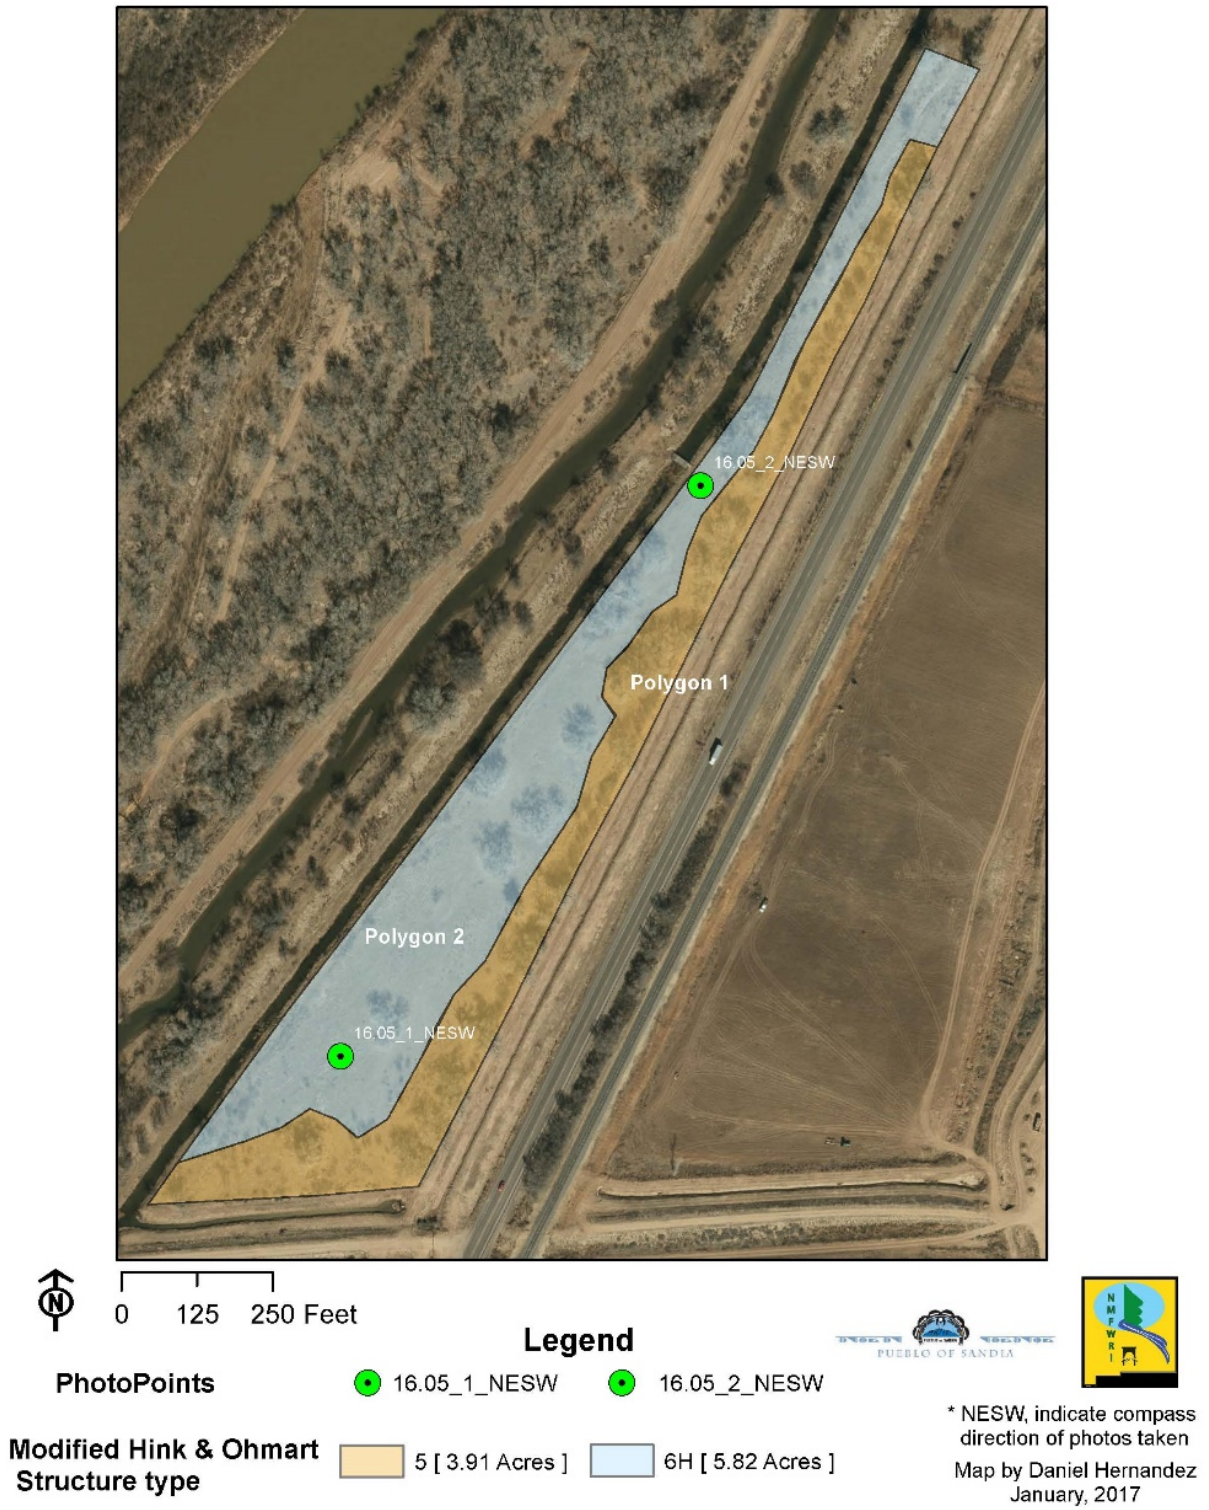
Figure 13. 16-05 Vegetation polygons and photopoints.

Field crew observations included several Siberian elm seedlings/resprouts as well as trees in banks that were left from a previous treatment. At the time of the site visit, there were signs of recent livestock grazing and a beaver dam was present above the wooden bridge at the north end of the project.

Low scores for this project came in the Exotic Invasive Plant Species Cover and Native Riparian Tree Regeneration metrics from the high percentage of invasive plants and the lack of new native tree growth. Vegetation Vertical Structure also received a low score due to the absence of high-structure forest. The project scored best in the Soil Surface Condition metric. This is reflected in the vegetation polygon map, Figure 13. This site scored a 1.7 out of 4 overall, which is a “D” or “Poor” biotic rating. Most metrics were below average in comparison to the other 2016 Pueblo of Sandia sites.
