Pueblo of Sandia Projects 16-01, 16-02a, 16-02b, 16-03, 16-04, 16-05

Pre-treatment Monitoring Report

2016

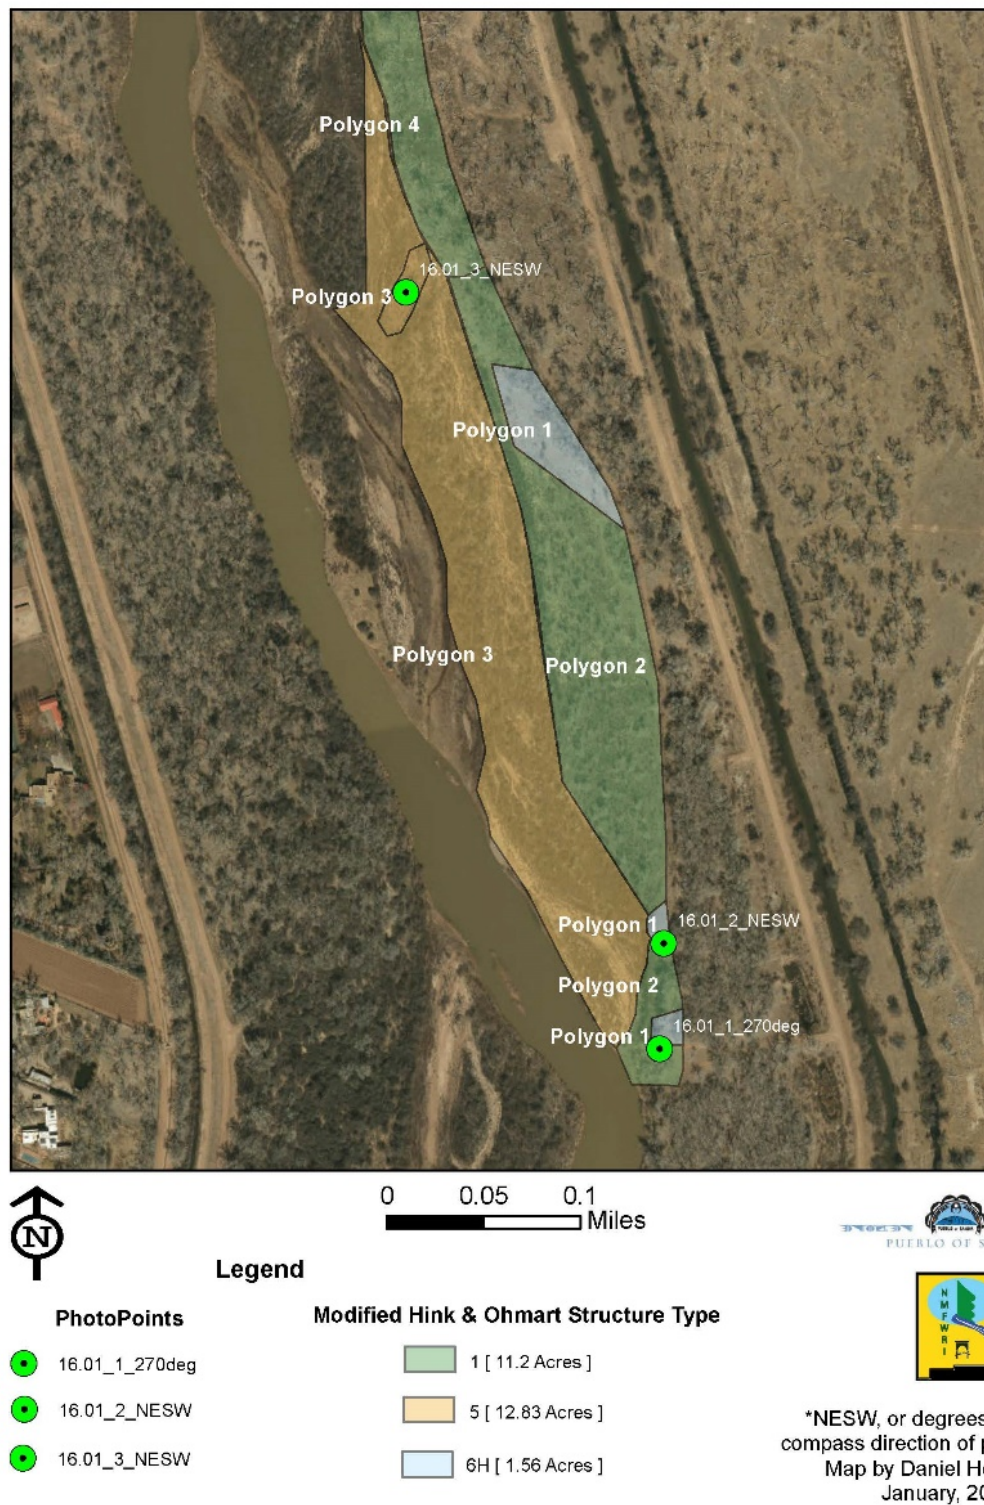
Figure 3. 16-01 Vegetation polygons and photopoints.

This site was observed to have beaver sign and cottonwood seedlings. Native vegetation including Rio Grande cottonwood, black willow, seepwillow, and coyote willow was noted in abundance; some cottonwoods appeared to have been burned in the Romero Fire and a patch of high mortality among willows, cottonwoods and salt cedar was observed near the Bureau of Reclamation fenceline. The

reason for this mortality was unclear at the time of the site visit. An old channel was present on site with wetland characteristics; the western edges of the project had the most hydrophilic vegetation. Sunflowers were abundant in the burned areas. In general, overstory was somewhat sparse, resulting in patchy shade. Other native species observed included New Mexico olive, dropseed grass, rough cocklebur and silverleaf nightshade. Exotic species observed on the site included Russian thistle (tumbleweed), Russian olive, salt cedar, tree-of-heaven, and sacred datura.

The lowest score for this project came in the Exotic Invasive Plant Species Cover metric, due to the high percentage of invasive plants (estimated over 50% of the site). The amount of surface fuels is due largely to residual mastication material and cottonwood duff. The project scored best in the Native Riparian Tree Regeneration metric, due to the abundance of cottonwood seedlings. This site scored a 2.2 out of 4 overall, which is a “C” or “Fair” biotic rating. Most metrics were average in comparison to the other 2016 Pueblo of Sandia sites.

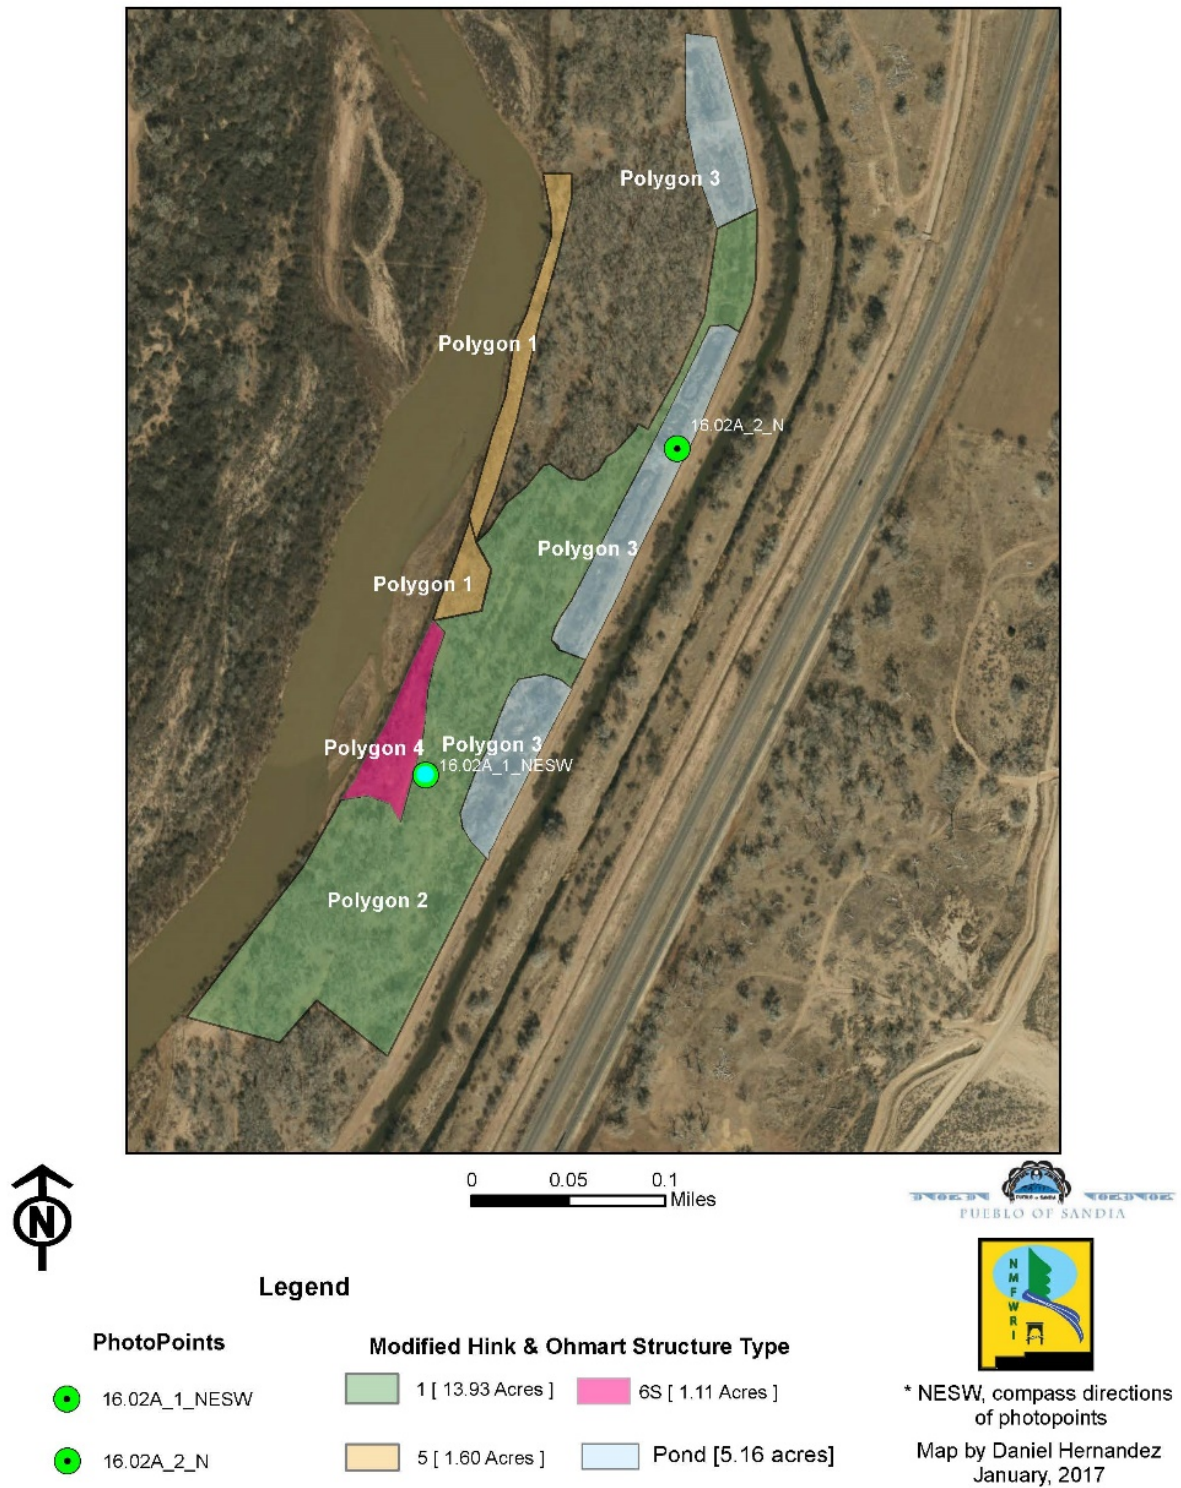
Figure 5. 16-02a Vegetation polygon and photopoints.

Field crew observations on this site included the presence of salt cedar and Russian olive trees, mostly under 8 feet tall. Native vegetation including Rio Grande cottonwood, dropseed grass, scratchgrass, and buffalo bur. Cattail was observed at some of the ponds. Exotic species observed included salt cedar, Russian olive, Siberian elm, and Russian thistle.

Lowest scores for this project came in the Relative Native Plant Community Composition and Exotic Invasive Plant Species Cover metrics, due to the high percentage of invasive plants (estimated at over 50% of the site). The amount of surface fuels is due largely to the presence of weedy species like Russian thistle. The project scored best in the vertical and horizontal structure metrics, because of the variety of communities and the dominance of high-structure forest. This is reflected in the vegetation polygon map (Figure 5). This site scored a 1.9 out of 4 overall, which is a “C” or “Fair” biotic rating. Most metrics were average or above average in comparison to the other 2016 Pueblo of Sandia sites.

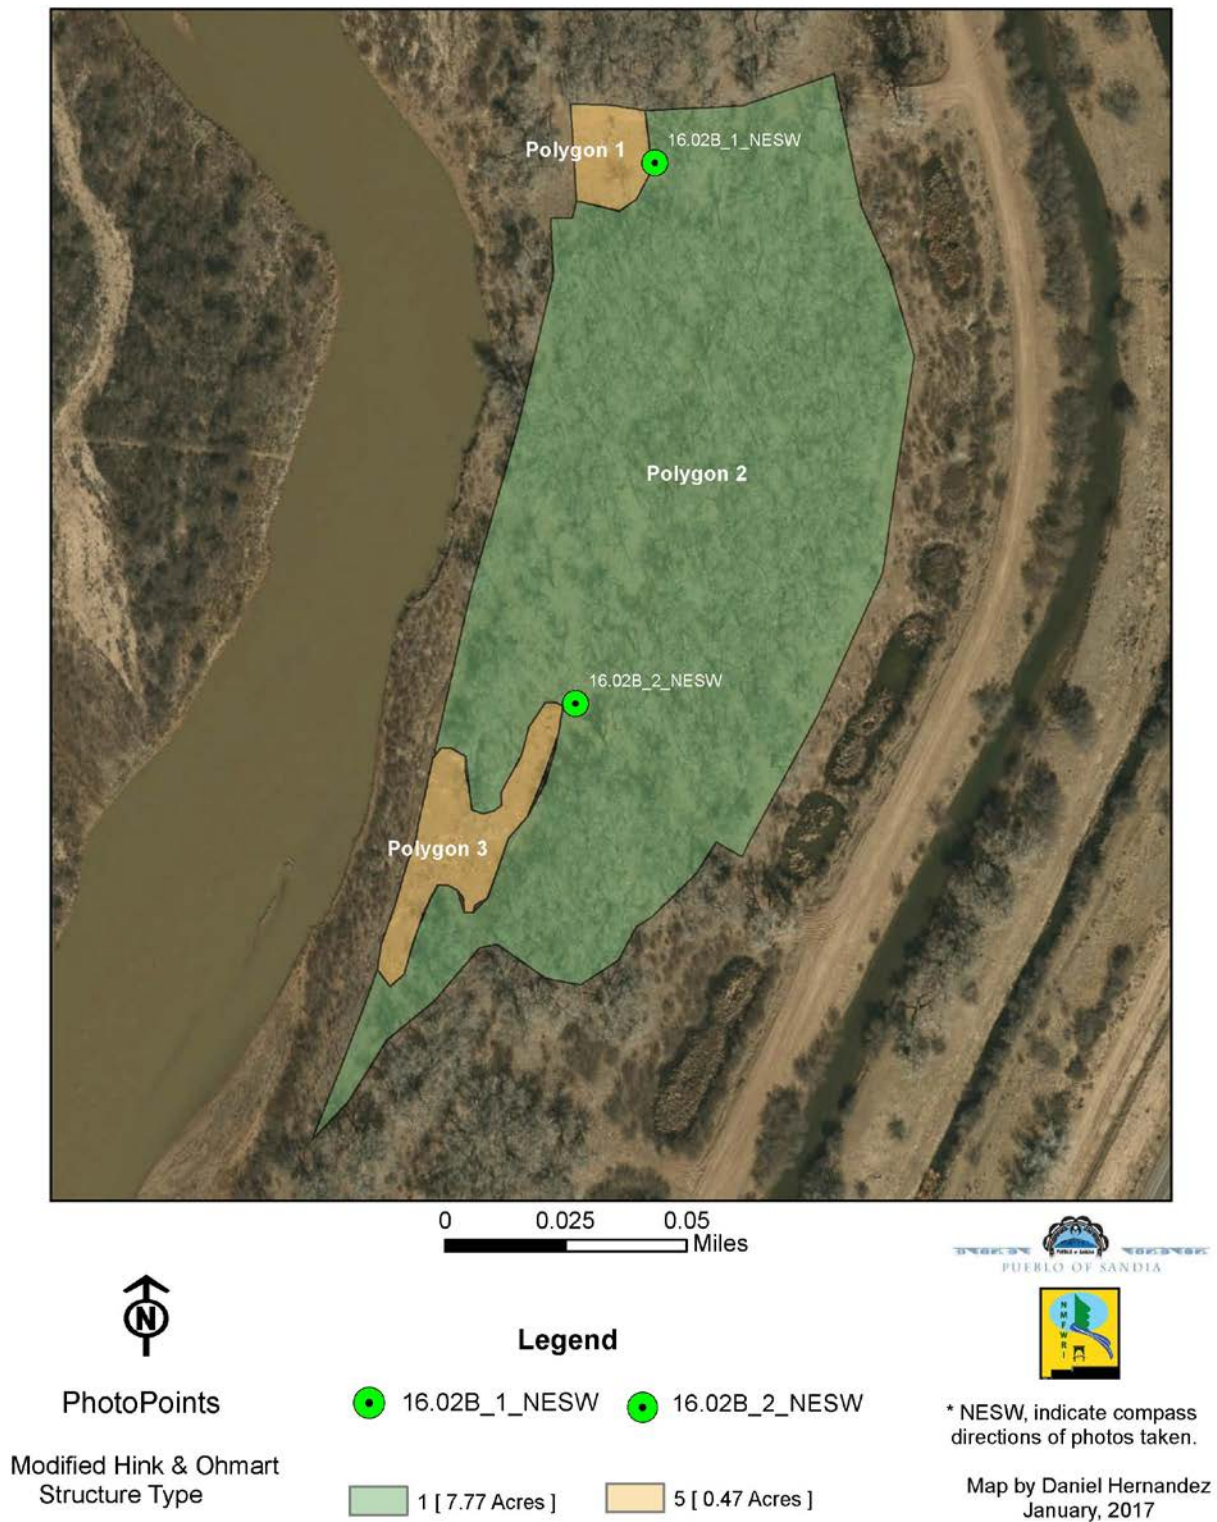
Figure 7. 16-02b Photopoints & Vegetation polygons.

Field crew observations on this site included the presence of Rio Grande cottonwood, New Mexico olive, juniper, dropseed and scratchgrass. Exotic species included salt cedar, Russian olive and a few Siberian elm, primarily as seedlings and saplings.

Lowest scores for this project came in the Relative Native Plant Community Composition and Exotic Invasive Plant Species Cover metrics, due to the high percentage of invasive plants (estimated at over 50% of the site). Low scores were also recorded in the Vegetation Horizontal Patch Structure and Native Riparian Tree Regeneration metrics, due to the low diversity of plant communities within the project area and the lack of native riparian regeneration. The amount of surface fuels is due largely to the presence of weedy species, mastication material and down woody debris, and cottonwood duff. The project scored best in the vertical structure metrics, because of the dominance of high-structure forest. This is reflected in the vegetation polygon map (Figure 7). This site scored a 1.5 out of 4 overall, which is a “D” or “Poor” biotic rating. Most metrics were below average in comparison to the other 2016 Pueblo of Sandia sites.

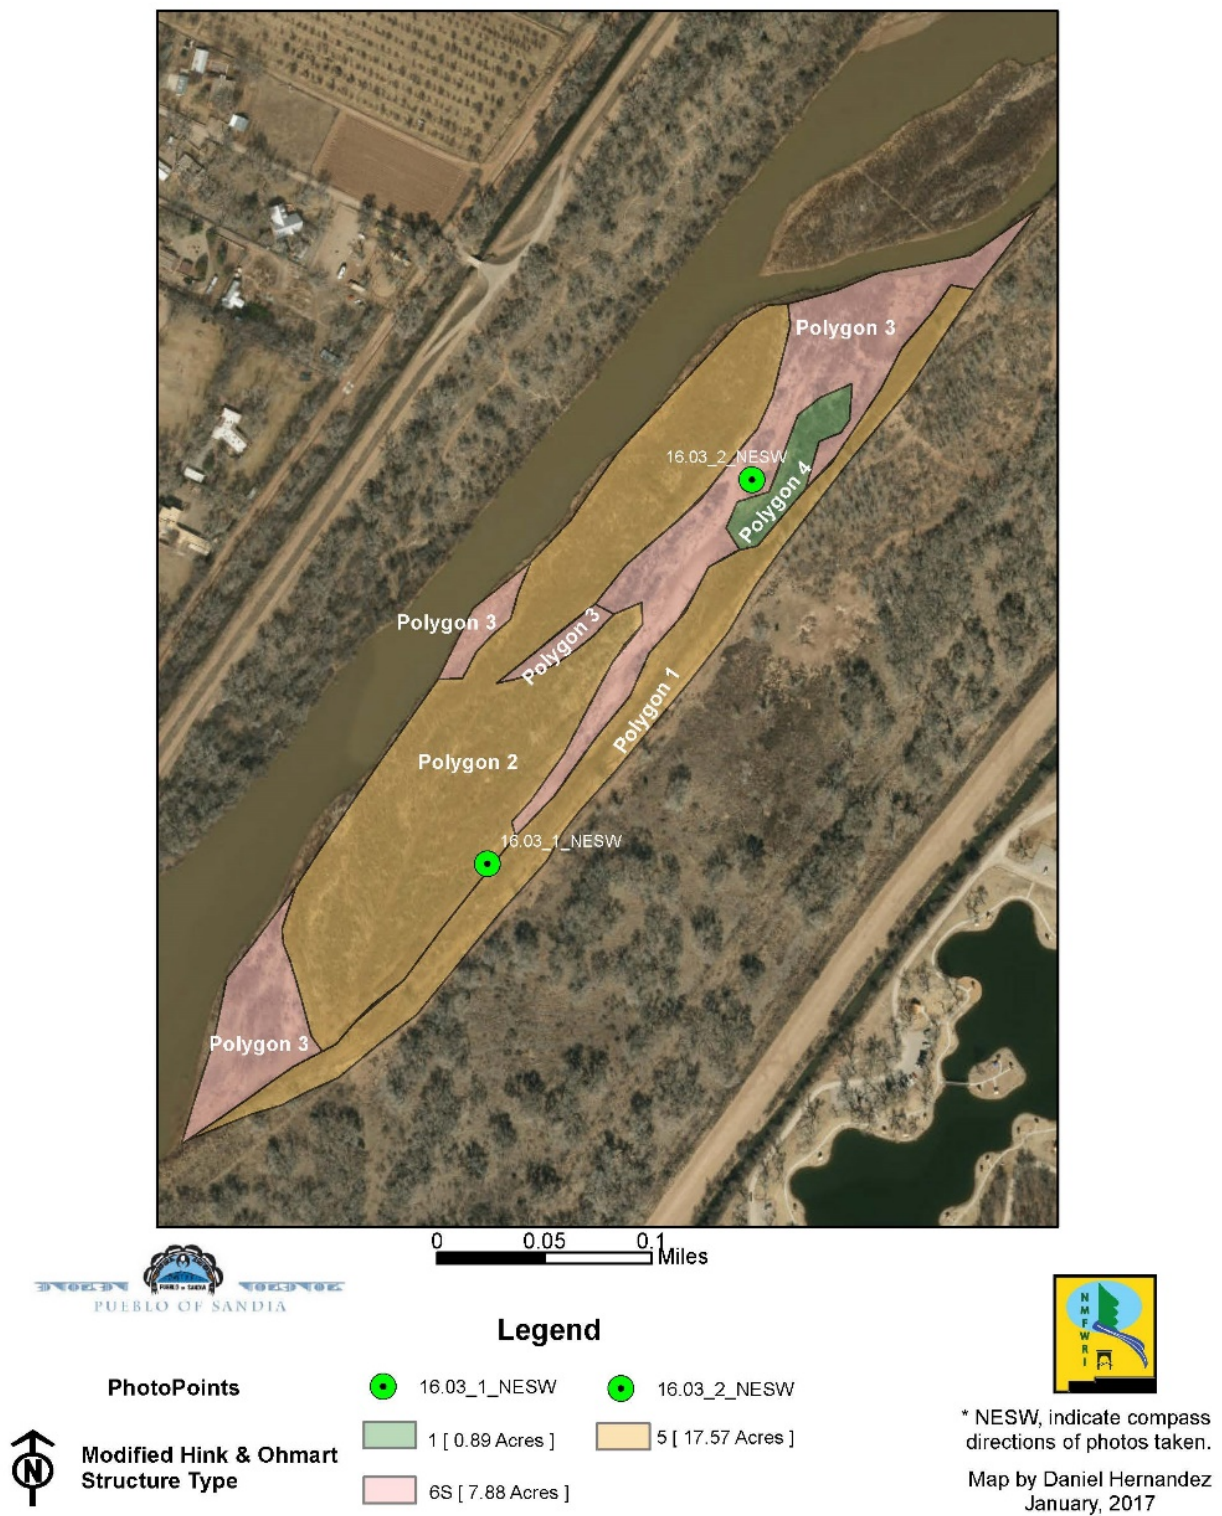
Figure 9. 16-03 Vegetation polygons and photopoints.

Native species observed by the field crew included Rio Grande cottonwood, coyote willow, horseweed, horsetail, as well as other forbs and grasses. Exotic species included Siberian elm, Russian olive, salt cedar, and Russian thistle.

The lowest scores for this project came in the Relative Native Plant Community and Exotic Invasive Plant Species Cover metrics due to the high percentage of invasive plants. The project scored best in the Native Riparian Tree Regeneration metric because of the presence of cottonwood regeneration. This site scored a 1.7 out of 4 overall, which is a “D” or “Poor” biotic rating. Most metrics were average in comparison to the other 2016 Pueblo of Sandia sites.

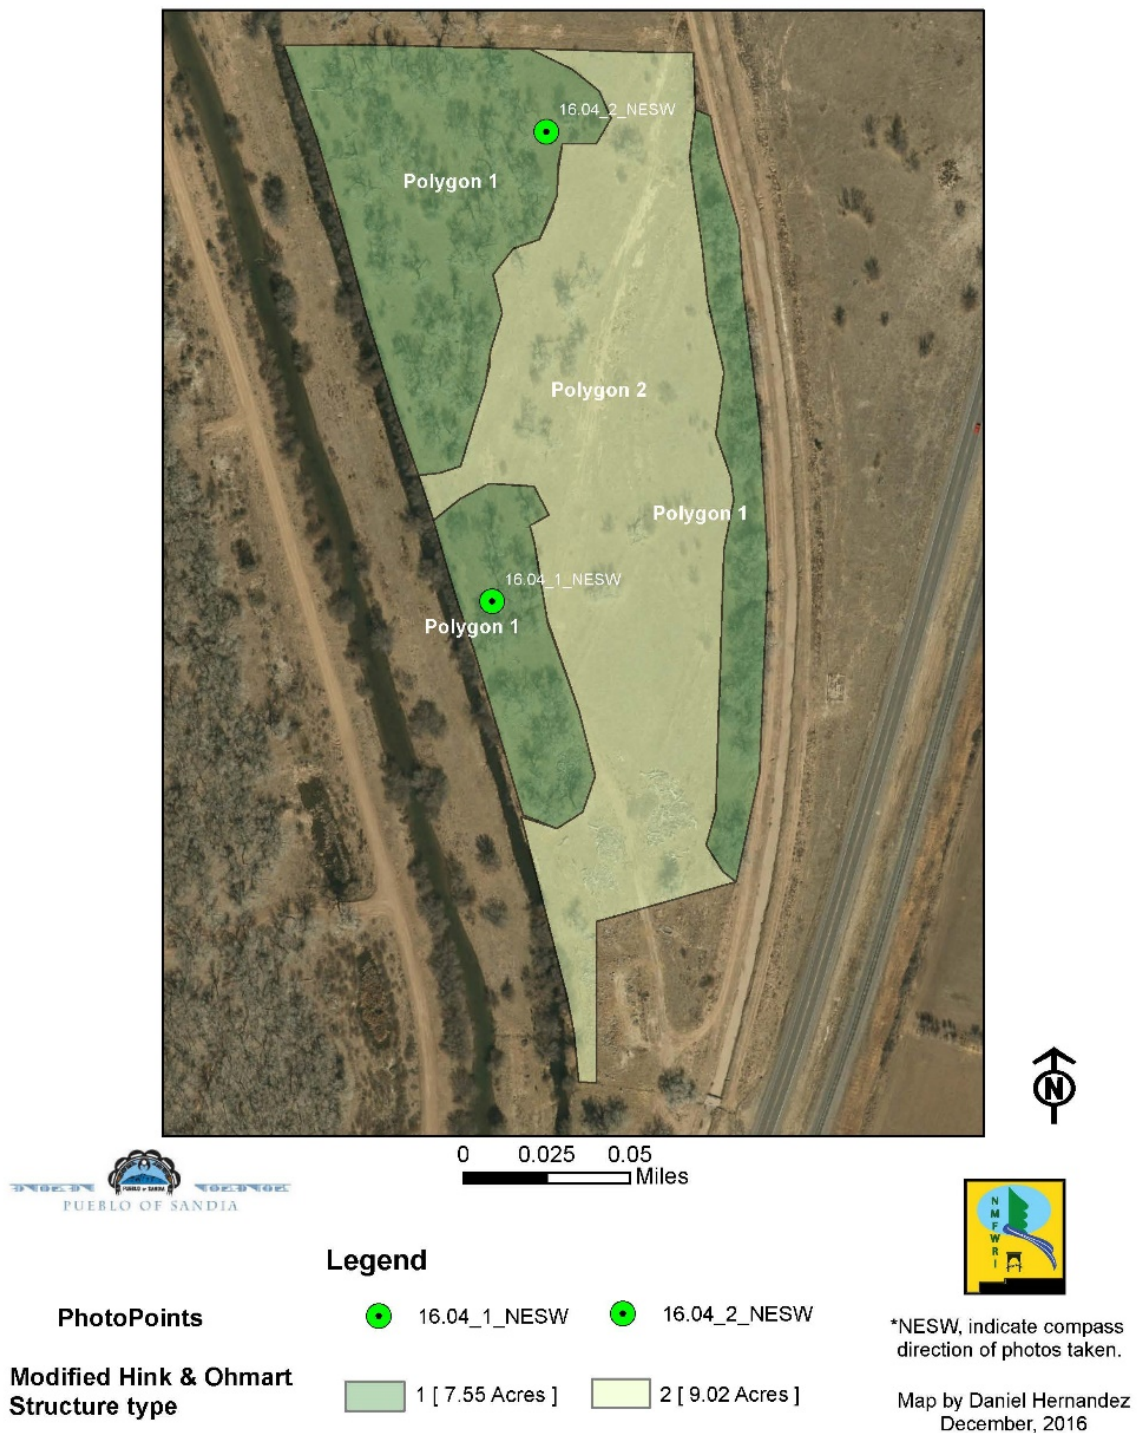
Figure 11. 16-04 Vegetation polygons and photopoints.

At the time of the site visit, large cottonwood pieces from the Sandia Lakes clearing were near the project boundaries. Target species on the project are mostly Russian olive. The Pueblo of Sandia had already begun extracting some Russian olive trees and piling them for the contractor to masticate. Cows were on-site during the pre-treatment monitoring site visit. Native species observed by the field crew

included Rio Grande cottonwood, dropseed grass and scratchgrass. Exotic species included Russian olive and Siberian elm.

Low scores for this project came in the Native Riparian Tree Regeneration and Exotic Invasive Plant Species Cover metrics because of the high percentage of invasive plants. The highest score came in the Soil Surface Condition metric. Other vegetation and structural metrics were also low because there were only two vegetation communities with two structure types. This is reflected in the vegetation polygon map, Figure 11. This site scored a 1.9 out of 4 overall, which is a “C” or “Fair” biotic rating. Most metrics were average in comparison to the other 2016 Pueblo of Sandia sites.

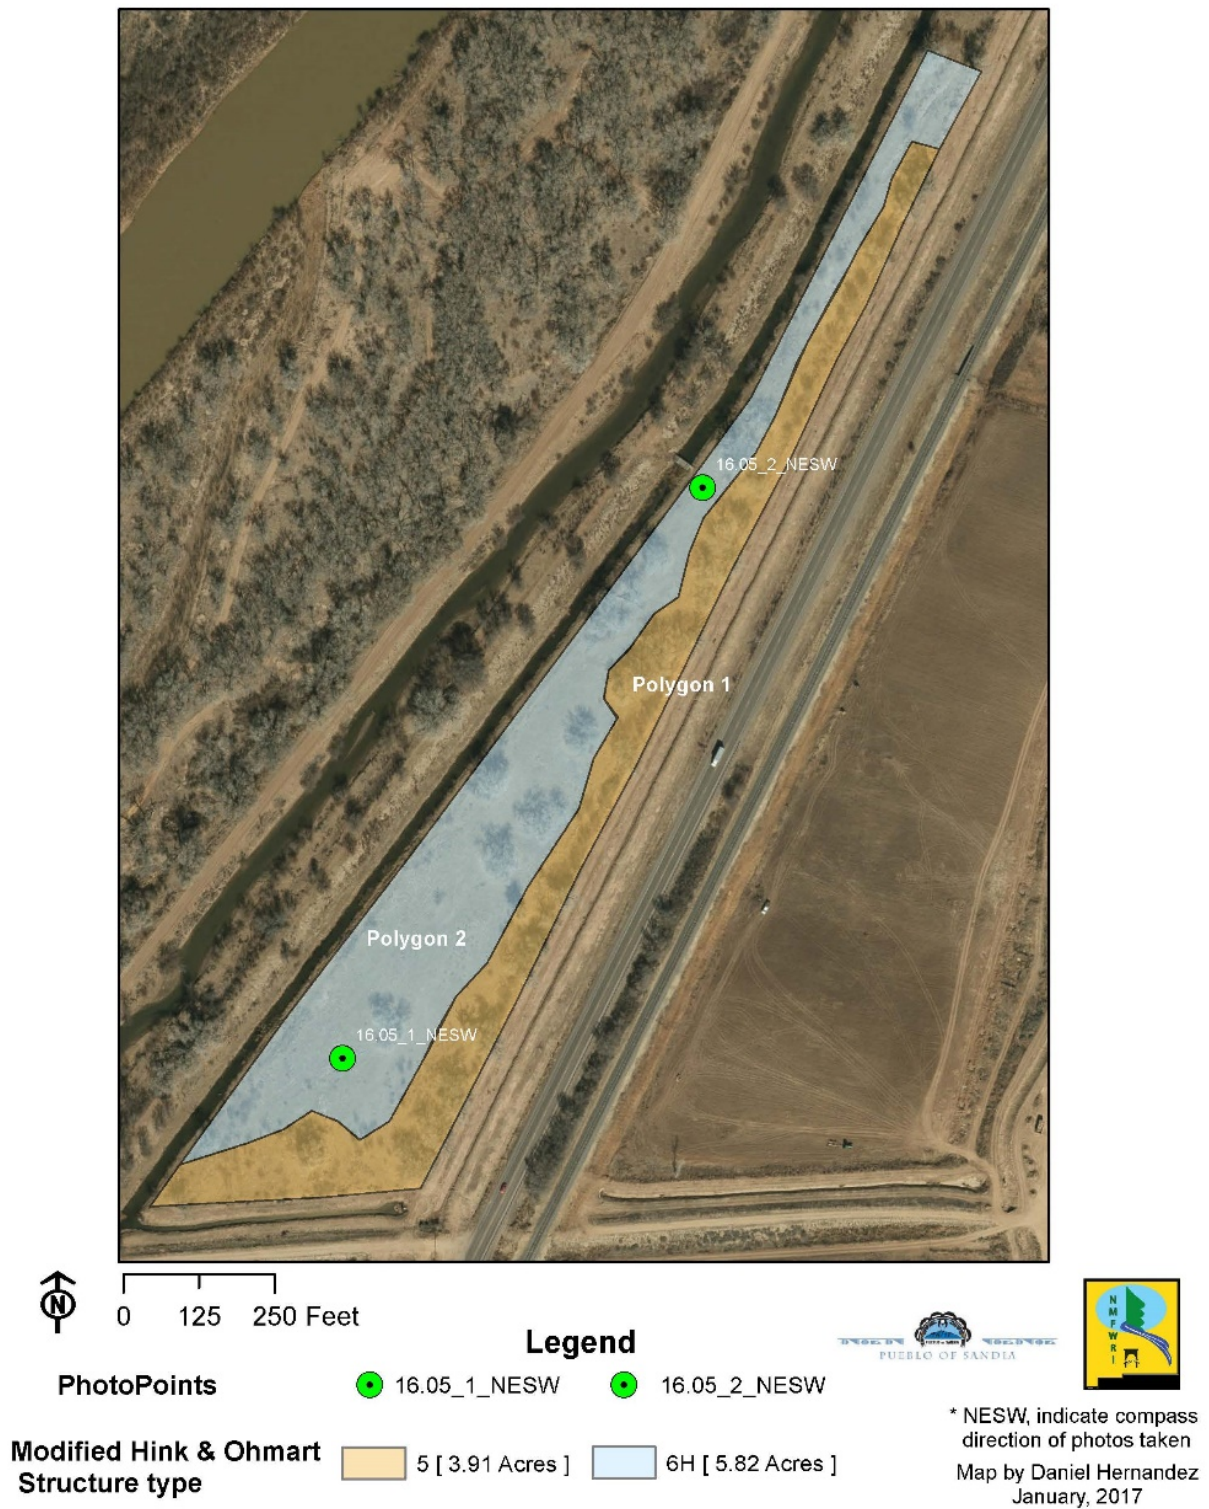
Figure 13. 16-05 Vegetation polygons and photopoints.

Field crew observations included several Siberian elm seedlings/resprouts as well as trees in banks that were left from a previous treatment. At the time of the site visit, there were signs of recent livestock grazing and a beaver dam was present above the wooden bridge at the north end of the project.

Low scores for this project came in the Exotic Invasive Plant Species Cover and Native Riparian Tree Regeneration metrics from the high percentage of invasive plants and the lack of new native tree growth. Vegetation Vertical Structure also received a low score due to the absence of high-structure forest. The project scored best in the Soil Surface Condition metric. This is reflected in the vegetation polygon map, Figure 13. This site scored a 1.7 out of 4 overall, which is a “D” or “Poor” biotic rating. Most metrics were below average in comparison to the other 2016 Pueblo of Sandia sites.
