Pueblo of Sandia Projects 16-01, 16-02a, 16-02b, 16-03, 16-04, 16-05

Post-treatment Monitoring Report

2021

Prepared by
Kathryn R Mahan, Monitoring Program Manager, & Alex Makowicki, Ecological Monitoring Technician,
New Mexico Forest and Watershed Restoration Institute
for the Greater Rio Grande Watershed Alliance

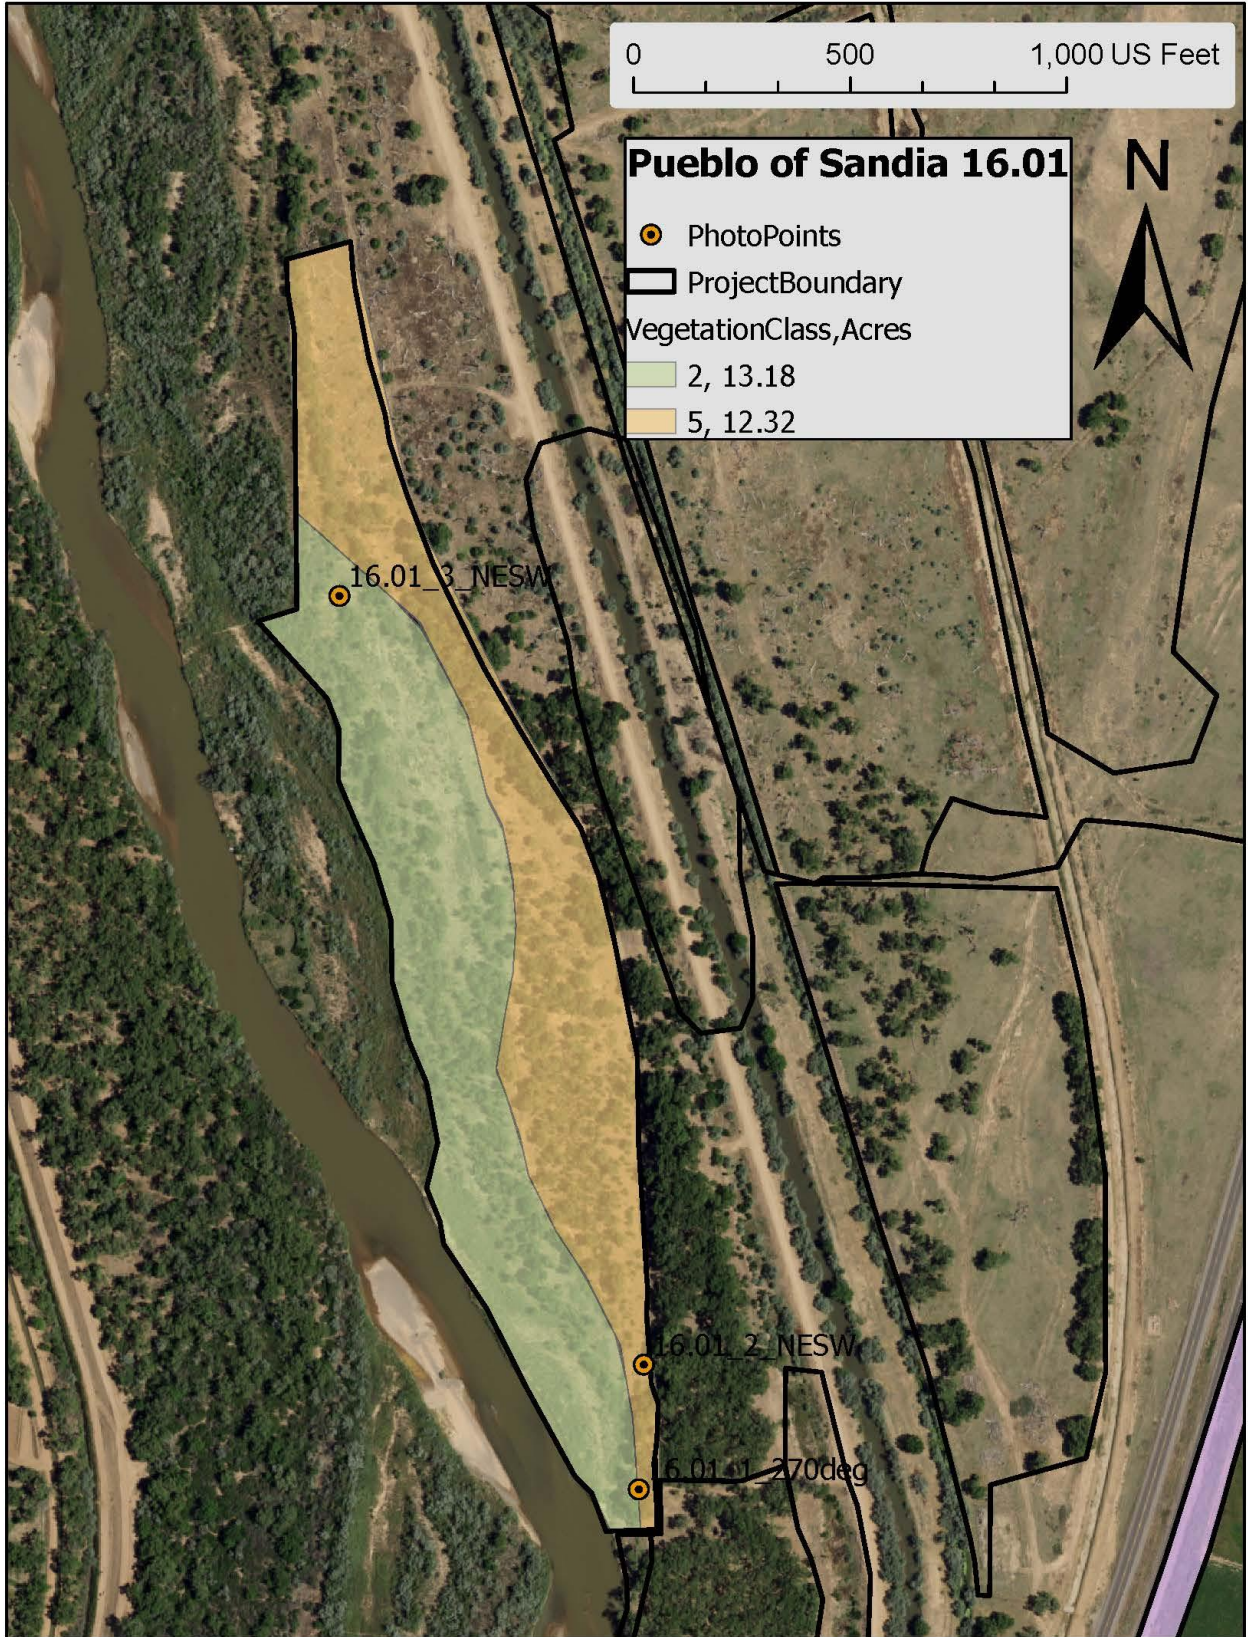
Figure 3. 16.01 Vegetation polygons and photopoints.

This site was observed to have beaver sign and cottonwood seedlings. Native vegetation including Rio Grande cottonwood, black willow, seepwillow, and coyote willow was noted in abundance; some cottonwoods appeared to have been burned in the Romero Fire and a patch of high mortality among willows, cottonwoods and salt cedar was observed near the Bureau of Reclamation fenceline. The

reason for this mortality was unclear at the time of the site visit. An old channel was present on site with wetland characteristics; the western edges of the project had the most hydrophilic vegetation. Sunflowers were abundant in the burned areas. In general, overstory was somewhat sparse, resulting in patchy shade. Other native species observed included New Mexico olive, dropseed grass, rough cocklebur and silverleaf nightshade. Exotic species observed on the site included Russian thistle (tumbleweed), Russian olive, salt cedar, tree-of-heaven, and sacred datura.

In 2021 the only metric which dropped in rating was Native Riparian Tree Regeneration. No young riparian trees were observed in 2021. In 2016 more than 5% of the sample area had riparian tree saplings on site, in 2021 high cottonwood mortality was noted in the sample area. Invasive species cover dropped from 70% to 25%, due to the vegetation treatment, though patches of dense invasive species were noted where cottonwood mortality had created light gaps. From 2015 to 2021 there was a loss of high structure forests, and this can be attributed to cottonwood mortality which was represented by down woody debris scattered across the site. Tall shrub vegetation was the dominant vegetation type for both years the site was monitored. Overall, the site score went down from 2015, from a “C” or “Fair” to a “D” “Poor”.

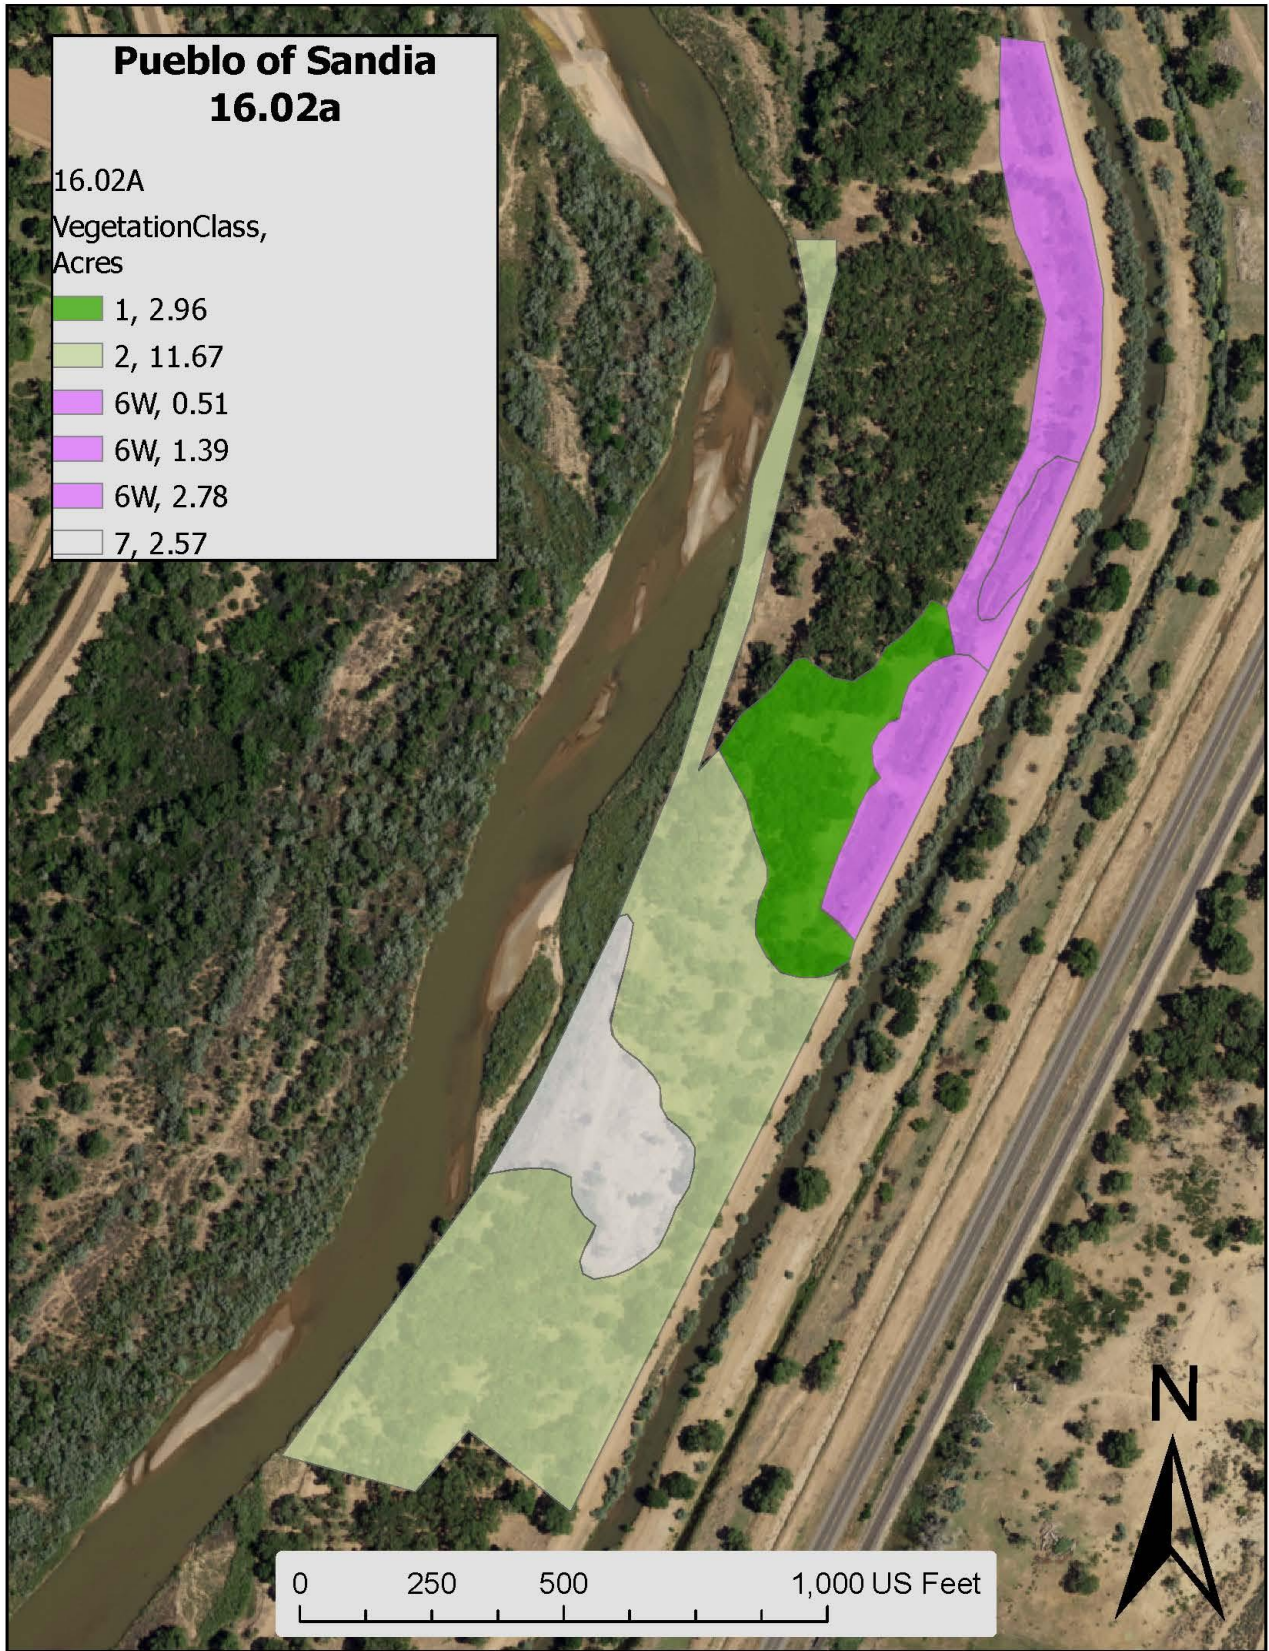
Figure 5. 16.02a Vegetation polygon and photopoints.

Field crew observations on this site included the presence of salt cedar and Russian olive trees, mostly under 8 feet tall. Native vegetation including Rio Grande cottonwood, dropseed grass, scratchgrass, and buffalo bur. Cattail was observed at some of the ponds. Exotic species observed included salt cedar, Russian olive, Siberian elm, and Russian thistle.

The site score remained the same as observed in 2016, though there were small changes in significant areas of the monitoring. These significant areas of change were Native Riparian Tree Regeneration and Relative Native Plant Community Composition. In 2016 a small amount of native tree saplings was found in the sample area; this observation was not made in 2021. This means the area lacks the next generation of native trees required to maintain a healthy ecosystem and ensure the survival of the species in the area. Native species, such as New Mexico Olive and Seep Willow were observed in areas that previously contained Tamarisk and Russian Olive. This could be correlated with the dominance of low structure forest vegetation type within the sample area that was once dominated by high-structure forest. Overall, the site has improved in quality due to the reduction in invasive species cover (70% from 2016 to 40% in 2021).

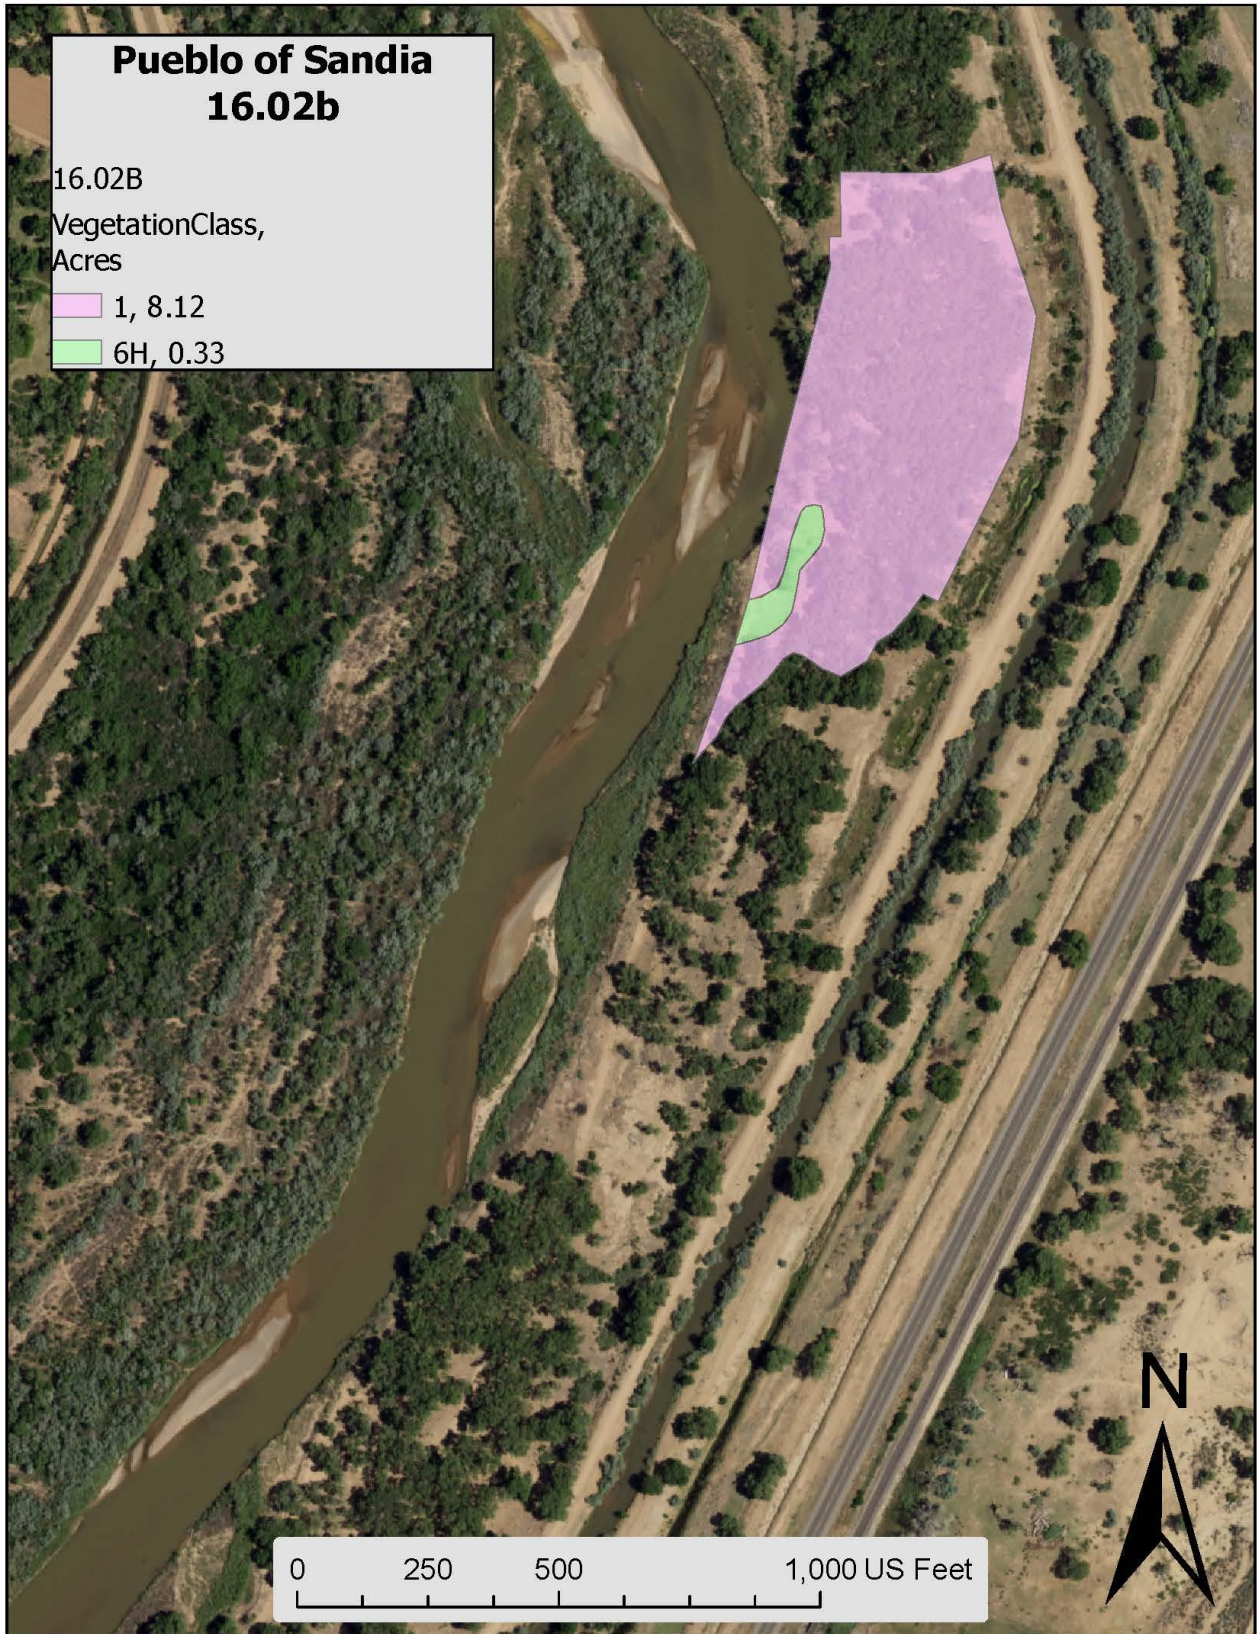
Figure 7. 16.02b Vegetation polygons.

Field crew observations on this site included the presence of Rio Grande cottonwood, New Mexico olive, juniper, dropseed and scratchgrass. Exotic species included salt cedar, Russian olive and a few Siberian elm, primarily as seedlings and saplings.

Scores for the sample area remained similar to those observed in 2016, with changes occurring in the Invasive Exotic Plant Species Cover and Native Plant Community Composition. Invasive Exotic Plant Species Cover score improved from 2016 to 2021, coverage went from 40% in 2016 to 10% in 2021. Low scores for Native Plant Community Composition in 2016 can be attributed to Tamarisk occupying significant portions of their vegetation community. In 2021 more native species such as New Mexican Olive and Desert Saltgrass were observed which contributed to a higher scoring. An increase in native shrubs and grass could be due to reduced competition from plants such as Tamarisk and Russian Olive which were removed during treatment. The amount of surface fuels observed in 2021 was also lower than in 2016 and this could be a result of less Tamarisk present to produce flammable leaf litter.

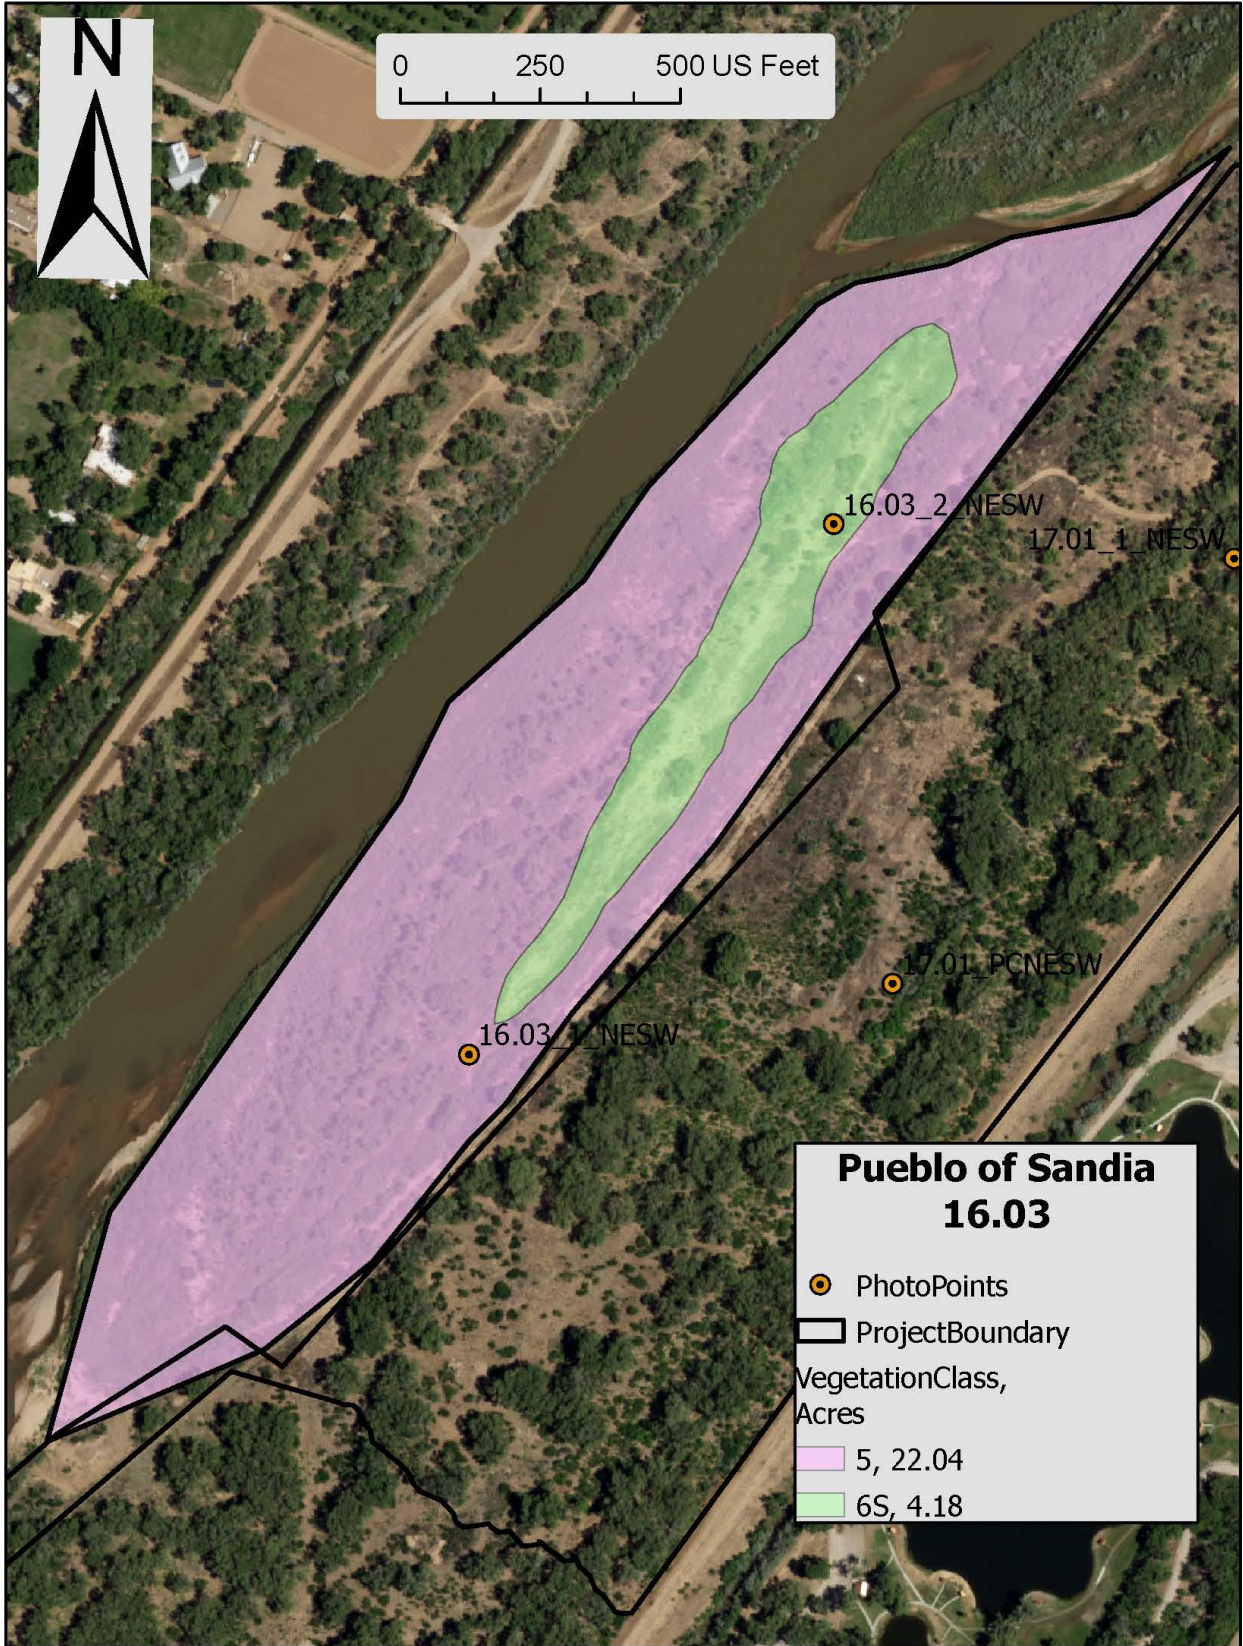
Figure 9. 16.03 Vegetation polygons and photopoints.

Native species observed by the field crew included Rio Grande cottonwood, coyote willow, horseweed, horsetail, as well as other forbs and grasses. Exotic species included Siberian elm, Russian olive, salt cedar, and Russian thistle.

The lowest score came in Native Riparian Tree Regeneration while the Relative Native Plant Community Composition score increased. In 2016 it was noted that native riparian tree saplings were 'well represented, displayed obvious regeneration, and covered more than 5% of the sample area'. In 2021 none of this was observed. Cottonwoods were observed within the sample area during 2021 monitoring but were not the dominant vegetation and therefore were not recorded as a significant species present. Instead, coyote and black willows, both native species, were present and dominant enough to positively affect the Native Plant Community Composition Rating.

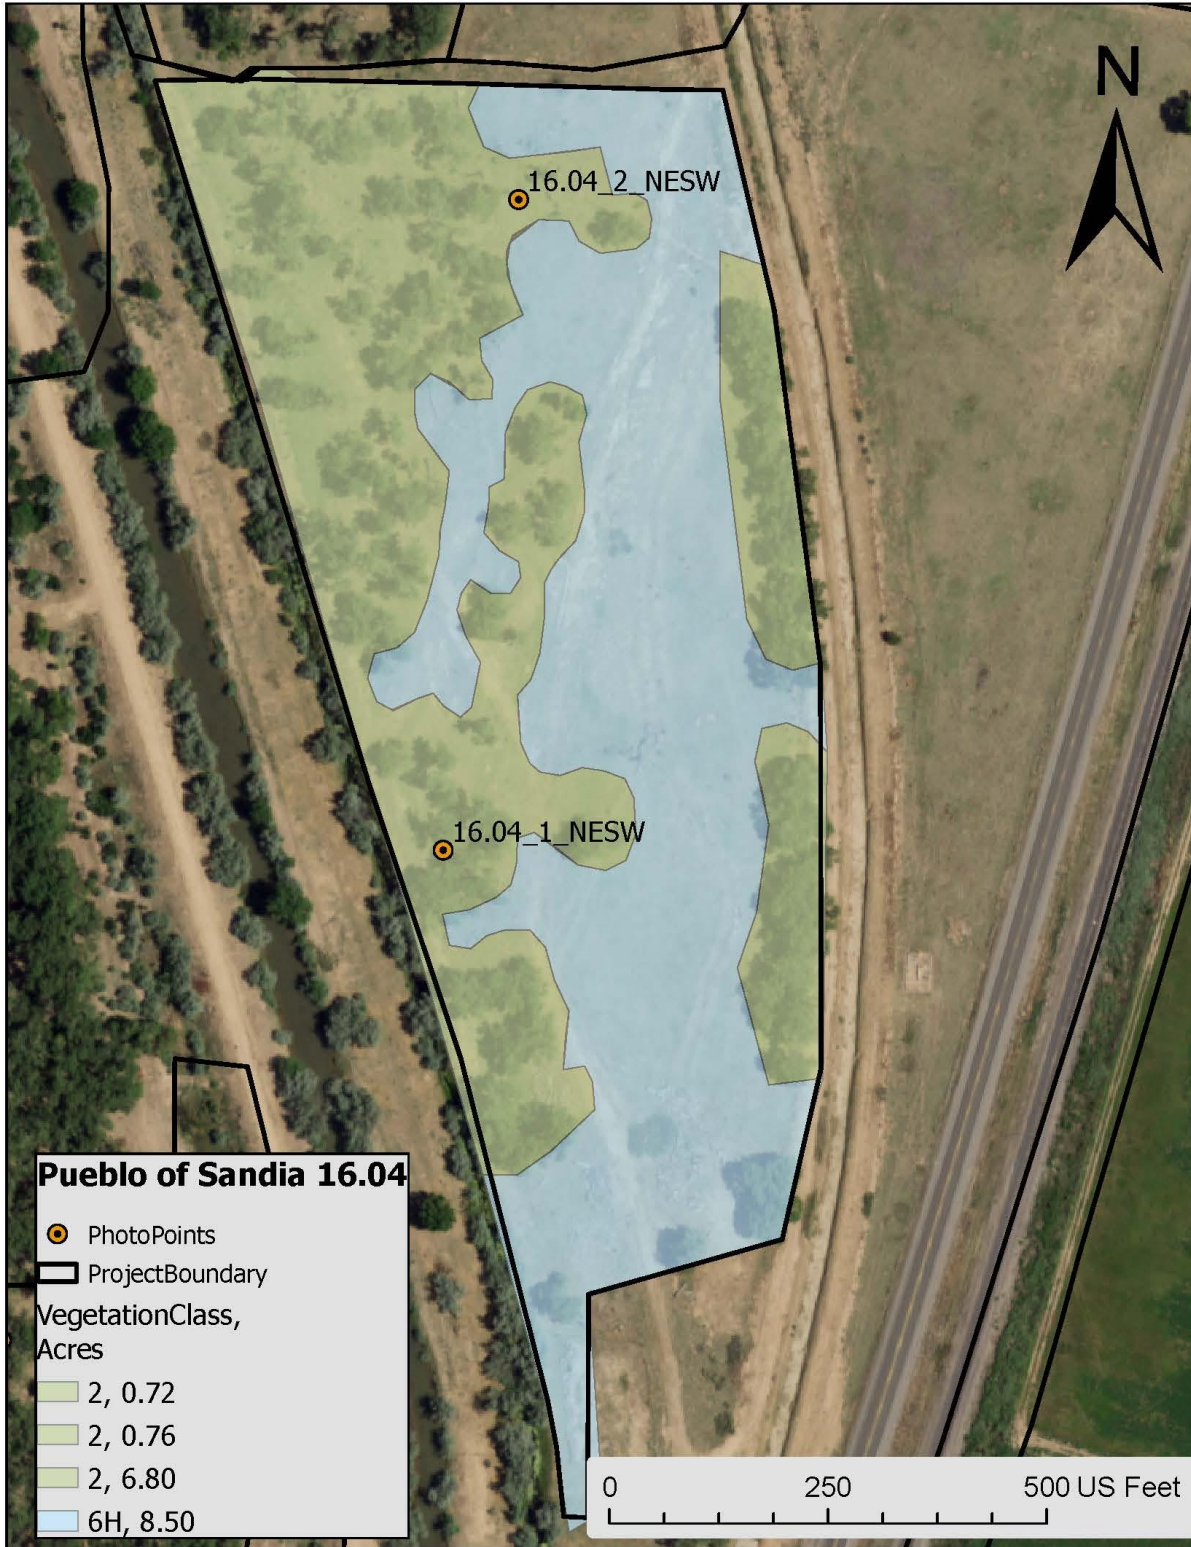
Figure 11. 16.04 Vegetation polygons and photopoints.

At the time of the site visit, large cottonwood pieces from the Sandia Lakes clearing were near the project boundaries. Target species on the project are mostly Russian olive. The Pueblo of Sandia had already begun extracting some Russian olive trees and piling them for the contractor to masticate. Cows were on-site during the pre-treatment monitoring site visit. Native species observed by the field crew

included Rio Grande cottonwood, dropseed grass and scratchgrass. Exotic species included Russian olive and Siberian elm.

Low scores for this project were the same as in 2016's. Five-year post monitoring observed only two vegetation structure types, the same number observed in 2016, though there was a change in which vegetation structure types. As in 2016, Low Structure Forest remained the dominant vegetation structure type, but in 2021 no tall structure forest was observed, instead there was short herbaceous vegetation. This observation makes sense because the sample area was seeded with grass mix after the removal of invasive exotic woody plants. The short herbaceous vegetation type occupied 40% of the sample area; in 2016 Tall Structure Forest occupied 46% of the sample area. Overall, the site scored a "D" or "Poor".

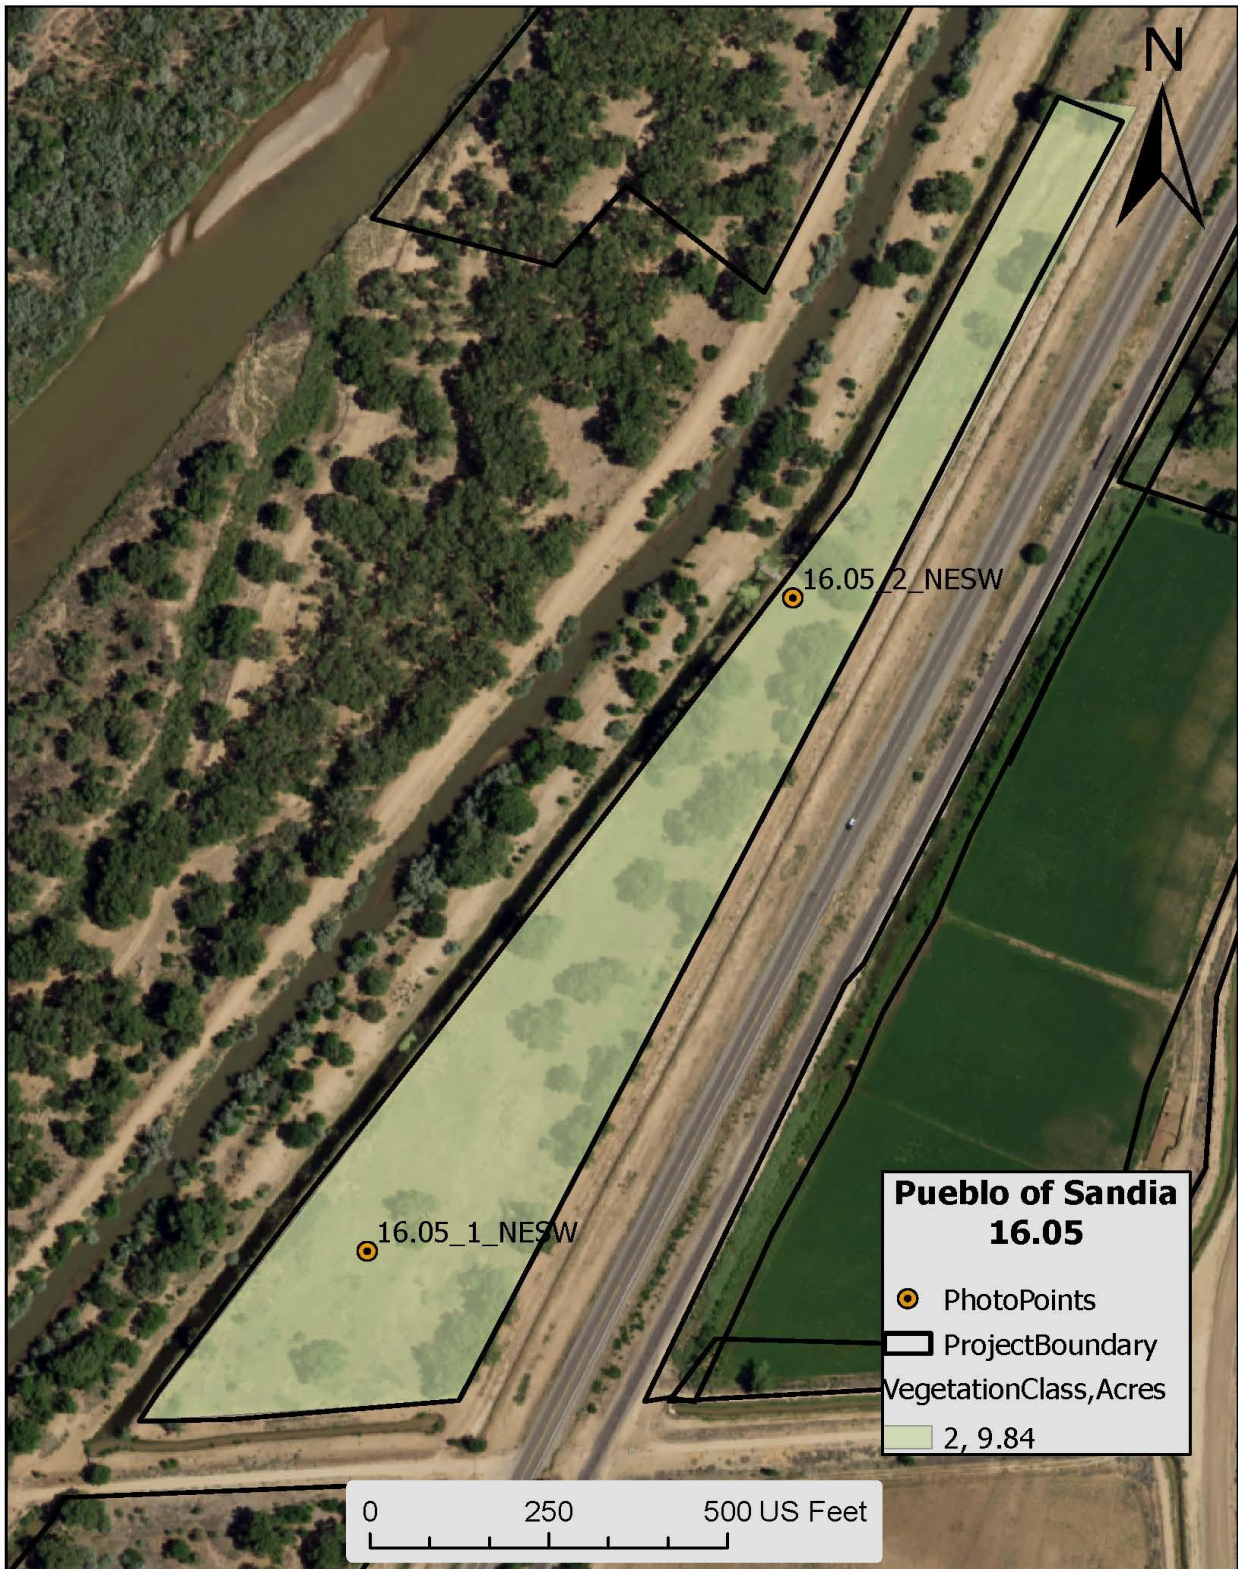
Figure 13. 16.05 Vegetation polygons and photopoints.

Field crew observations included several Siberian elm seedlings and resprouts as well as trees in banks that were left from a previous treatment. At the time of the site visit, there were signs of recent livestock grazing and a beaver dam was present above the wooden bridge at the north end of the project.

Low scores for this project came in Vegetation Horizontal Patch Structure and Invasive Exotic Plant Species Cover. In 2016 two different types of vegetation structure were observed: Tall Shrub structure and herbaceous vegetation. In 2021, only Low Structure Forest vegetation was observed, this could be due to maturing trees in the area shading out smaller plants and keeping the understory clear of growth. Invasive exotic vegetation cover was reduced by 8% from 2016 to 2021 and can be attributed to the removal of these plants during treatment. More surface fuels were observed in 2021 possibly a result of mastication.
