**Pueblo of Sandia Projects 15.01, 15.02, 15.03, 15.04, 15.05**

**Post-treatment Monitoring Report**

2021

Kathryn R Mahan, Monitoring Program Manager & Alex Makowicki, Ecological Monitoring Technician,  
New Mexico Forest and Watershed Restoration Institute  
for the Greater Rio Grande Watershed Alliance

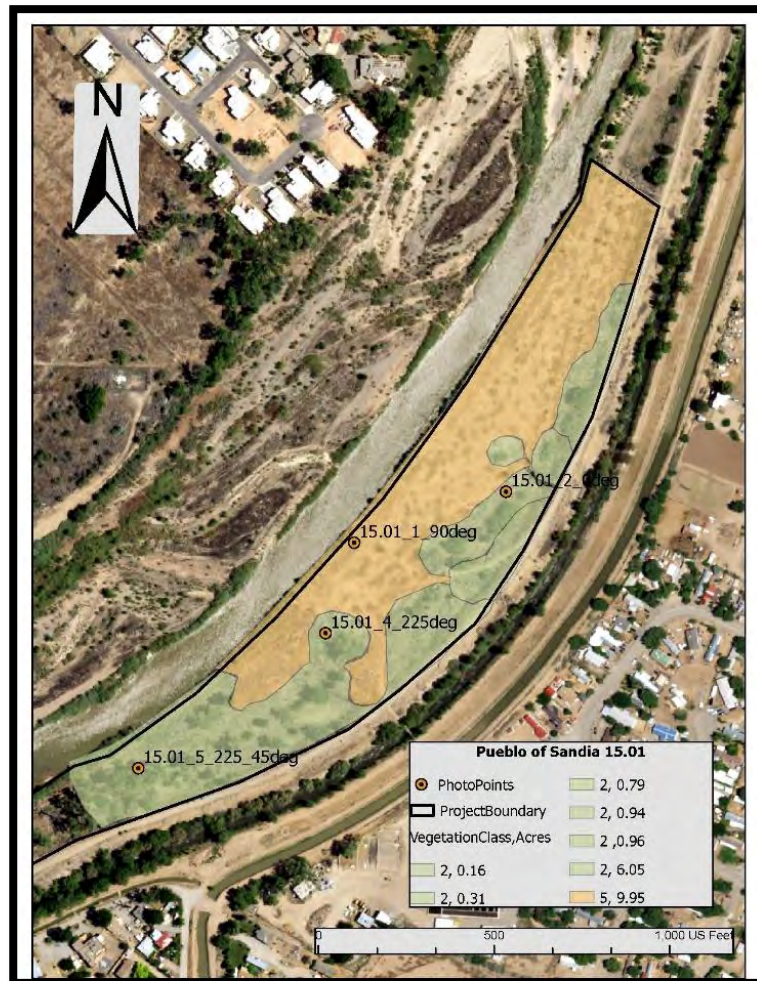
Figure 2. 15.01 in geographic context. 'Deg' indicates the compass direction photos were taken

This site was observed to have beaver sign and cottonwood seedlings. Native vegetation including Rio Grande cottonwood, black willow, seepwillow, and coyote willow was noted in abundance; some cottonwoods appeared to have been burned in the Romero Fire and a patch of high mortality among willows, cottonwoods and salt cedar was observed near the Bureau of Reclamation fence line. The reason for this mortality was unclear at the time of the site visit. An old channel was present on site with wetland characteristics; the western edges of the project had the most hydrophilic vegetation. Sunflowers were abundant in the burned areas. In general, overstory was somewhat sparse, resulting in patchy shade. Other native species observed included New Mexico olive, dropseed grass, rough cocklebur and silverleaf nightshade. Exotic species observed on the site included Russian thistle (tumbleweed), Russian olive, salt cedar, tree-of-heaven, and sacred datura.

The lowest scores for this project were the Invasive Exotic Plant Species Cover and Vertical Vegetation Structure. Vertical Vegetation Structure differs from 2015 observations due to the decrease in vegetation structure diversity. In 2015 15.01 contained three vertical vegetation structure types: Type 1 High Structure Forest, Type 5 Tall Shrubs and Type 6H, Herbaceous, defined as woody species representing less than ten percent of the area. In 2021 the monitoring team observed only two Vertical Vegetation Structure types; Type 2, Low Structure Forest with little or no understory and Type 5, Tall Shrub Stands. The Exotic Invasive Plant Species Cover score remained the same due to the presence of Siberian Elm, White Mulberry and Tree of Heaven. The Relative Native Plant Community Composition score increased because there were few invasive species in the overstory, though the understory still contained non-native invasive plants like in 2015. The score for the entire site remained 1.9, which is a "C" or "Fair" biotic range.

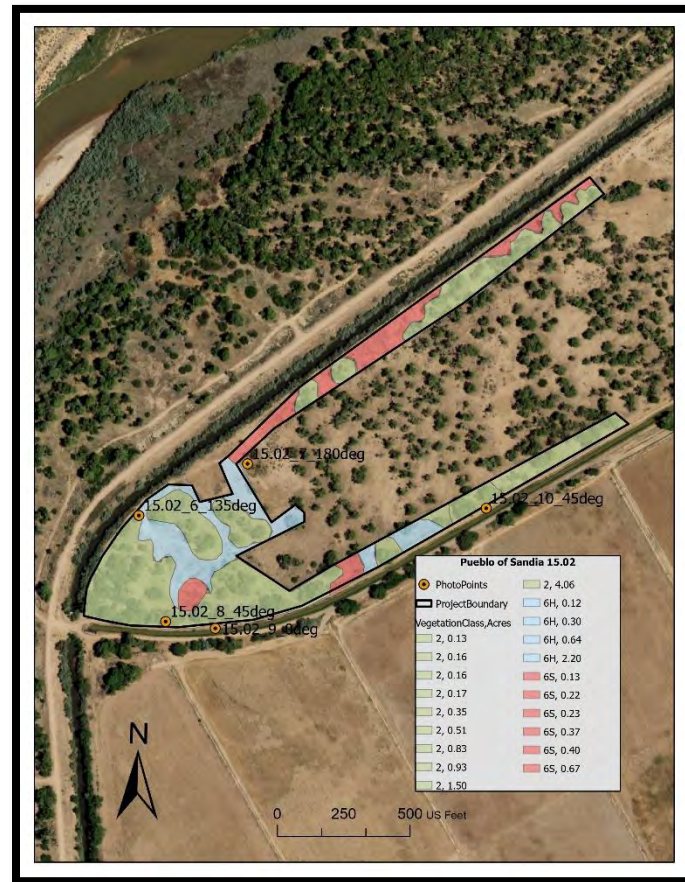
Figure 3. 15.02 in geographic context with photopoints

The project at this time is planned to be 13 acres. The delineation of this project was based on the distribution of Siberian elms and Russian olives, which explains its unusual shape. Other exotics observed included tamarisk and Russian thistle. Native species noticed in abundance included cottonwood, juniper, silverleaf nightshade, globemallow and sage. This site supported more xeric plant communities than did project 15-01.

Lowest scores for this project came in the Relative Native Plant Community Composition and Exotic Invasive Plant Species Cover metrics, due to the high percentage of invasive plants (estimated at over 50% of the site). The amount of surface fuels is due largely to the presence of weedy species like Russian thistle. The project scored best in the vertical and horizontal structure metrics, because of the variety of communities and the dominance of high-structure forest. This is reflected in the vegetation polygon map (Figure 5). This site scored a 1.9 out of 4, which is a “C” or “Fair” biotic rating. Most metrics were average or above average in comparison to the other 2016 Pueblo of Sandia sites.

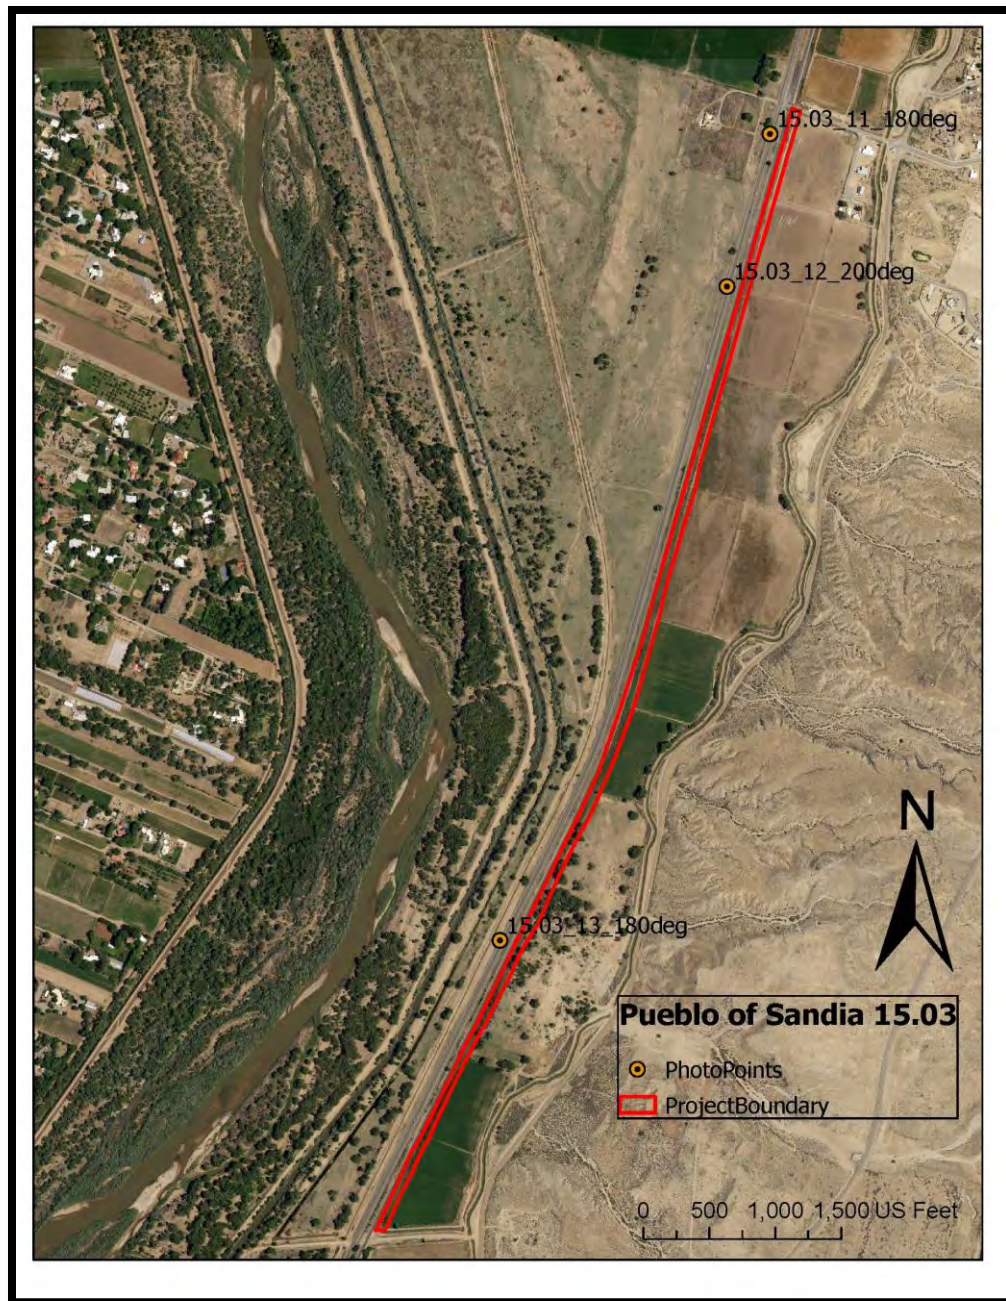
Figure 4. 15.03 in geographic context.

Due to the expense and complication involved in accessing the right-of-way (insurance, safety certifications, railroad personnel, etc), as well as the proximity to the highway, the only monitoring accomplished on this site was the selection of three photo points, reflected in Figure 4, above. It is notable that the site has several large Siberian elms on the northern portion and on the southern end, with fewer towards the middle. In 2021, only photos were collected.

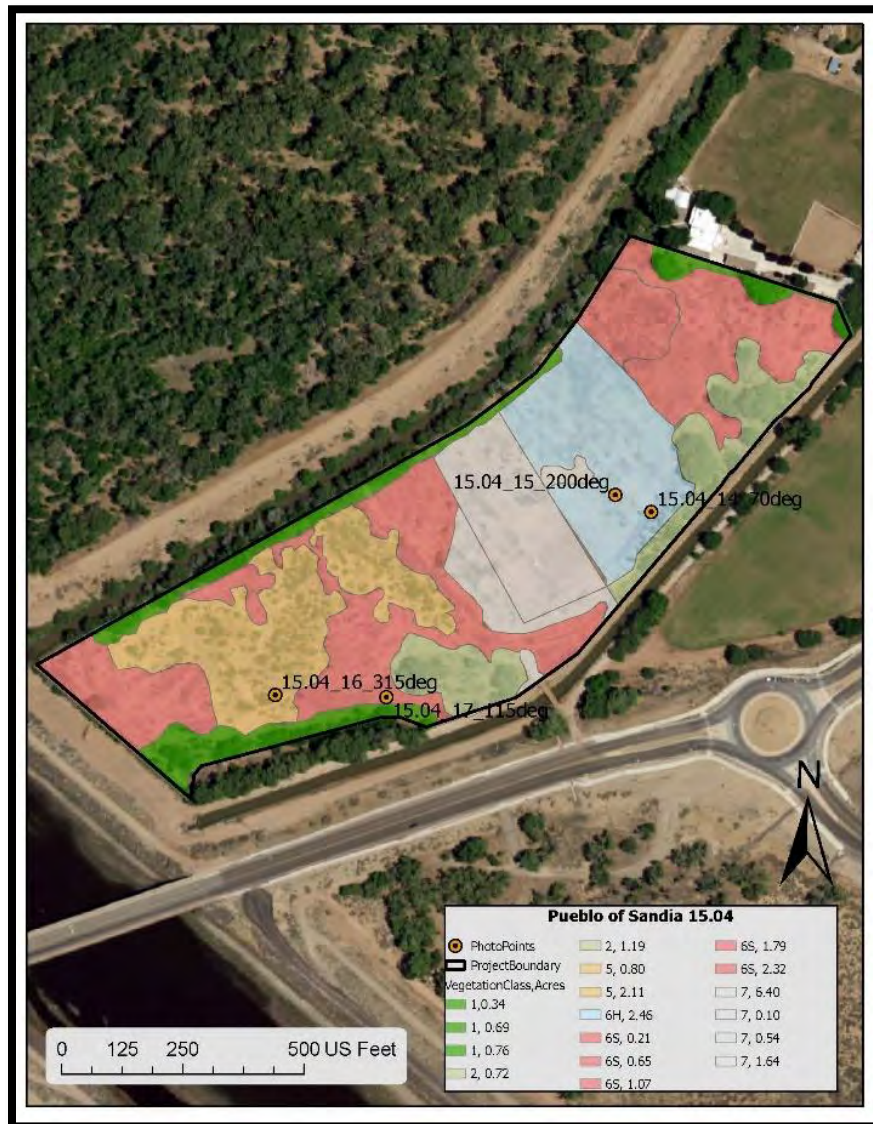
Figure 5. 15.04 in geographic context.

This site is an abandoned farm field where many Siberian elms have grown up along old irrigation ditches. Some salt cedar is present as well as one patch of tree-of-heaven. Alternative methods were discussed for treating tree-of-heaven, including extraction, but at this time they have not been explored. Other exotic species observed include Russian thistle, kochia, and Siberian elm. Native species observed in abundance include cottonwood, cota, sunflower, silverleaf nightshade, amaranth, and winterfat.

Low scores for this project came from Invasive Exotic Plant Species Cover and Vegetation Vertical Structure. Exotic Invasive Plant Species Cover increased 30%; Siberian elm was the most abundant exotic plant followed by tumbleweed which could be taking advantage of the open spaces created during restoration. Previous monitoring in 2015 also observed Siberian Elm to be the dominant species. Vertical Vegetation Structure score dropped from 2015 due to a larger percentage of the sample area being vegetation structure type 6S. In 2015 Vertical Vegetation Structure was dominated by Type 6H and Type 1 which is characterized as a high structured forest with a well-developed understory. This change makes sense because of the loss of tree species such as Russian Elm, Salt Cedar and Tree-of-Heaven during restoration. The loss of an overstory would create suitable habitat for shrub species to invade and could explain the dominance of 6H structure type observed in 2021. Overall, the score rose from a “D” or “Poor” rating to a “C” or “Fair” rating.

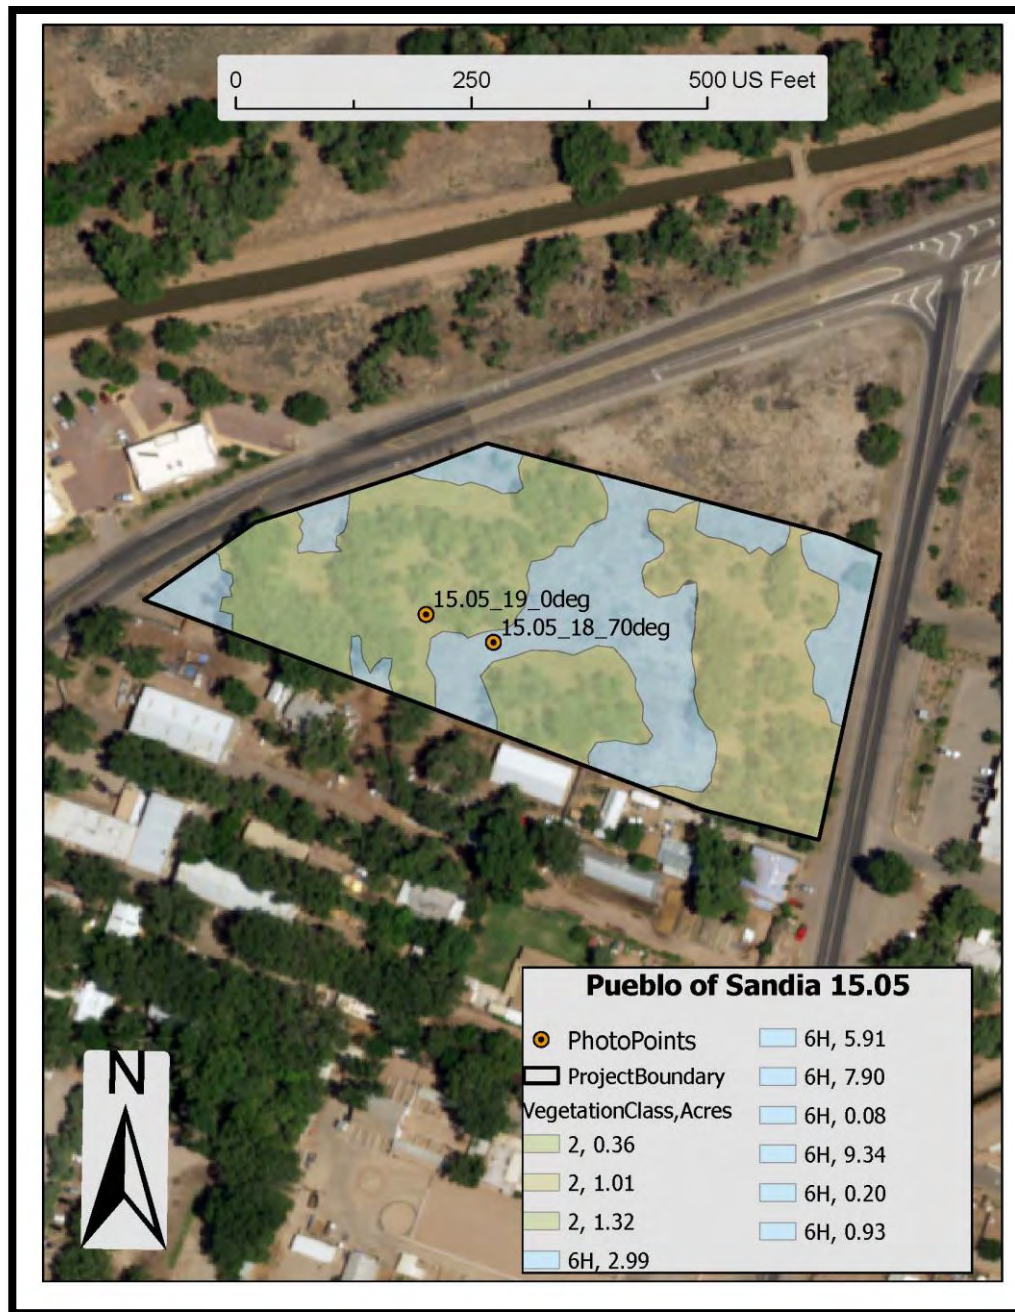
Figure 6 15.05 in geographic context.

This site was recently purchased by the Pueblo. The property is bordered by a fence, though it is incomplete on the northeast side. There is no known development on the property, although there is a two-track road and concrete debris present. There are small to medium Siberian elms present, as well as some Russian thistle. This project has good ground cover, due largely to cottonwood leaves. It also has good canopy cover and shade. Native species observed in abundance included Canada lettuce, Canada wild rye, bursage, cota, and dropseed grass.

On average scores increased from 2015. The only score that decreased was Vegetation Vertical Structure, which went from a 3 to a 2. This can be attributed to the loss of Type 1 vegetation structure, which is classified as a tall structure forest with a well-developed understory. Type 1 gave way to Type 2 which is a low structure forest with little to no understory, this could be due to the removal of species like Russian Olive and Tamarisk that would have contributed to a well-developed understory. Type 2 was the dominant vertical vegetation, made up of tall shrubs such as Siberian Elm. Herbaceous cover was the next most dominant vegetation type and includes plants such as dropseed and Alkaline Sakatoon. The site received an overall rating of 2.5 out of 4 which rates it a “B” or “Good”, which is an increase from 2015’s rating of a “C” or “Fair”. Surface fuels increased from 2015. In 2015 they were attributed to leaf litter, it is likely the increase in exotic species cover such as tumbleweed and Redroot Amaranth contributed to the increase in surface fuels.
