Rancho Las Lagunas Project 14-14

Post-treatment Monitoring Report

2015 & 2020

Prepared by Kathryn R Mahan, Ecological Monitoring Specialist, New Mexico Forest and Watershed Restoration Institute for the Greater Rio Grande Watershed Alliance

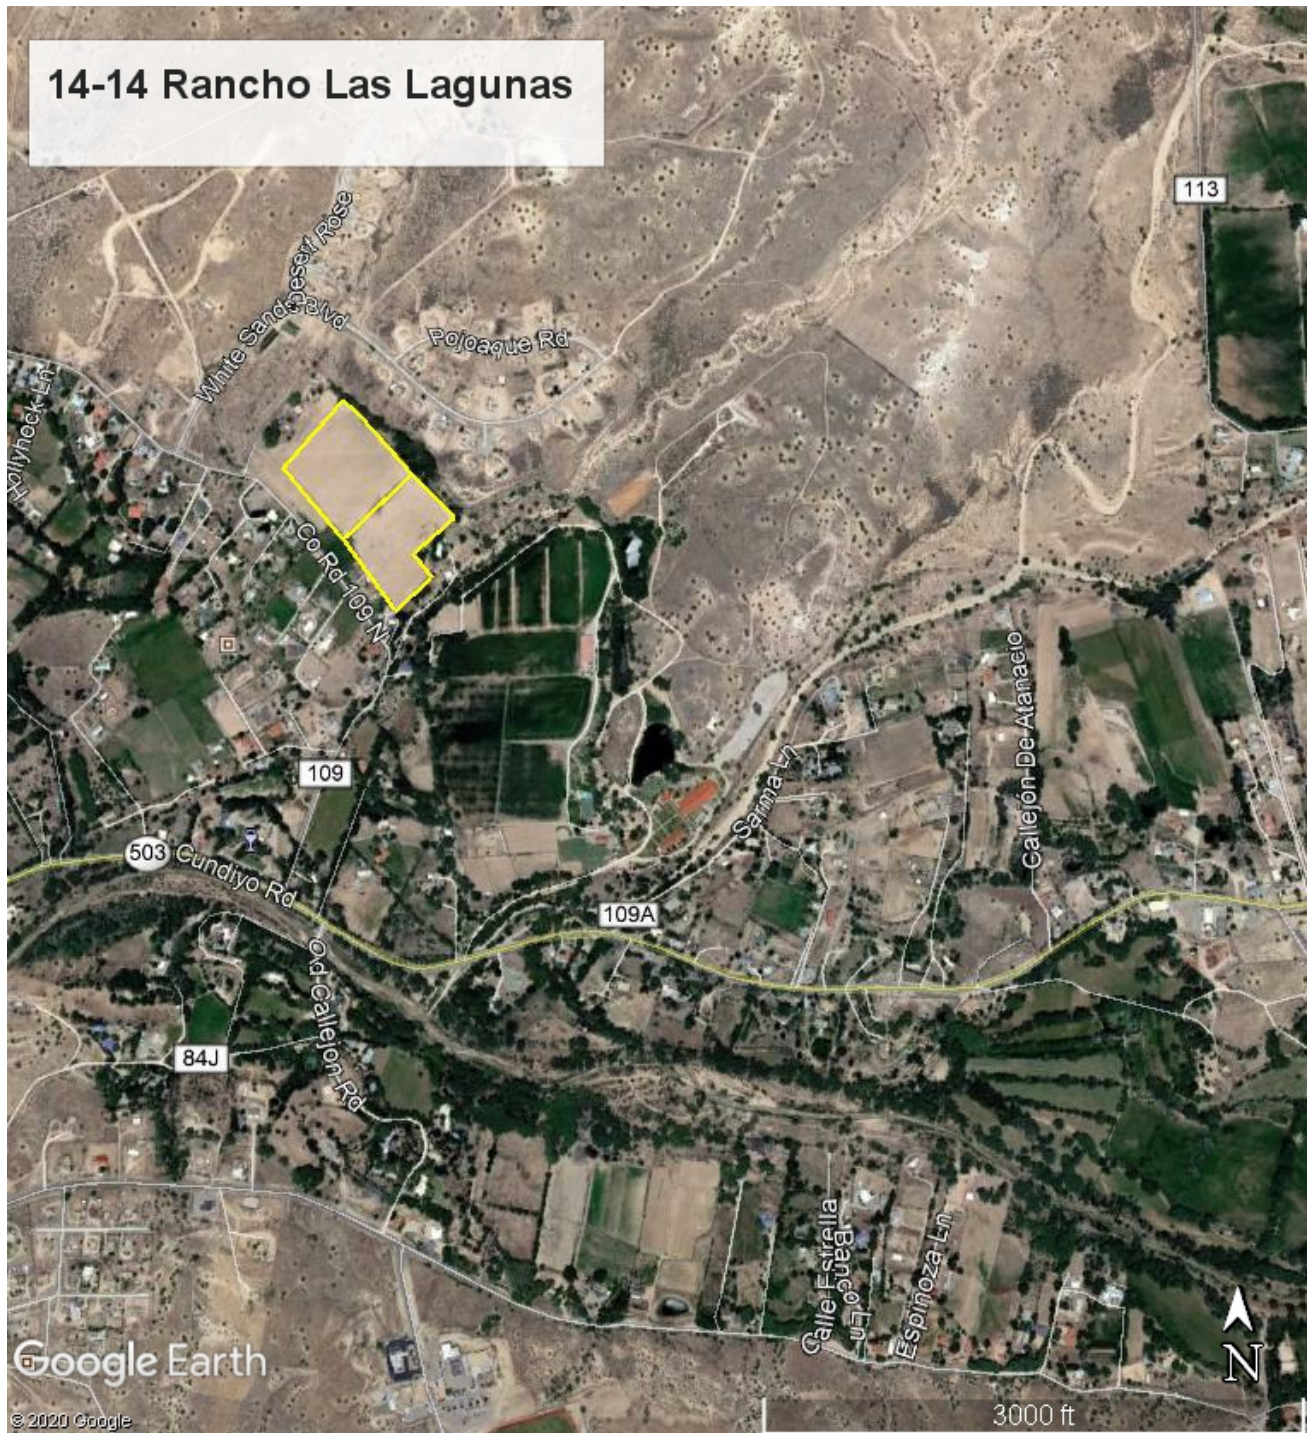
Figure 1. 14-14 Rancho Las Lagunas

Project 14-14 is located in the community of Pojoaque in Santa Fe County, NM (Figure 1). The nearby city of Santa Fe receives an average of 14.21 inches of precipitation per year. The average high temperature is 86° F in July and the average low is 17° F in December and January. (U.S. Climate Data, 2017)

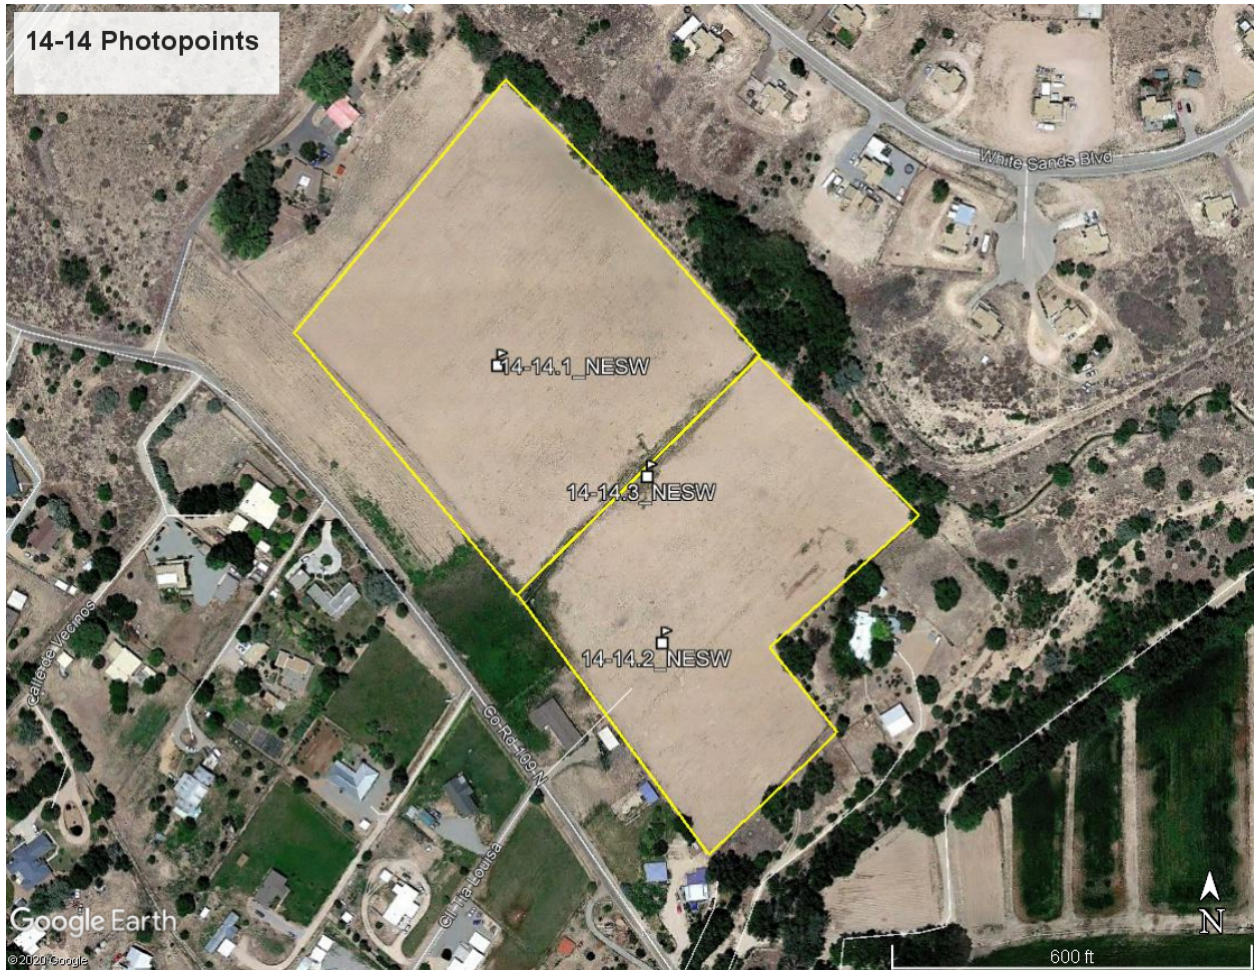
Figure 2. 14-14 Rancho Las Lagunas photopoints.

Photopoint ID	Latitude	Longitude
14-14_1	35.90403933° N	106.00810114° W
14-14_2	35.90277815° N	106.00715353° W
14-14_3	35.90354460° N	106.00721452° W

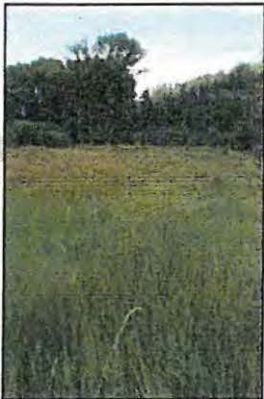
Type 6W- Herbaceous Wetland.

Herbaceous wetland vegetation covering >10% of the area of the community (polygon). Stands dominated by obligate wetland herbaceous species. Woody species absent, or <10% cover. Photograph of *Carex nebrascensis* meadow on upper Rio Santa Barbara by Y. Chauvin, 2009.
