La Villita 6 and 7, Project 14-22

Pre-treatment and Post-treatment Monitoring Report

2015 and 2019

Prepared by Kathryn R Mahan, Ecological Monitoring Specialist, New Mexico Forest and Watershed Restoration Institute for the Greater Rio Grande Watershed Alliance

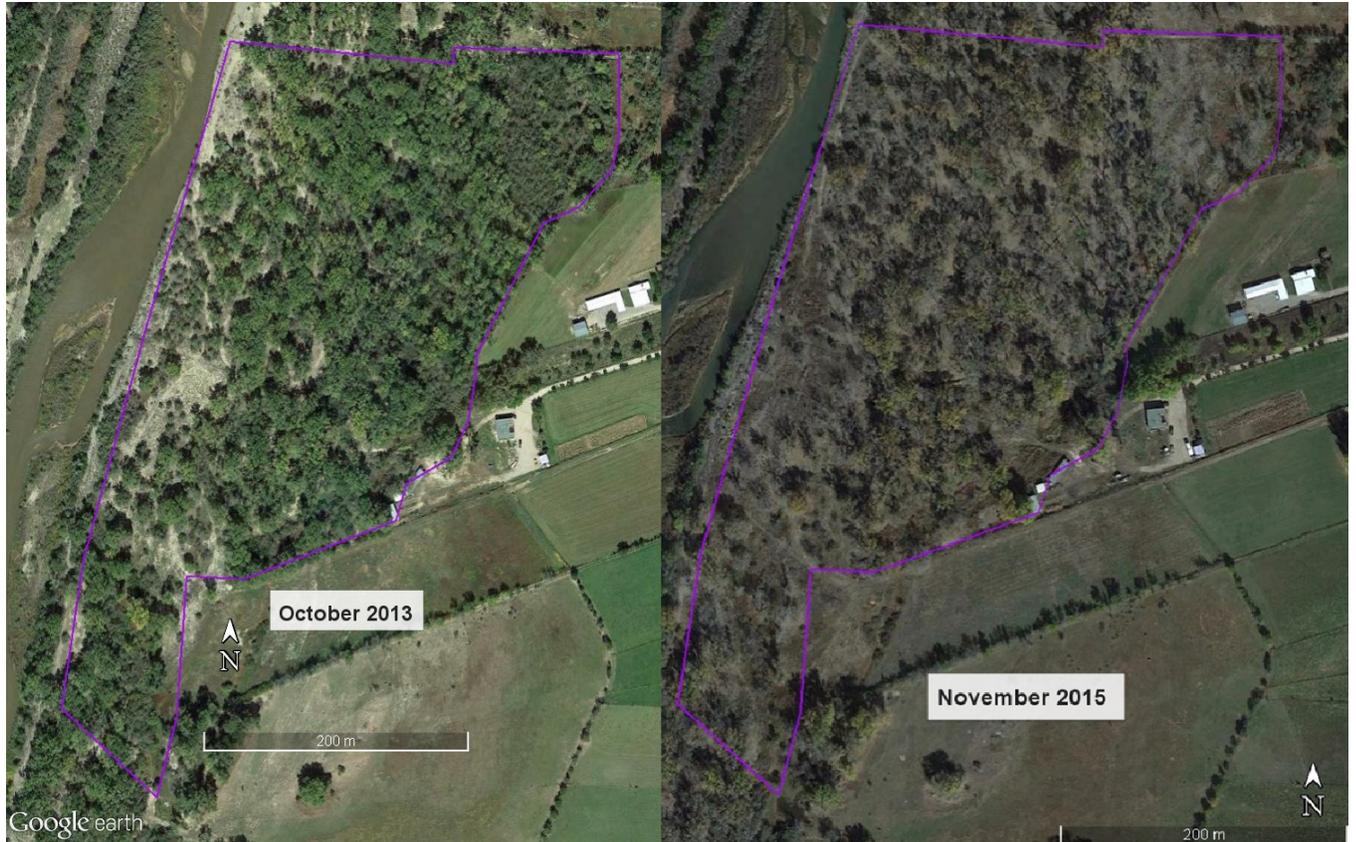
Figure 2. 14-22 La Villita pre- and post-treatment monitoring.

Pre-treatment monitoring was conducted at this 28.3-acre project site on January 6, 2015 as part of a restoration project targeting non-native phreatophytes scheduled for 2014-2015. Treatment was completed by the end January 2015, and re-treatment of Russian olive seedlings and other resprouts occurred in October 2015. Post-treatment monitoring was conducted in November 2019. Google imagery below is from October 2013 (pre-treatment) and November 2015 (immediately post-treatment).

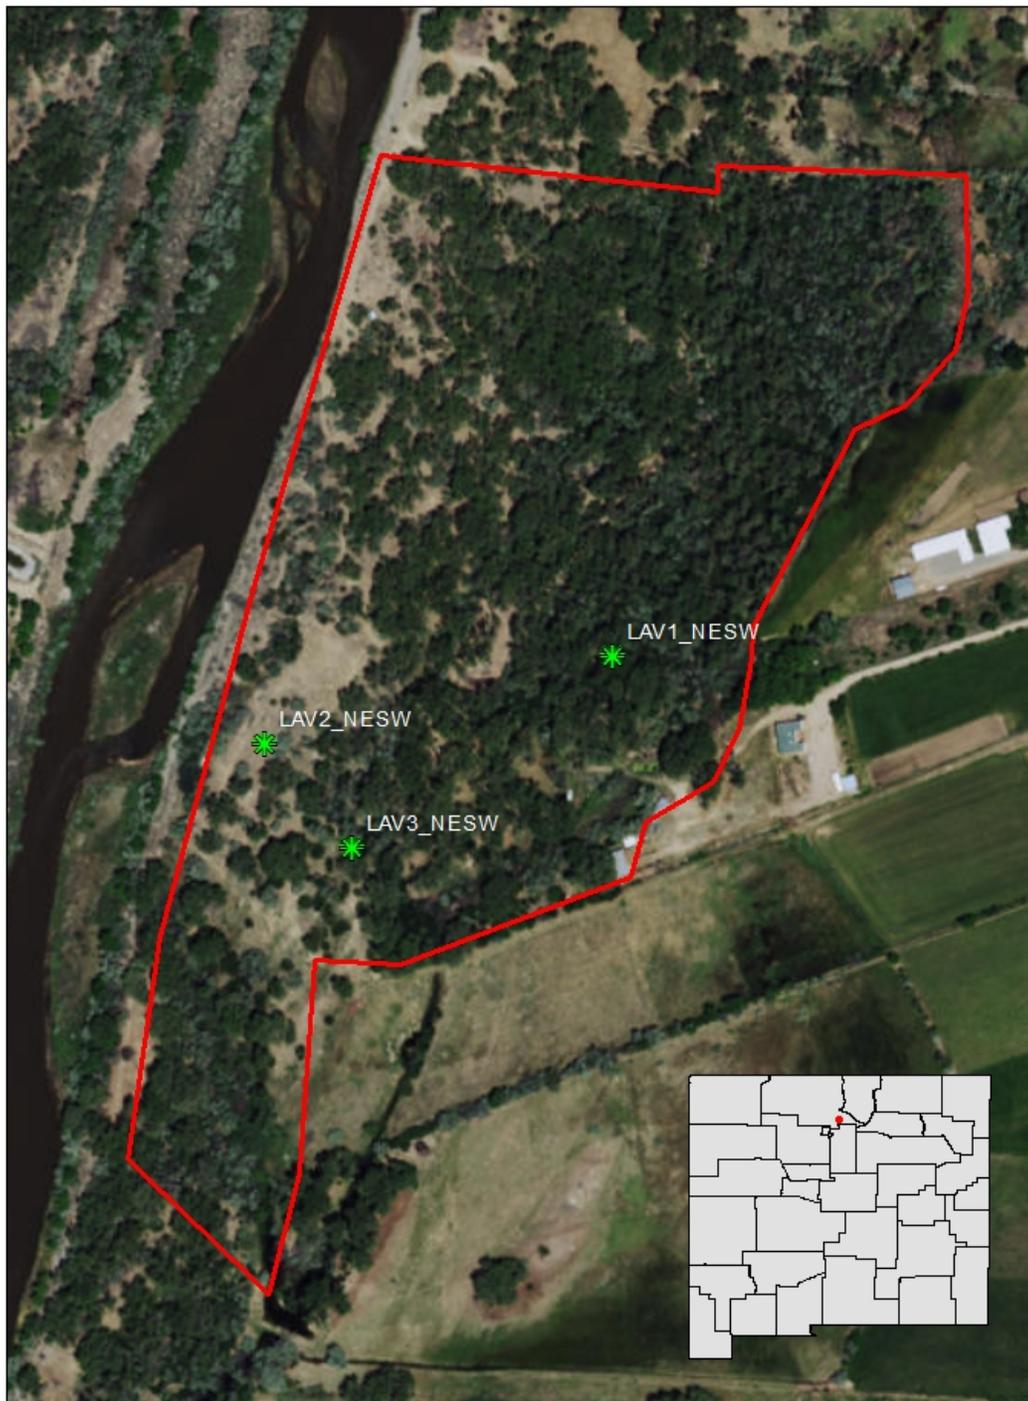
Figure 3. 14-22 La Villita with photopoints.

Photopoints were established to capture images where vegetation shifts were observed. Waypoints were marked with a Garmin GPS unit and named sequentially by site. Photos were taken in the direction that most effectively captured the diverse vegetation community(ies). Where appropriate, one waypoint was used for photos taken in multiple directions.

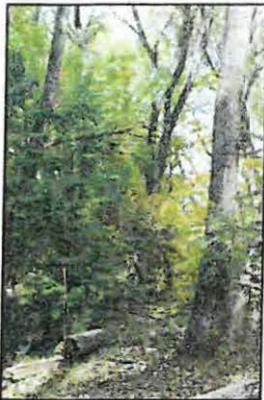
Type 1 –High Structure Forest with a well-developed understory.

Tall mature to intermediate-aged trees (>5 m [>15 feet]) with canopy covering >25% of the area of the community (polygon) and understory layer (0-5 m [0-15 feet]) covering >25% of the area of the community (polygon). Substantial foliage is in all height layers. (This type incorporates Hink and Ohmart structure types 1 and 3.) Photograph on Gila River by Y. Chauvin, 2012.

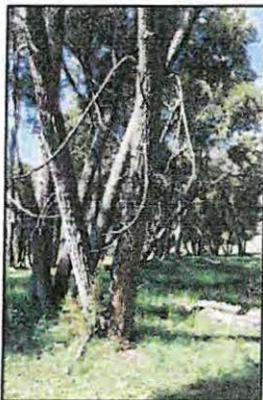
Type 2 –Low Structure Forest with little or no understory.

Tall mature to intermediate-aged trees (>5 m [>15 feet]) with canopy covering >25% of the area of the community (polygon) and understory layer (1-5 m [3-15 feet]) covering <25% of the area of the community (polygon). Majority of foliage is over 5 m (15 feet) above the ground. (This type incorporates Hink and Ohmart structure types 2 and 4.) Photograph on Diamond Creek by Y. Chauvin, 2012.

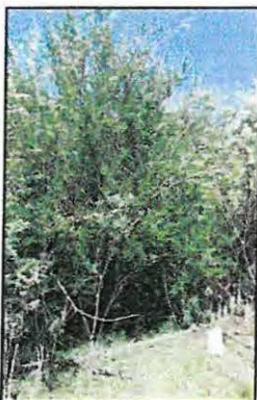
Type 5 –Tall Shrub Stands.

Young tree and shrub layer only (15-5 m [4.5-15 feet]) covering >25% of the area of the community (polygon). Stands dominated by tall shrubs and young trees, may include herbaceous vegetation

underneath the woody vegetation. Photograph on San Francisco River by Y. Chauvin, 2012.

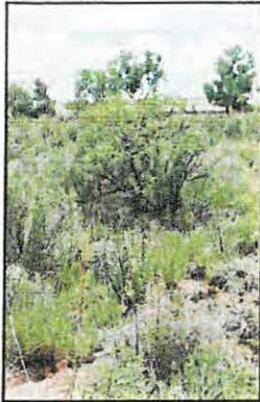
Type 6S- Short Shrub Stands.

Short stature shrubs or very young shrubs and trees (up to 1.5 m [up to 4.5 feet]) covering >10% of the area of the community (polygon). Stands dominated by short woody vegetation, may include herbaceous vegetation underneath the woody vegetation. Photograph on Lower Pecos River by E. Lindahl, 2008.

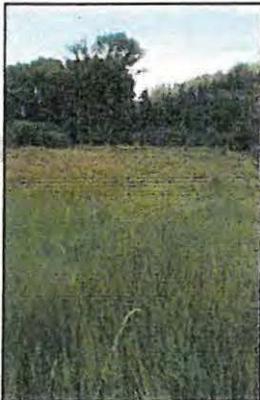
Type 6W- Herbaceous Wetland.

Herbaceous wetland vegetation covering >10% of the area of the community (polygon). Stands dominated by obligate wetland herbaceous species. Woody species absent, or <10% cover. Photograph of *Carex nebrascensis* meadow on upper Rio Santa Barbara by Y. Chauvin, 2009.

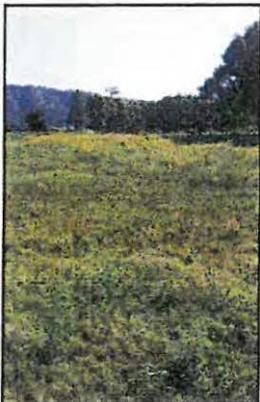
Type 6H- Herbaceous.

Herbaceous vegetation covering >10% of the area of the community (polygon). Stands dominated by herbaceous vegetation of any type except obligate wetland species. Woody species absent or <10% cover. Photograph on Diamond Creek by Y. Chauvin, 2012.

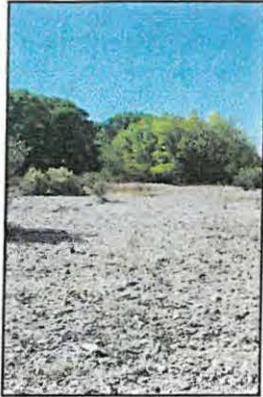
Type 7–Sparse Vegetation/Bare Ground.

Bare ground, may include sparse woody or herbaceous vegetation, but total vegetation cover <10%. May be natural in origin (cobble bars) or anthropogenic in origin (graded or plowed earth) Photograph on Lower Gila River by Y. Chauvin,2012.
