La Canova Project 15-19, 14-23

Pre-treatment Monitoring Report

2015

Prepared by Kathryn R Mahan, Ecological Monitoring Specialist, New Mexico Forest and Watershed Restoration Institute for the Greater Rio Grande Watershed Alliance

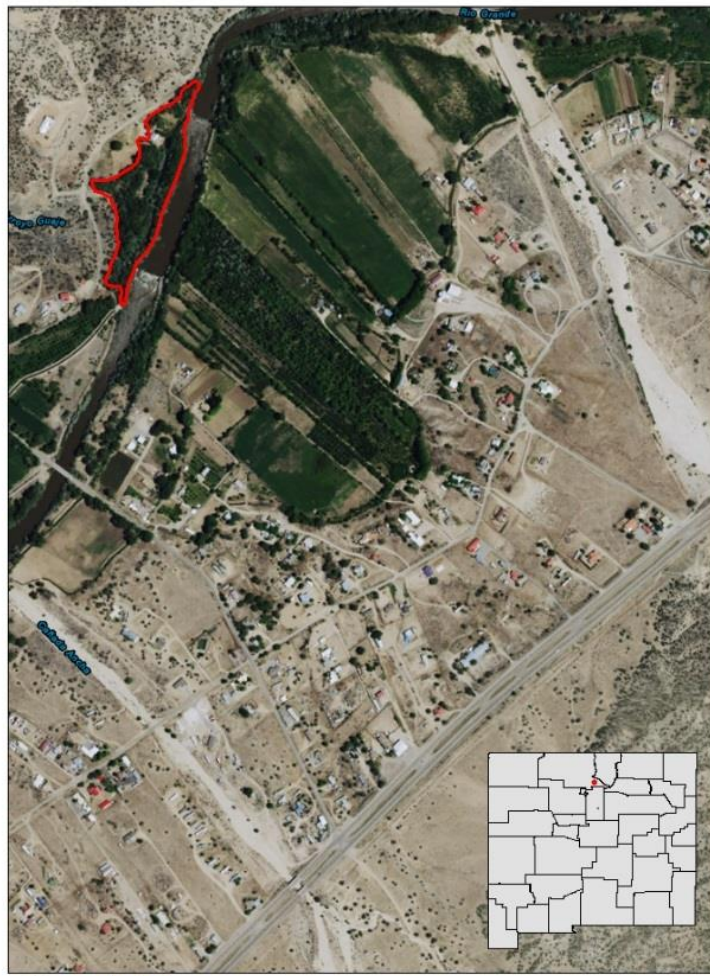
Figure 1. 15-19 La Canova in geographic context.

Project 15-19 is located in the community of La Canova, two miles south of Velarde, and approximately 13 miles north of Española, NM (Figure 1).

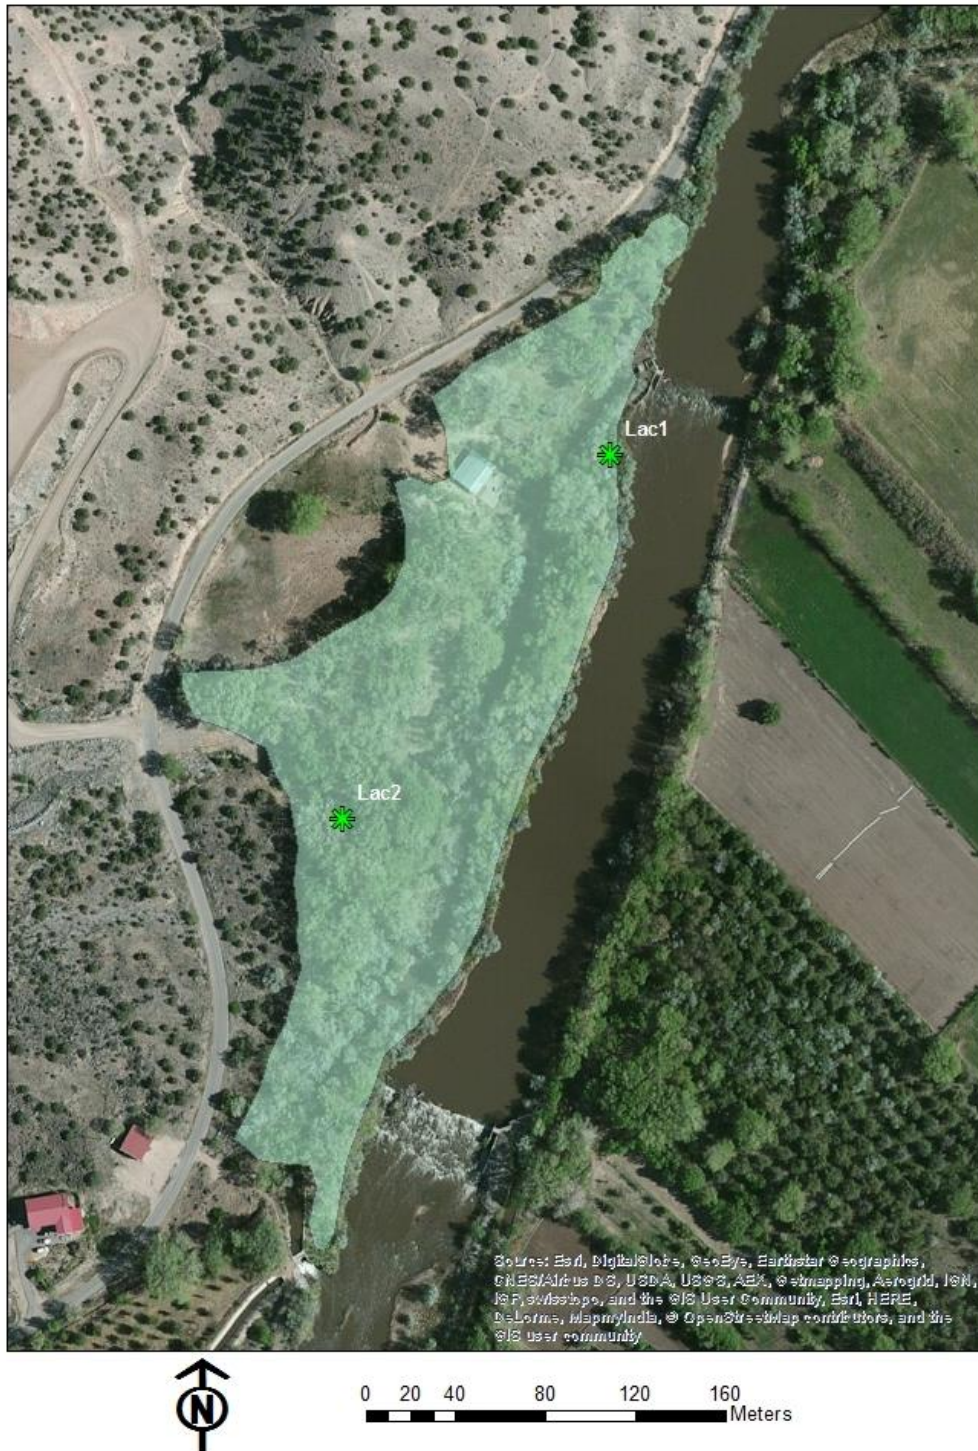
Figure 2. 15-19 La Canova photopoints.

15-19 La Canova Photopoints

Project Name	Point number in NMFWRIGarmin	Photo name on maps	Direction facing	Coordinates
14.23 pre	Lac1	Lac1	N	36.152420584, -105.995207028
			E	
			S	
			W	
14.23 pre	Lac2	Lac2	N	36.150949057, -105.99651251
			E	
			S	
			W

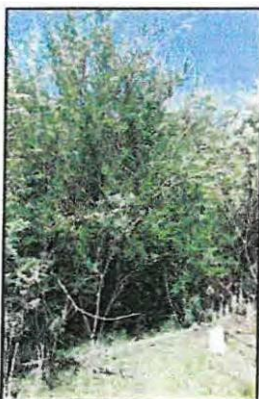
Type 5 –Tall Shrub Stands.

Young tree and shrub layer only (15-5 m [4.5-15 feet]) covering >25% of the area of the community (polygon). Stands dominated by tall shrubs and young trees, may include herbaceous vegetation underneath the woody vegetation. Photograph on San Francisco River by Y. Chauvin, 2012.
