# La Canova Project 15-19, 14-23

## Post-treatment Monitoring Report

2015 & 2019

Prepared by Kathryn R Mahan, Ecological Monitoring Specialist, New Mexico Forest and Watershed Restoration Institute for the Greater Rio Grande Watershed Alliance

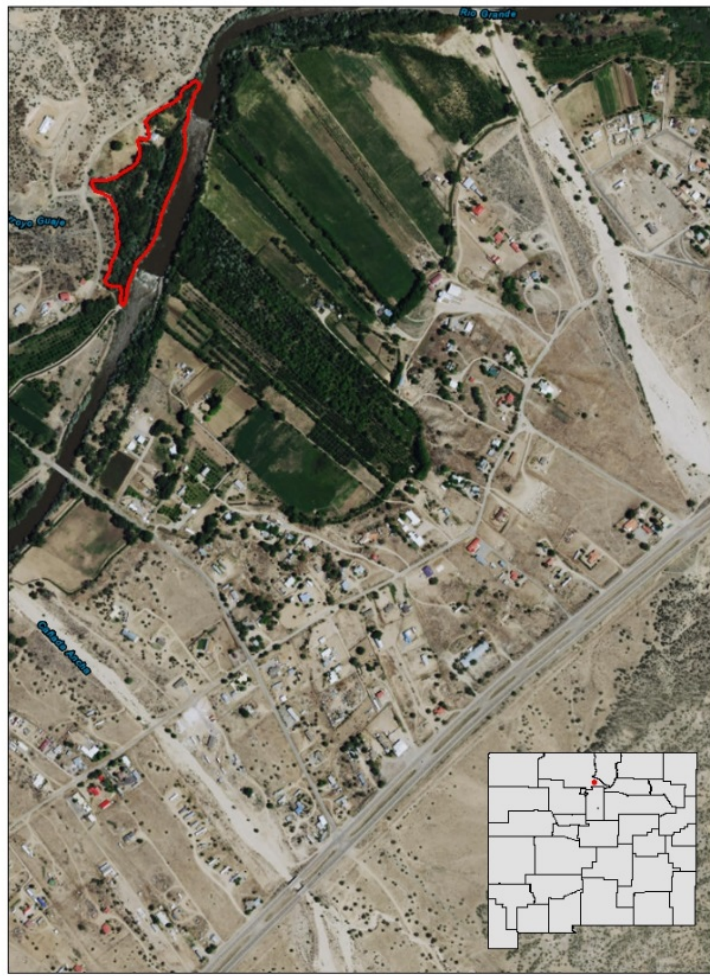
Figure 1. 15-19 La Canova in geographic context.

Project 15-19 is located in the community of La Canova, two miles south of Velarde, and approximately 13 miles north of Española, NM (Figure 1).

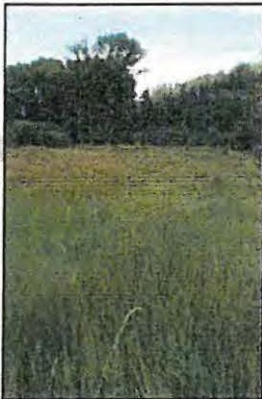
**Type 6W- Herbaceous Wetland.**

Herbaceous wetland vegetation covering >10% of the area of the community (polygon). Stands dominated by obligate wetland herbaceous species. Woody species absent, or <10% cover. Photograph of *Carex nebrascensis* meadow on upper Rio Santa Barbara by Y. Chauvin, 2009.
