Sommer (Ojo Caliente/Hernandez) Project 15-08

Pre-treatment Monitoring Report

2015

Ojo Caliente Project

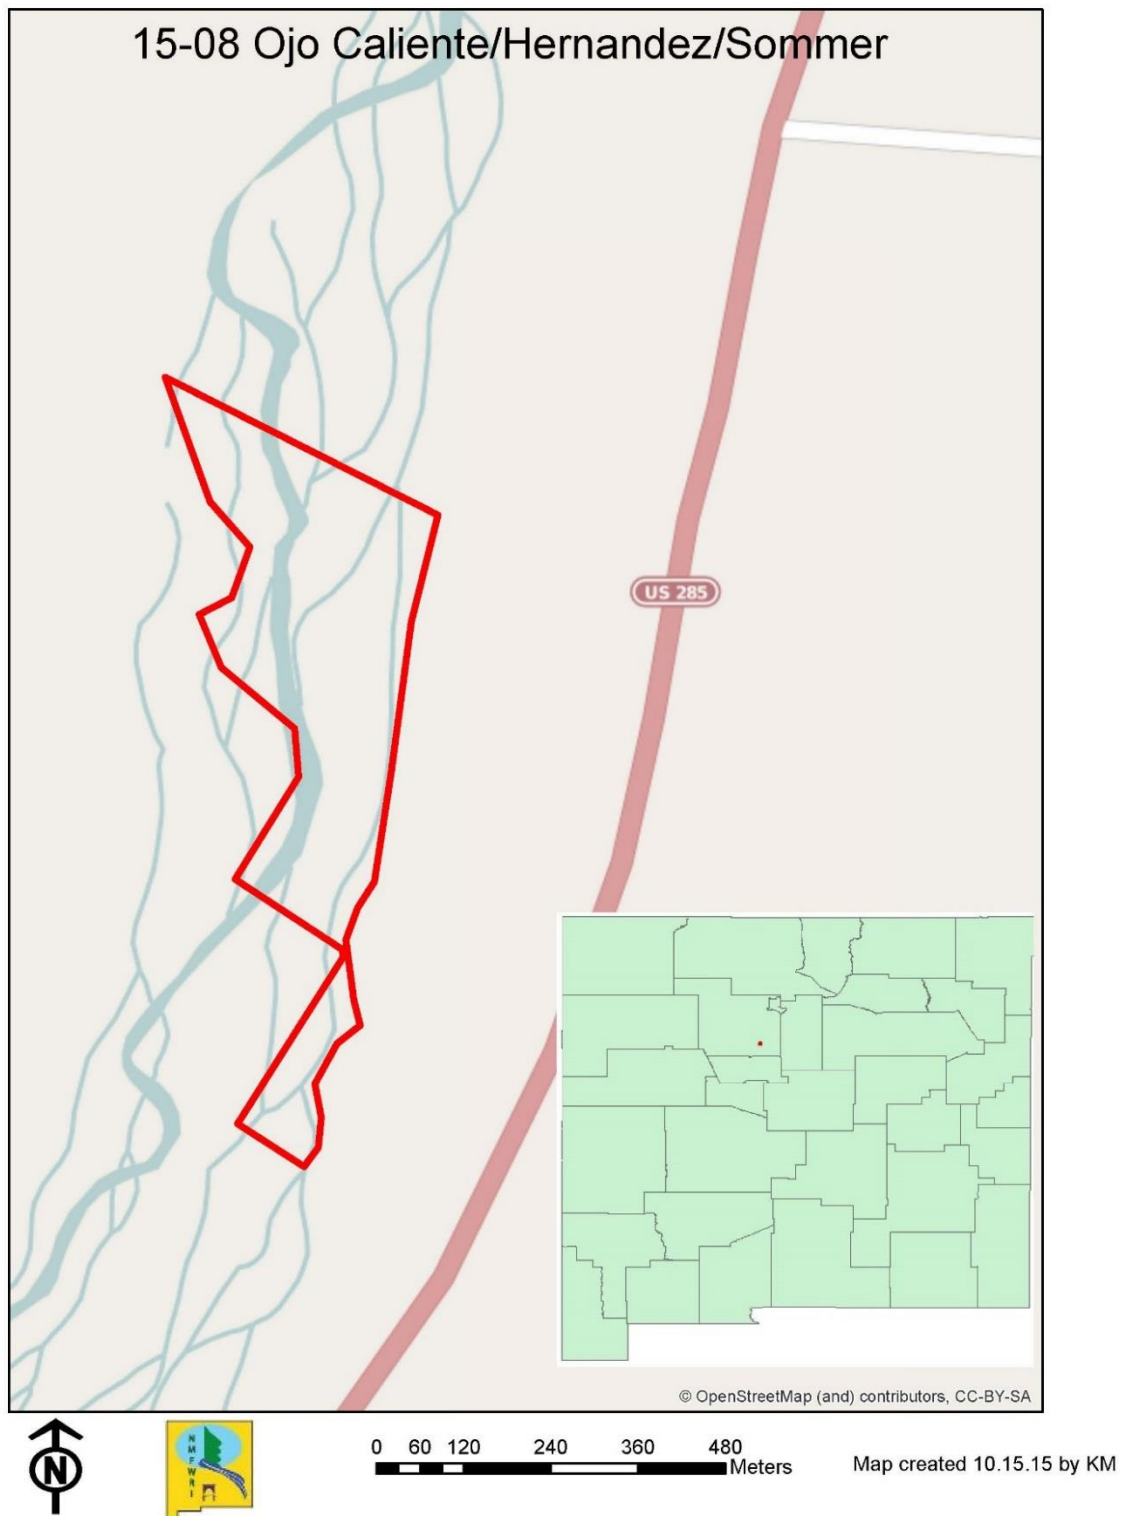
Figure 1. Project 15-08 in geographic context.

The Rio Ojo Caliente, as visible in the image above, can take different paths depending on the amount of flow. During our site visit, young willows were buried in sand from the river's movement the week before. The Rio Ojo Caliente flows from the Tusas and Vallecitos near Lamadera through the Ojo Caliente valley, to join the Rio Chama near Chili, south of Medenales and north of El Duende and Hernandez. The USGS gauge 08289000 measures the Rio Ojo Caliente at La Madera.

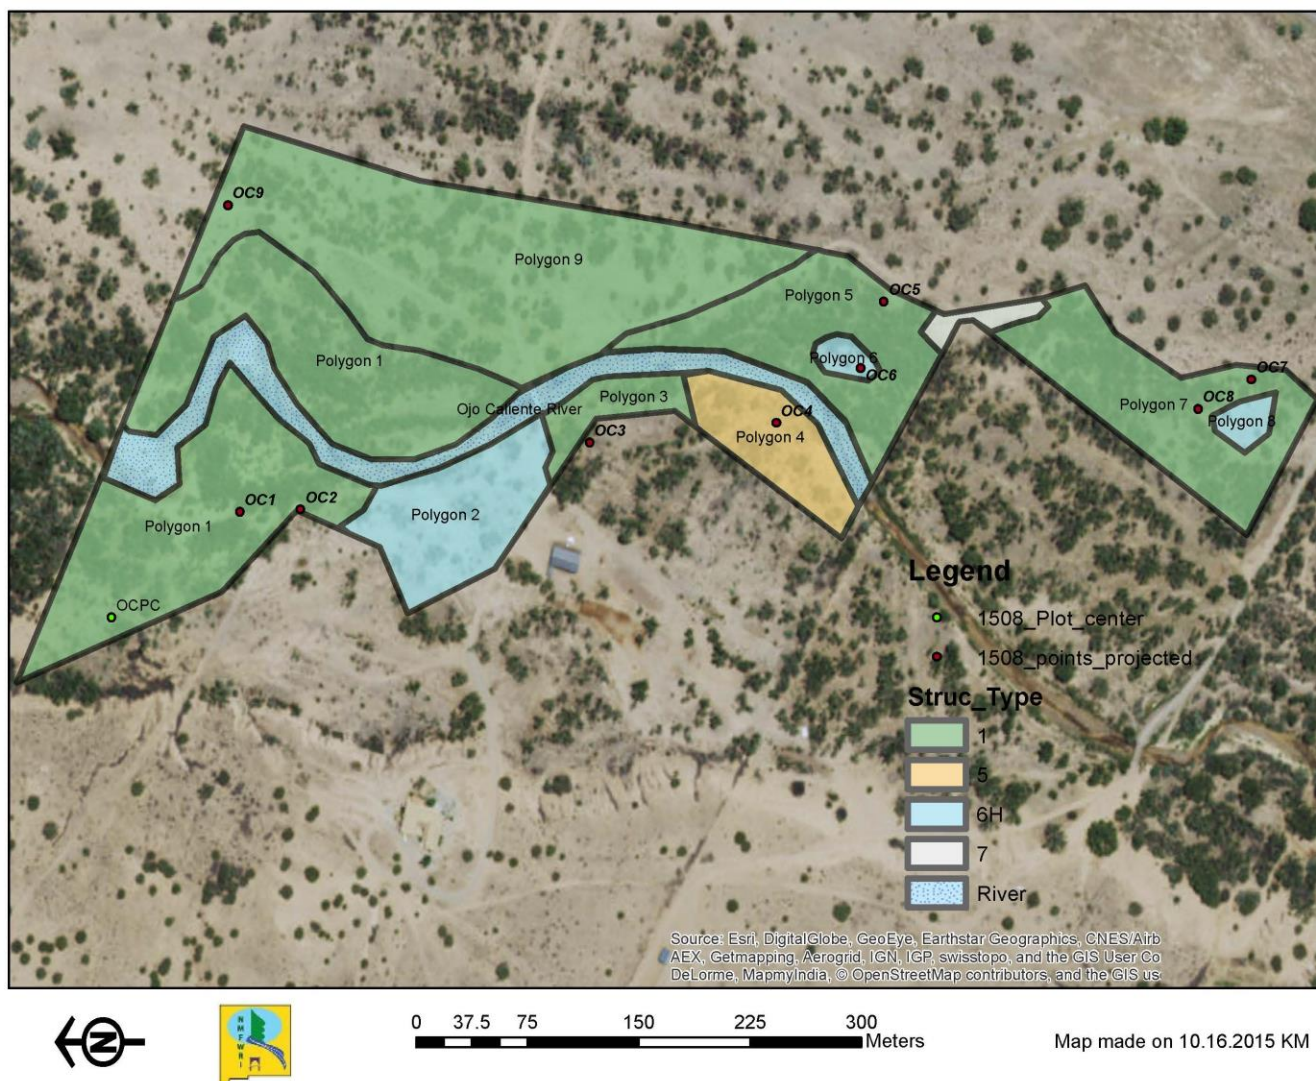
Figure 2. 15-08 Ojo Caliente project vegetation polygons.

This site also had one plot established (location shown on map below). At this plot, we collected data on vegetation cover and fuel loading using Submethods 1 and 2 outlined in Appendix III, the BEMP plots and the Brown's transects.

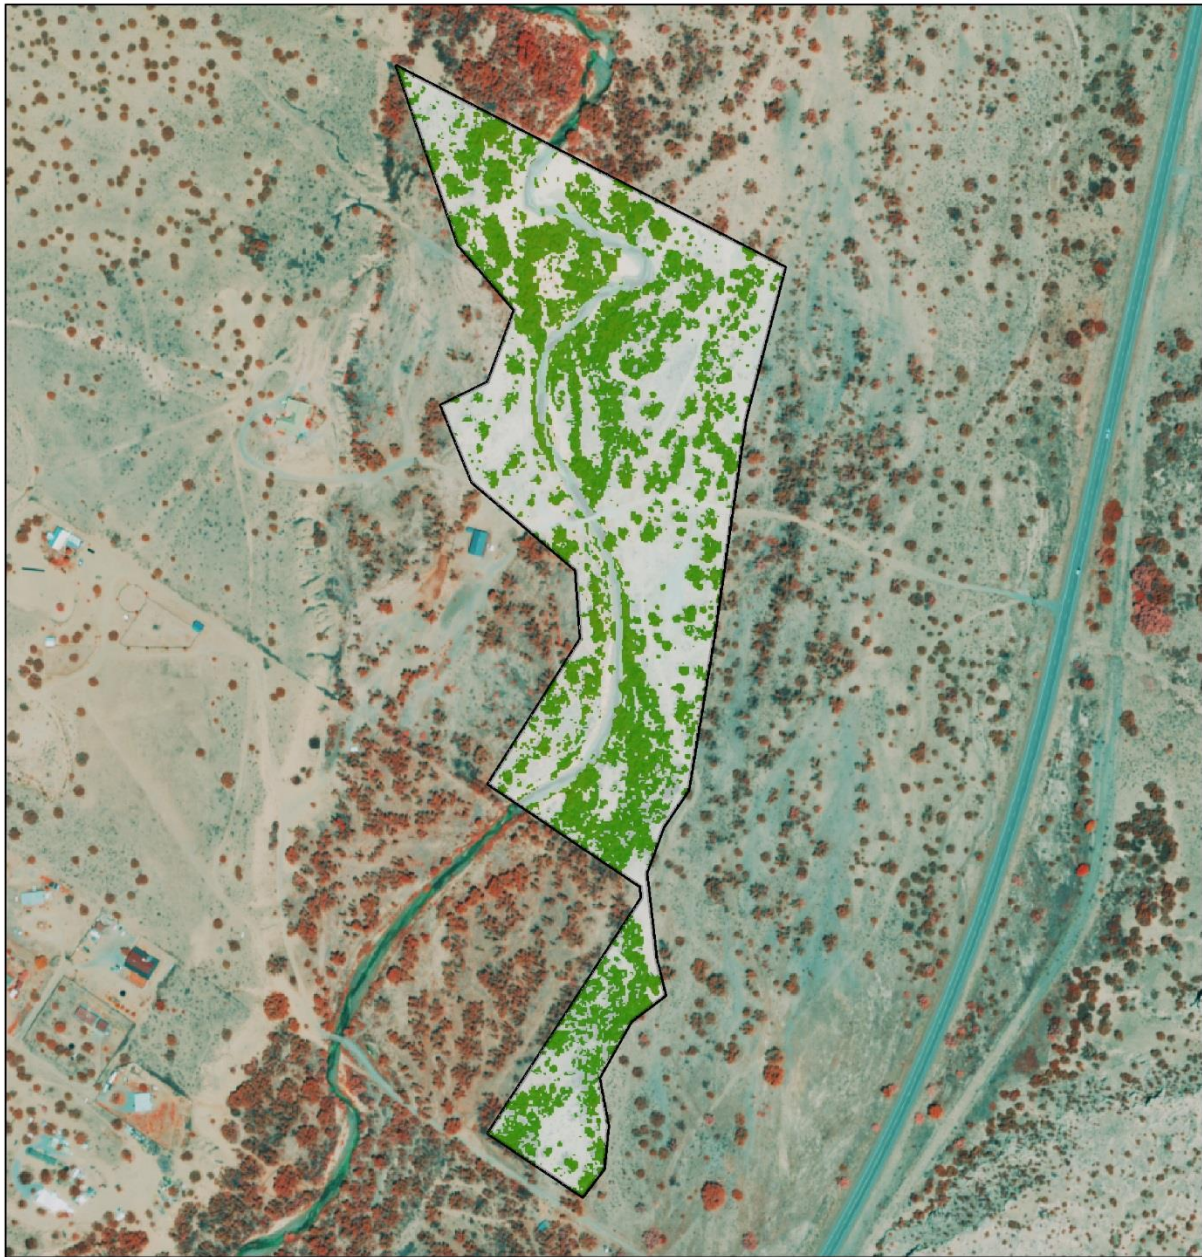
Figure 3. NAIP veg/ non-veg classification for 15-08.
Table 2. 15-08 Surface fuels from plot.

The NAIP analysis resulted in an estimate of 10.3 acres of the project as vegetation (trees and shrubs). 15.4 acres of the project were classified as sparsely vegetated/bare ground.

Vegetation mapping was done using eCognition software with 2014 NAIP Imagery. These classifications are only general estimates. Map created by Patti Dappen 2-19-16

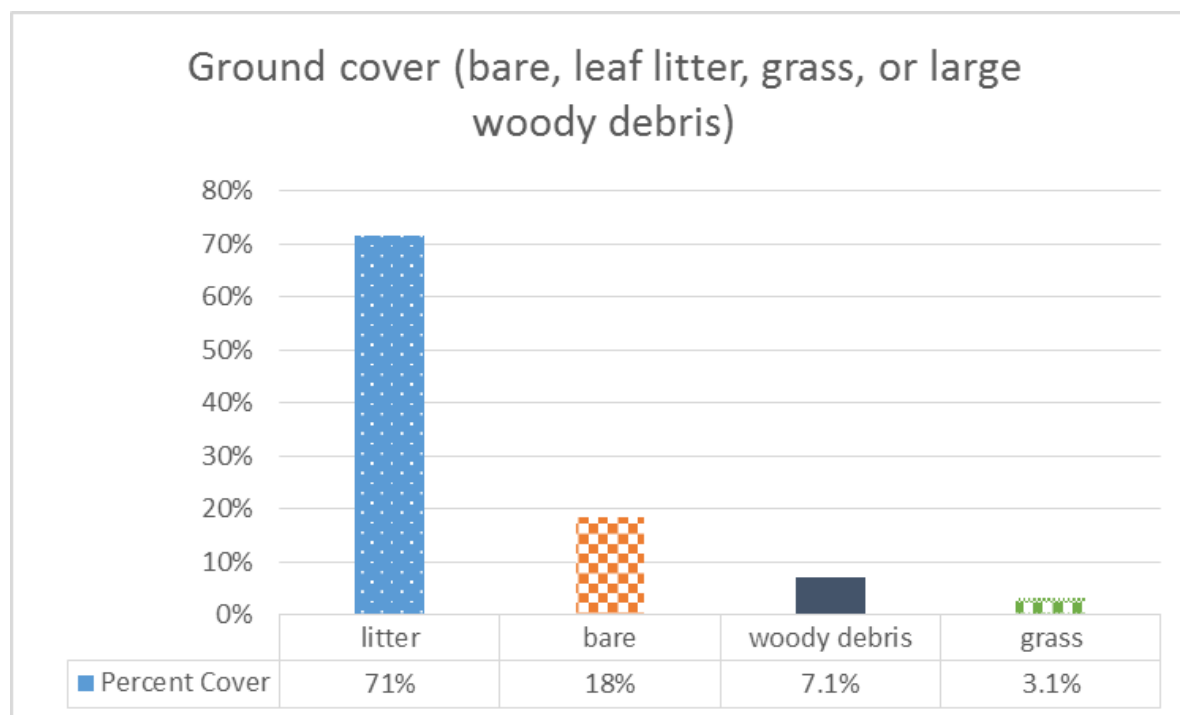
Figure 7.

Percent ground cover for plot on 15-08.

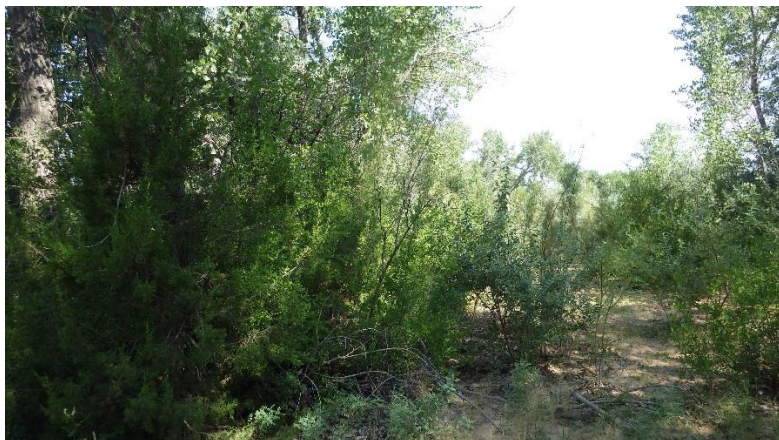
OC1, view of polygon 1.
Taken facing 20 degrees.

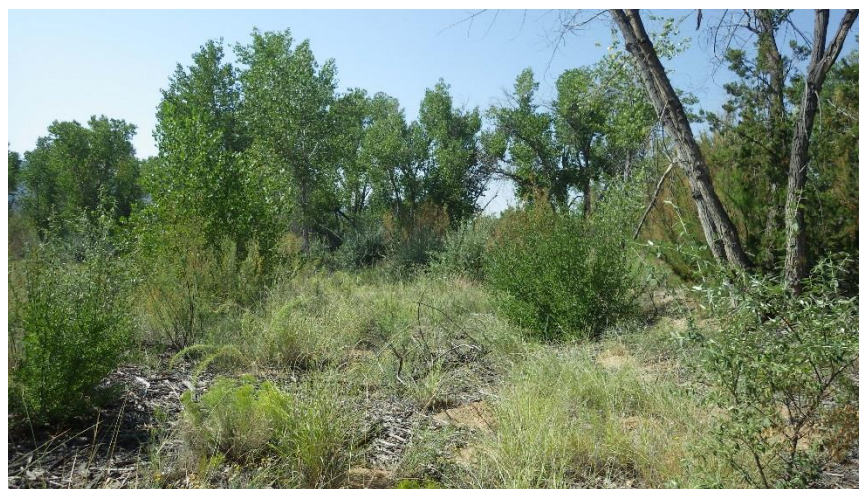
OC3, view of polygon 3.
Taken facing 180 degrees.

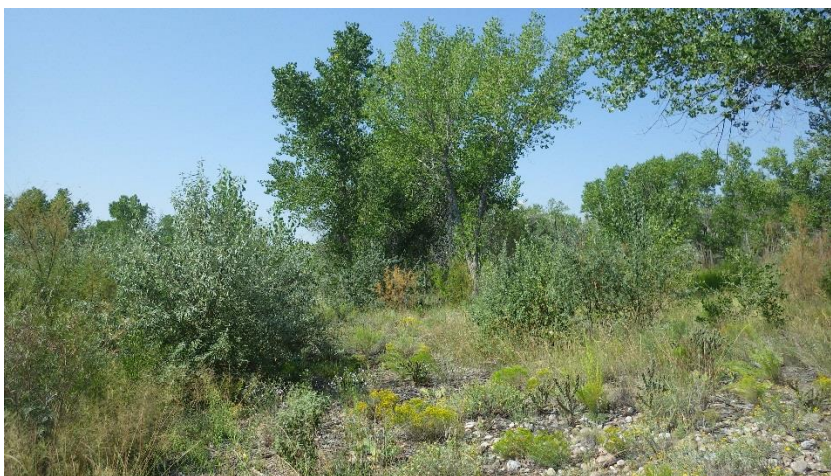
OC4, view of polygon 4,
previously masticated 4-5
years ago. Taken facing 195
degrees.

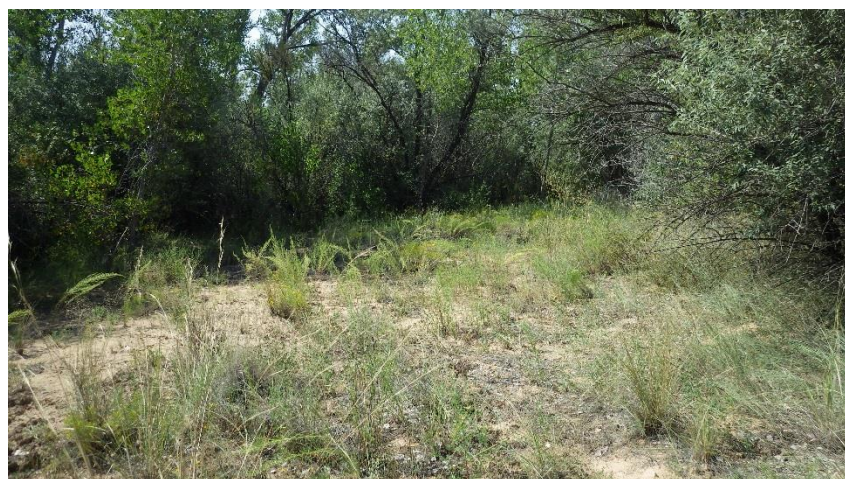
OC5, view of polygon 5.
Taken facing 335 degrees.

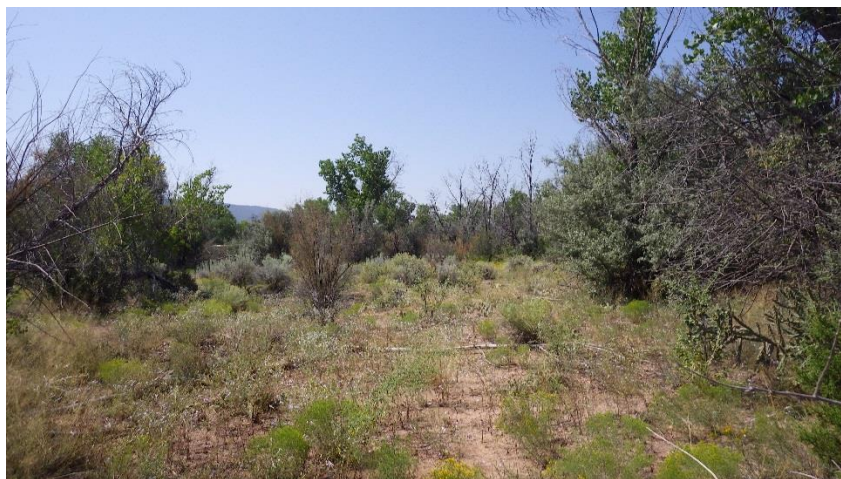
OC6, view of polygon 6.
Taken facing 155 degrees.

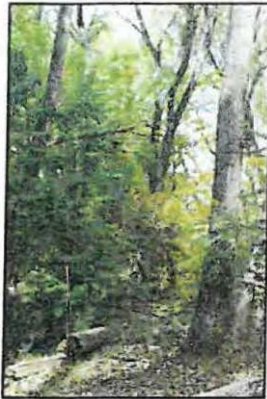
Type 1 –High Structure Forest with a well-developed understory.

Tall mature to intermediate-aged trees (>5 m [>15 feet]) with canopy covering >25% of the area of the community (polygon) and understory layer (0-5 m [0-15 feet]) covering >25% of the area of the community (polygon). Substantial foliage is in all height layers. (This type incorporates Hink and Ohmart structure types 1 and 3.) Photograph on Gila River by Y. Chauvin, 2012.

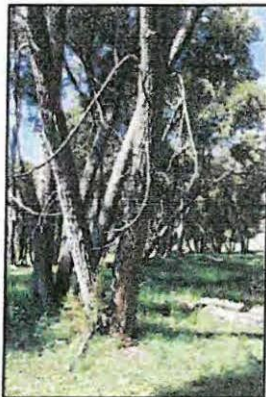
Type 2 -Low Structure Forest with little or no understory.

Tall mature to intermediate-aged trees (>5 m [>15 feet]) with canopy covering >25% of the area of the community (polygon) and understory layer (1-5 m [3-15 feet]) covering <25% of the area of the community (polygon). Majority of foliage is over 5 m (15 feet) above the ground. (This type incorporates Hink and Ohmart structure types 2 and 4.) Photograph on Diamond Creek by Y. Chauvin, 2012.

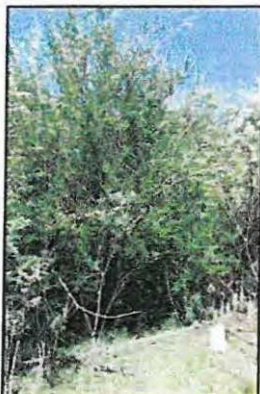
Type 5 -Tall Shrub Stands.

Young tree and shrub layer only (15-5 m [4.5-15 feet]) covering >25% of the area of the community (polygon). Stands dominated by tall shrubs and young trees, may include herbaceous vegetation underneath the woody vegetation. Photograph on San Francisco River by Y. Chauvin, 2012.

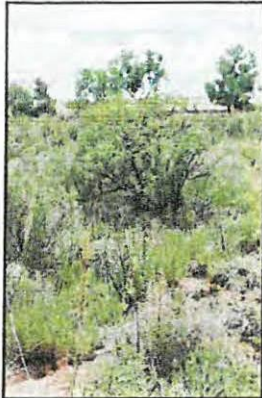
**Type 6S-Short Shrub Stands.**

Short stature shrubs or very young shrubs and trees (up to 1.5 m [up to 4.5 feet]) covering >10% of the area of the community (polygon). Stands dominated by short woody vegetation, may include herbaceous vegetation underneath the woody vegetation. Photograph on Lower Pecos River by E. Lindahl, 2008.

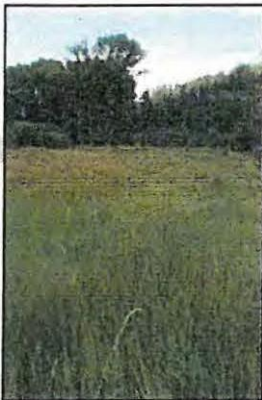
**Type 6W-Herbaceous Wetland.**

Herbaceous wetland vegetation covering >10% of the area of the community (polygon). Stands dominated by obligate wetland herbaceous species. Woody species absent, or <10% cover. Photograph of *Carex nebrascensis* meadow on upper Rio Santa Barbara by Y. Chauvin, 2009.

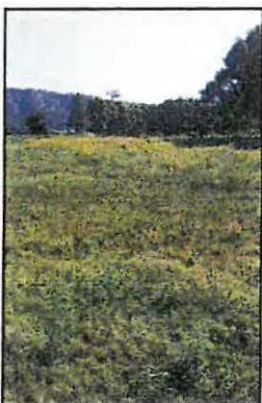
**Type 6H-Herbaceous.**

Herbaceous vegetation covering >10% of the area of the community (polygon). Stands dominated by herbaceous vegetation of any type except obligate wetland species. Woody species absent or <10% cover. Photograph on Diamond Creek by Y. Chauvin, 2012.

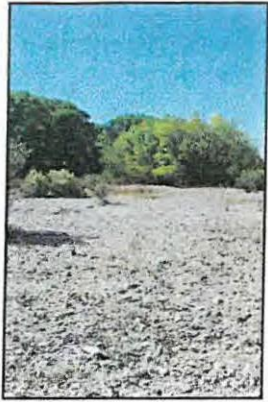
Type 7-Sparse Vegetation/Bare Ground.

Bare ground, may include sparse woody or herbaceous vegetation, but total vegetation cover <10%. May be natural in origin (cobble bars) or anthropogenic in origin (graded or plowed earth) Photograph on Lower Gila River by Y. Chauvin, 2012.
