# Lava SWCD Grants Projects 15.15 and 15.20

10-yr Post Treatment Monitoring Report – 2025

*New Mexico Forest and Watershed Restoration Institute*

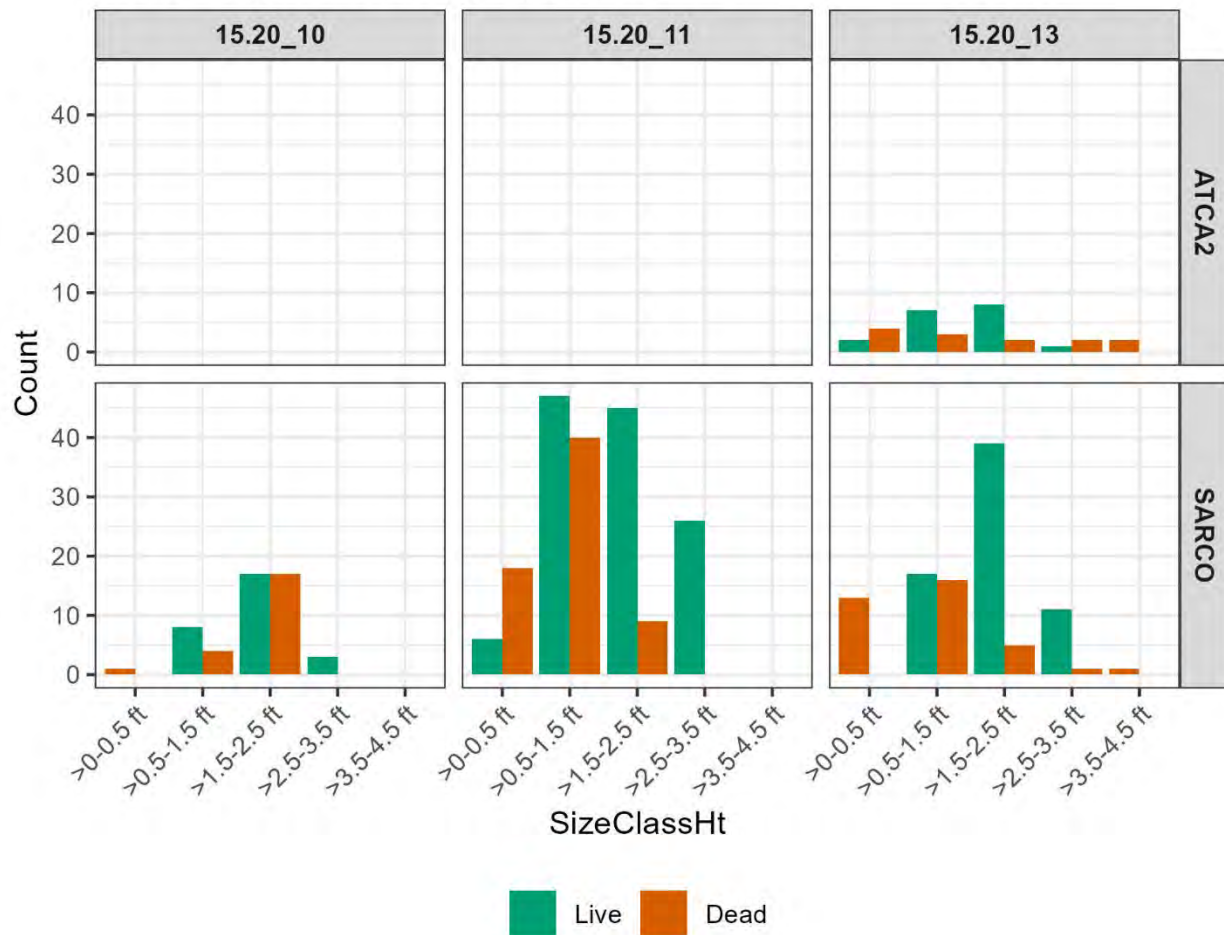
Figure 2: 15.20 number of seedlings by class height and live/dead status across plots.

There were no shrubs or trees on the 1/100<sup>th</sup> acre plots in the 15.15 project area. The 15.20 project had fourwing saltbush (*Atriplex canescens*, USDA Plant Code ATCA2) and greasewood (*Sarcobatus* sp., likely *vermiculatus*, USDA Plant Code SARCO). Greasewood was particularly common.

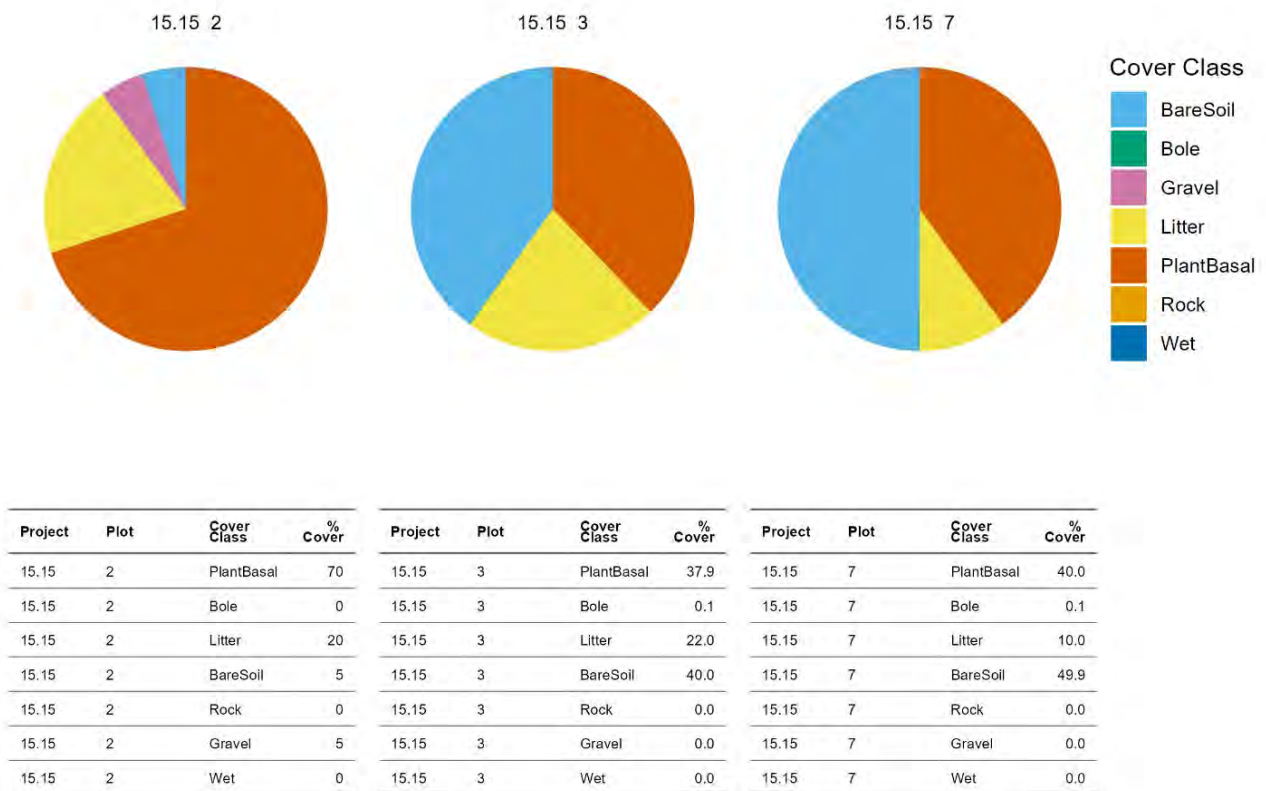
Figure 3: 15.15 ground cover by plot.

In the 15.15 project area, plant basal was consistently the largest portion of plot ground cover. For the two plots in the more open herbaceous plant community, it was around 40% with most of the remaining portion being bare soil and the final 10 to 20% covered in litter. Plot 2 is located on the edge of the denser, more shrub-dominated community type. This is reflected by 70% of its cover being plant basal and 20% litter, with bare soil and gravel only making up 10% jointly.

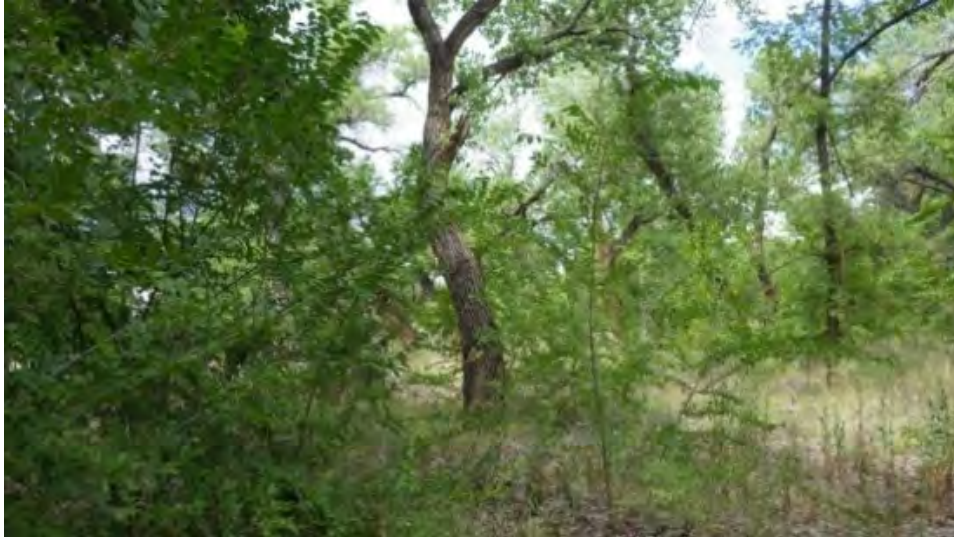
**Type 1- High Structure Forest** with a well-developed understory. Trees (>6 m) with a canopy covering >25% of the area of the community polygon and woody understory layer of tall shrubs or short trees (1.5-6 m) covering >25% of the area of the community (polygon). Substantial foliage is in all height layers.

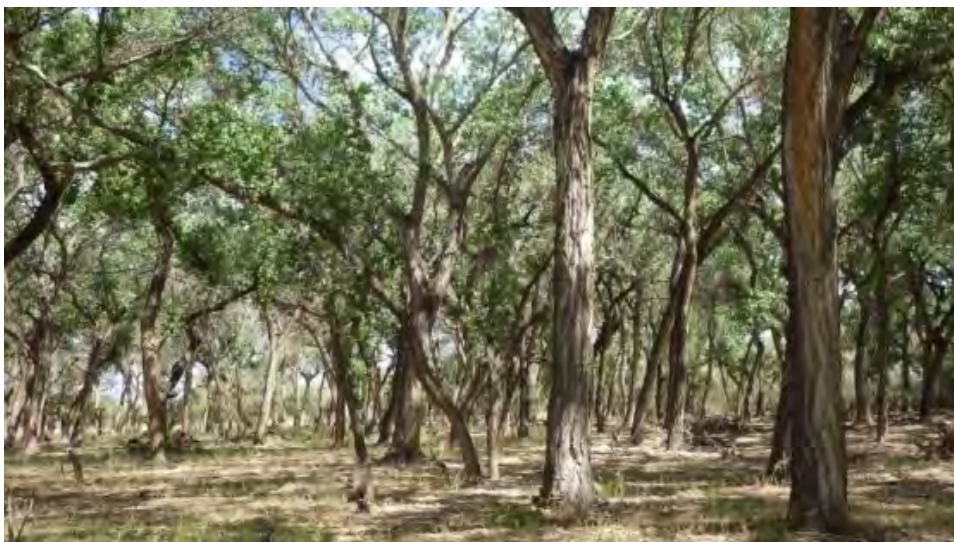
**Type 2 -Low Structure Forest** with little or no understory. Trees (>6 m) with canopy covering >25% of the area of the community polygon and minimal woody understory layer (1.5-6 m) covering <25% of the area of the community (polygon). Majority of foliage is over 7 m above the ground.

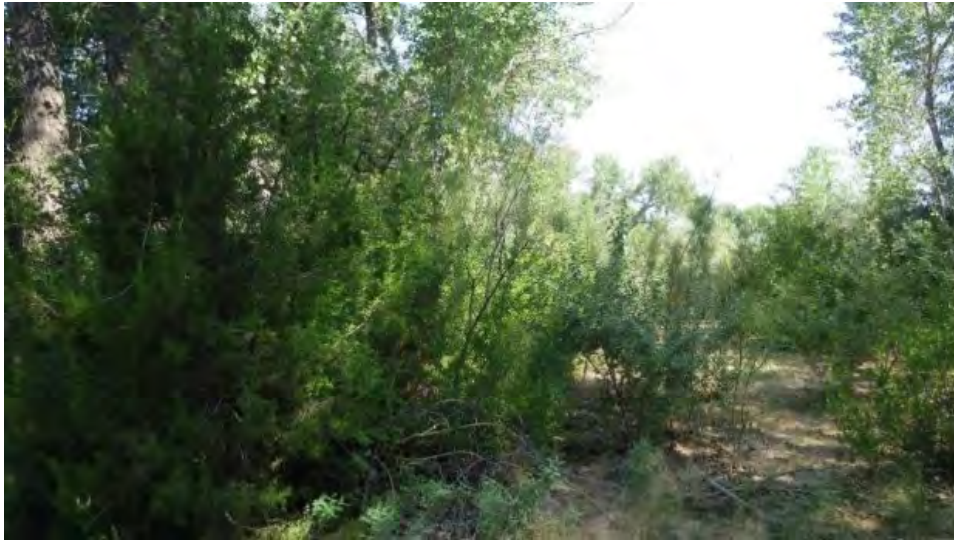
**Type 5 -Tall Shrubland.** Young tree and shrub layer (1.5-6 m ) covering >25% of the area of the community polygon. Stands dominated by tall shrubs and young trees, may include herbaceous vegetation underneath the woody vegetation.

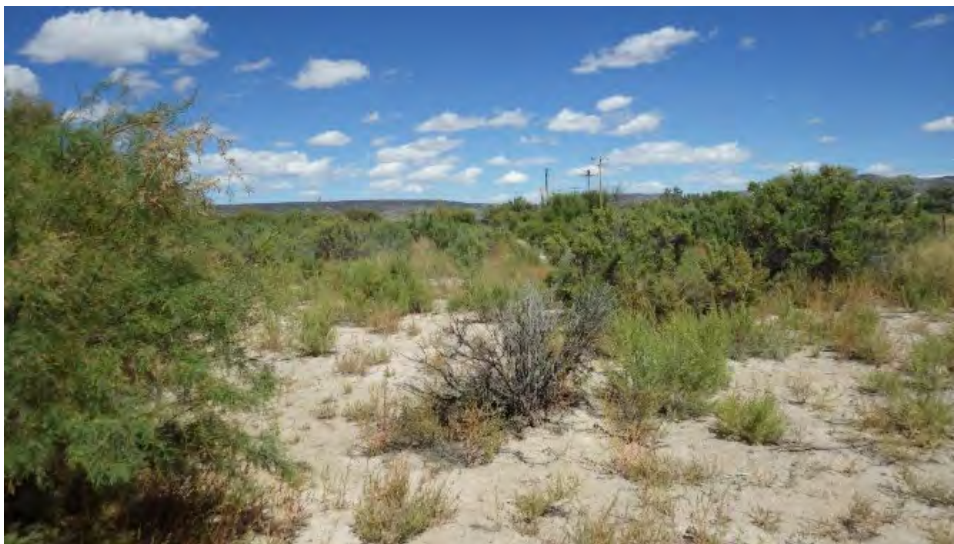
**Type 6S- Short Shrubland.** Short stature shrubs or very young trees (>1.5 m) covering >25% of the area of the community (polygon). Stands dominated by short woody vegetation, may include herbaceous vegetation among the woody vegetation.

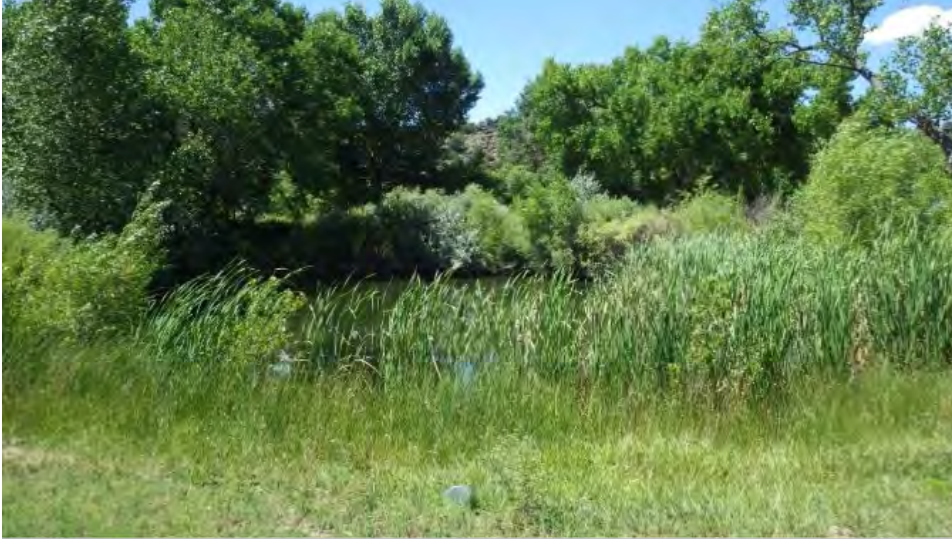
**Type 6W- Herbaceous Wetland.** Herbaceous wetland vegetation covering >10% of the area of the community polygon. Stands dominated by obligate wetland herbaceous species. Woody species absent, or <25% cover.

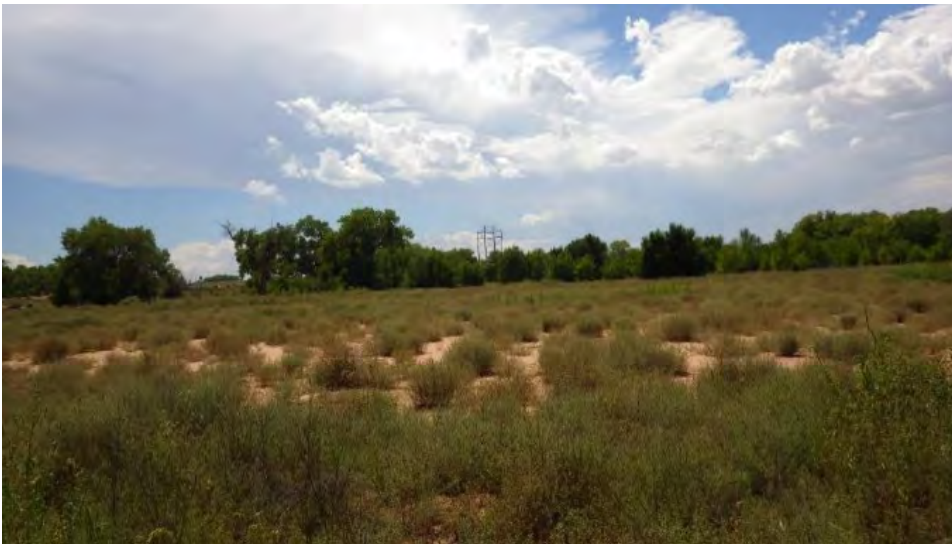
**Type 6H- Herbaceous vegetation.** Herbaceous vegetation covering >10% of the area of the community polygon. Stands dominated by herbaceous vegetation of any type except obligate wetland species. Woody species absent or <25% cover.

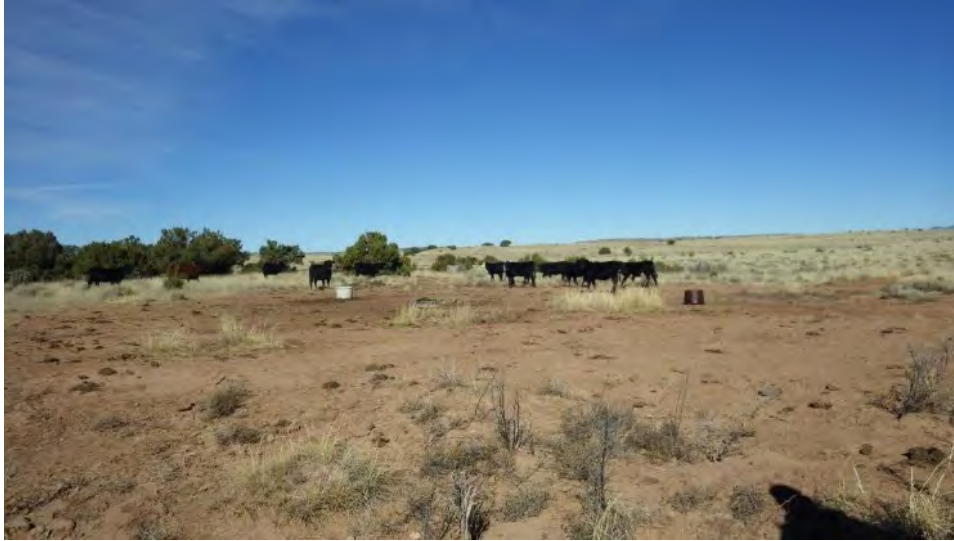
**Type 7-Sparse Vegetation, Bare Ground.** Bare ground, may include sparse woody or herbaceous vegetation, but total vegetation cover <10%. May be natural disturbance in origin (e.g., cobble bars) or anthropogenic (e.g., roads).

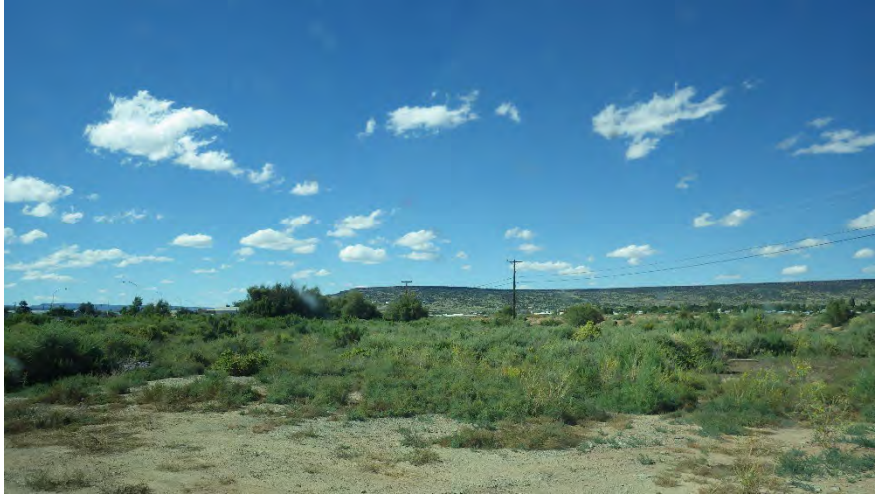
15.20\_12\_18DEG 2015

Note: 15.15\_13 is in the 15.20 project area.  
Between 2015 and 2021 all 15.20 points were  
renamed and moved up one number  
(15.20\_12 appears to have become 15.15\_13).

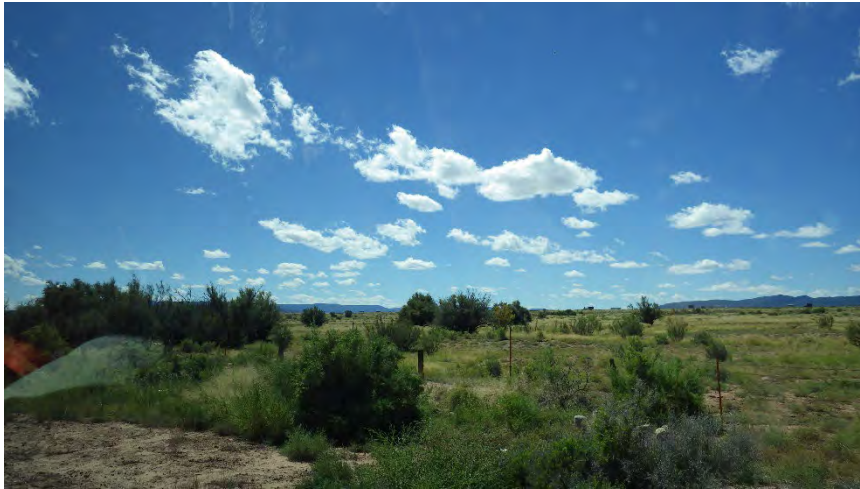
15.15\_13\_200DEG 2015

Note: 15.20\_07 is in the 15.15 project area. The 2015 photo appears to be from the same point, but is labeled as 15.15\_13. In 2025 the photopoint became a plot and was moved farther into the project area for safety. The 2025 photo is from that CSE plot and was chosen because it has the closest bearing to the 2015 photo. We forgot to take the photopoint in 2025.

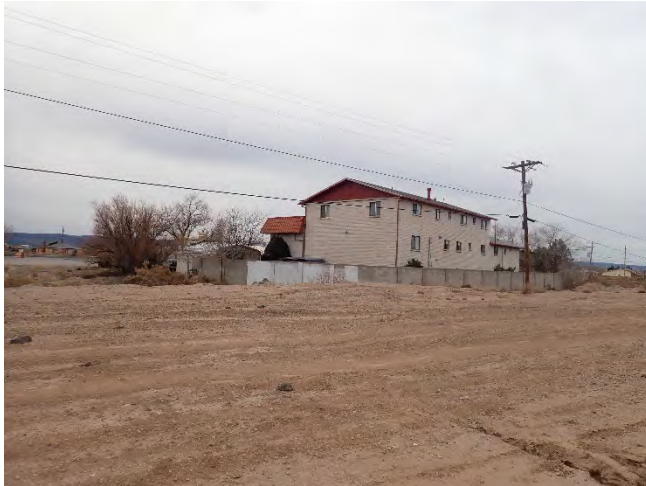
15.20\_08\_232DEG 2021

Note: The 2025 photo was taken to match the one from 2021, but the bearing was found to be 260 degrees.

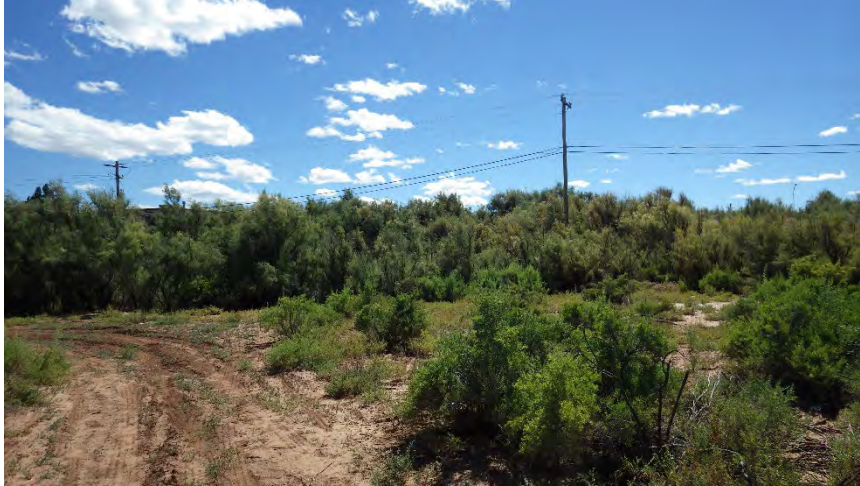
15.20\_08\_10DEG 2015

Note: The 2015 photo may be from the same point as the photos from subsequent years, however the 2021 photo was taken at a different bearing and the 2025 photo was taken to match it.

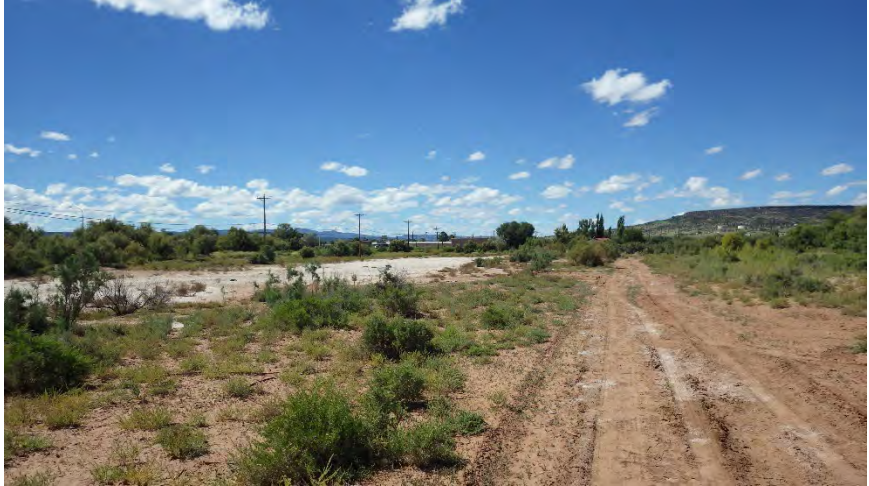
15.20\_09\_80DEG 2015

Note: The 2015 photo had a recorded bearing of 80 degrees but subsequent photos taken to match were found to be at 280 degrees.

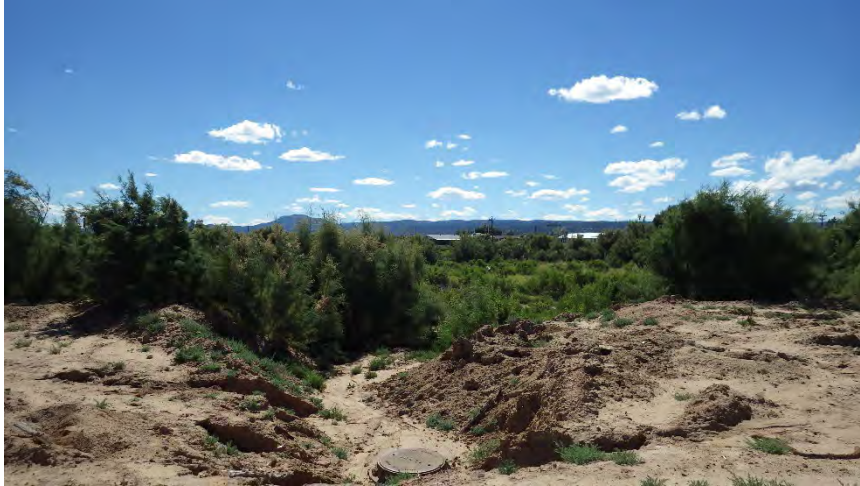
15.20\_11\_75DEG 2015

Note: The 2015 photo appears to have been taken from a different point. We attempted to locate it in 2025 and were unable to do so.
