San Cristobal Drainage Project 15.21

Post-treatment Monitoring Report

2021

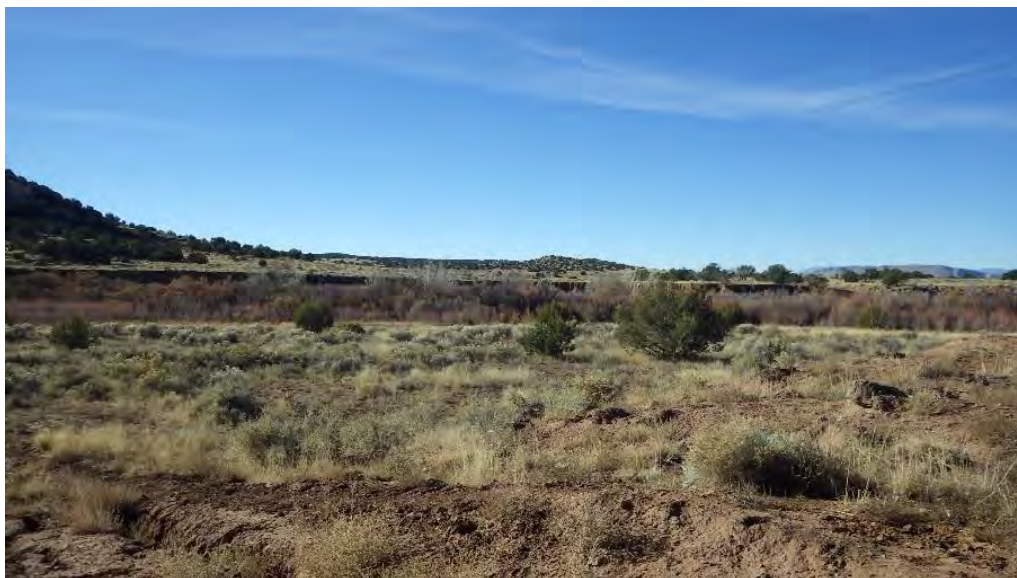
2015: SC1, view of drainage. Taken facing 184 degrees.

15.21_1_ 184deg	11/17/202 1 12:30pm	100- 0295	35.3871 9655	105.88 02675	184° S	Four-wing saltbrush @85' @186°	Coyote willow patch @ 529' @ 184°	-	Olymp us Red	CB, RM, AM	Very open field, a lot of bare ground. Facing S downhill, shrubby area.

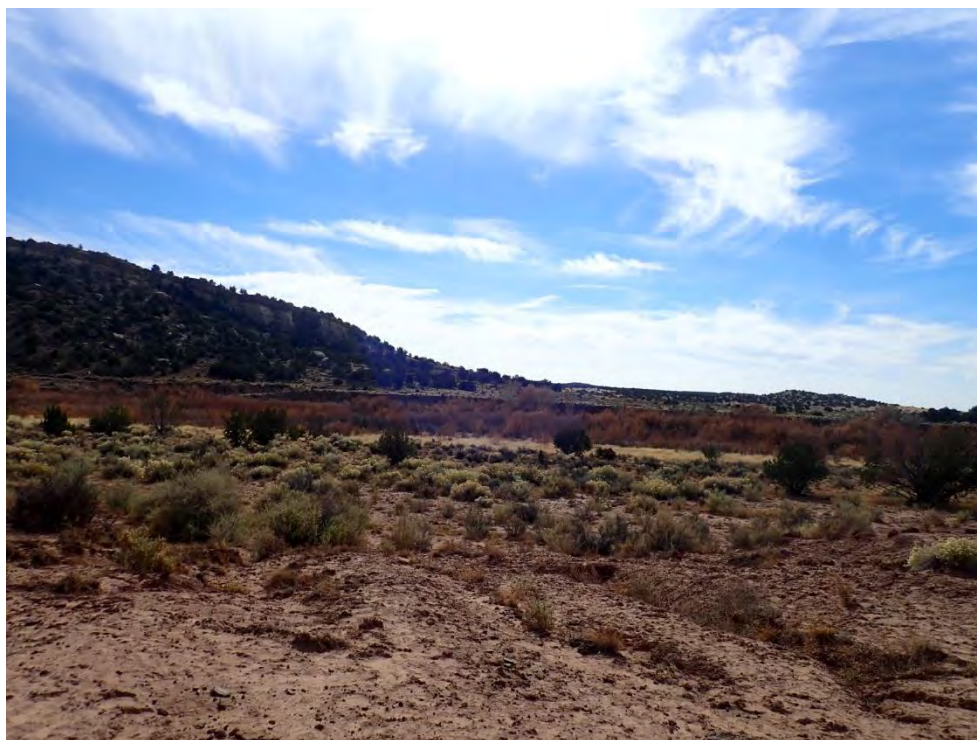
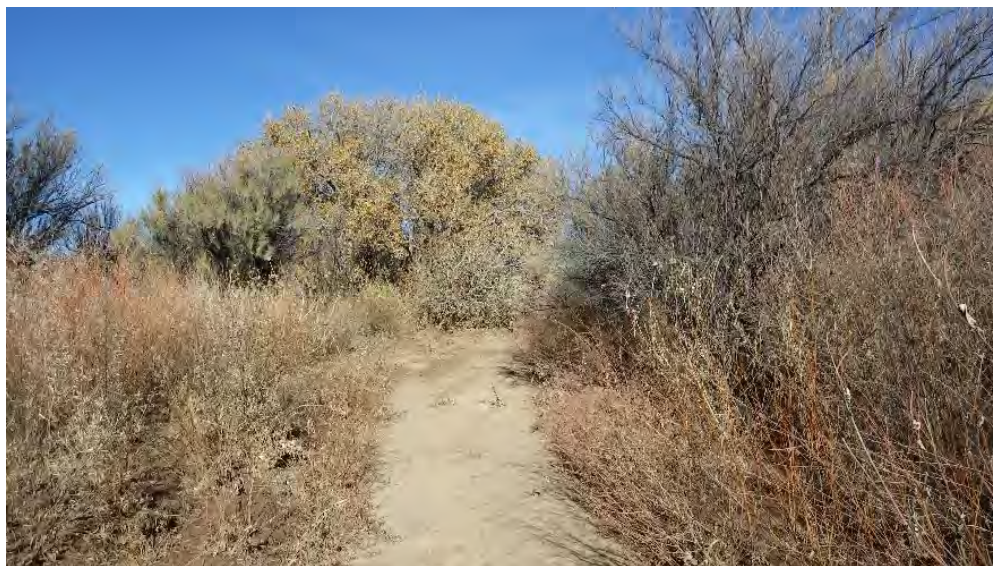
2015: SC2,
view up “arm”
of project.
Taken facing
320 degrees.

15.21_2_ 320deg	11/17/202 1 12:00pm	100- 0294	35.3870 1714	105.87 78462	328° N	Coyote willow @ 2' @ 320°	Cottonw ood @143' @314°	-	Olymp us Red	CB, RM, AM	Against bank wall, draw, drainage area (NE). Facing W thicken coyote willow patch.

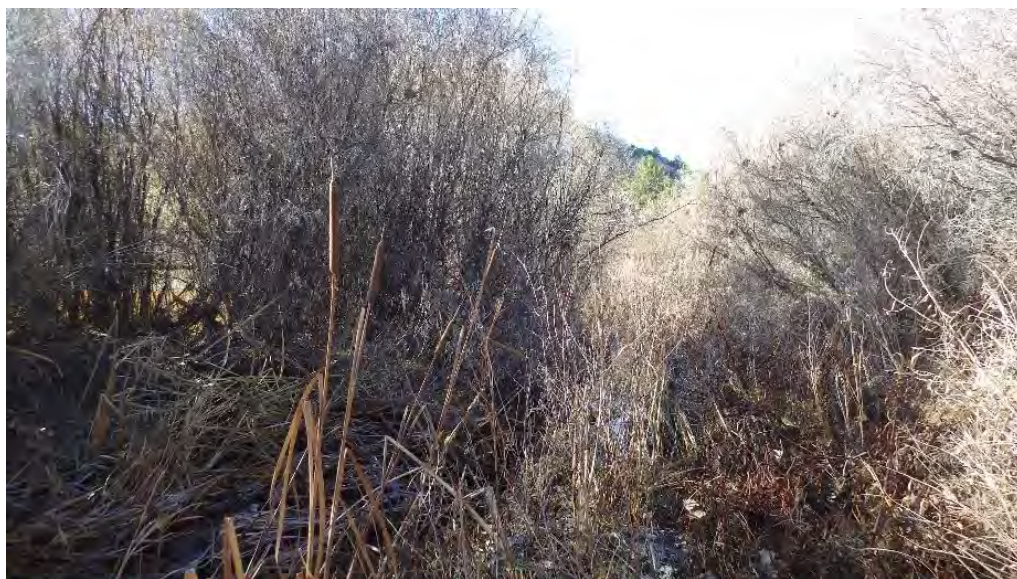
2015: SC3, view of drainage bottom. Taken facing 140 degrees.

15.21_3_ 148deg	11/17/202 1 11:37am	100- 0293	35.3864 7652	105.87 74782	148° S	Coyote willow @ 9' @ 148°	Coyote willow @ 9' @ 148°	-	Olymp us Red	CB, RM, AM	Coyote willow (15'), Cottonwood, minimal grass growth

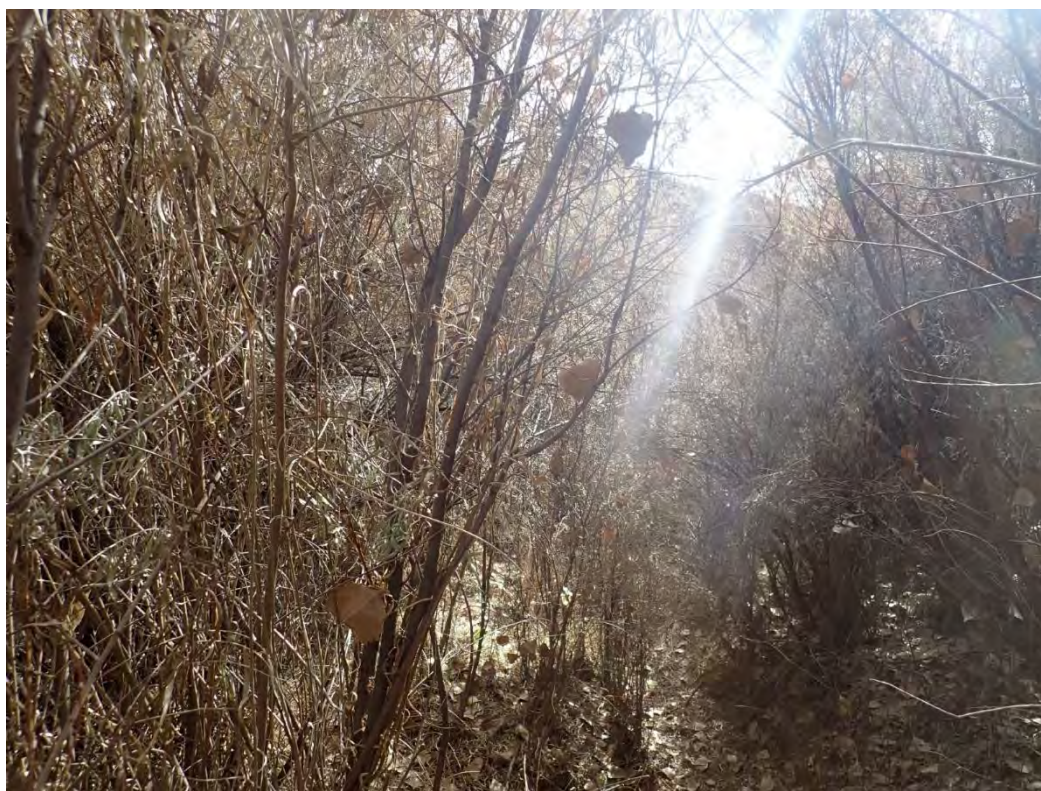
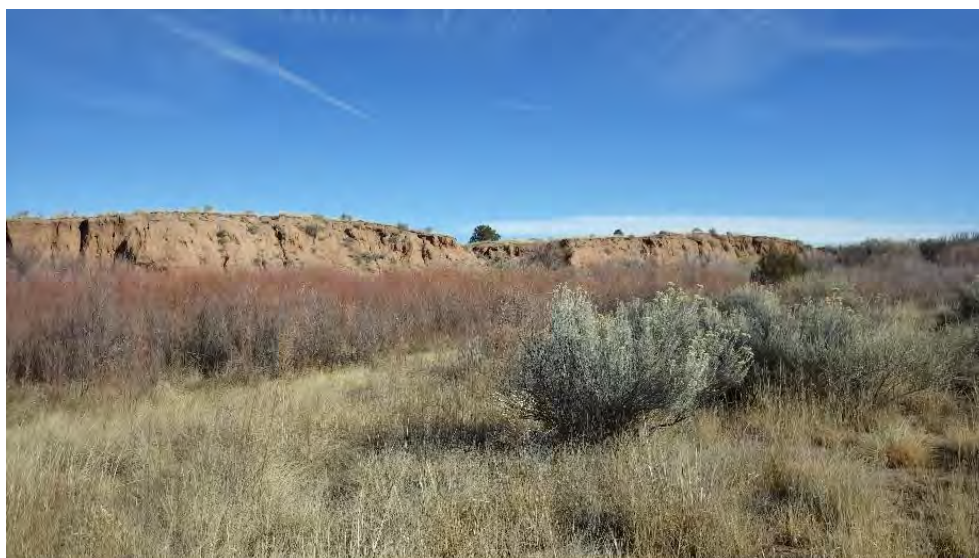
2015: SC4, view of fork. Taken facing 80 degrees.

15.21_4_ 80deg	11/17/202 1 11:16am	100- 0292	35.3865 4594	105.87 61301	80° E	Coyote willow @ 8' @ 60°	Jumo @148' @94°	-	Olymp us Red	CB, RM, AM	Coyote willow, rabbit brush, alkali grass, Jumo. Blue grama

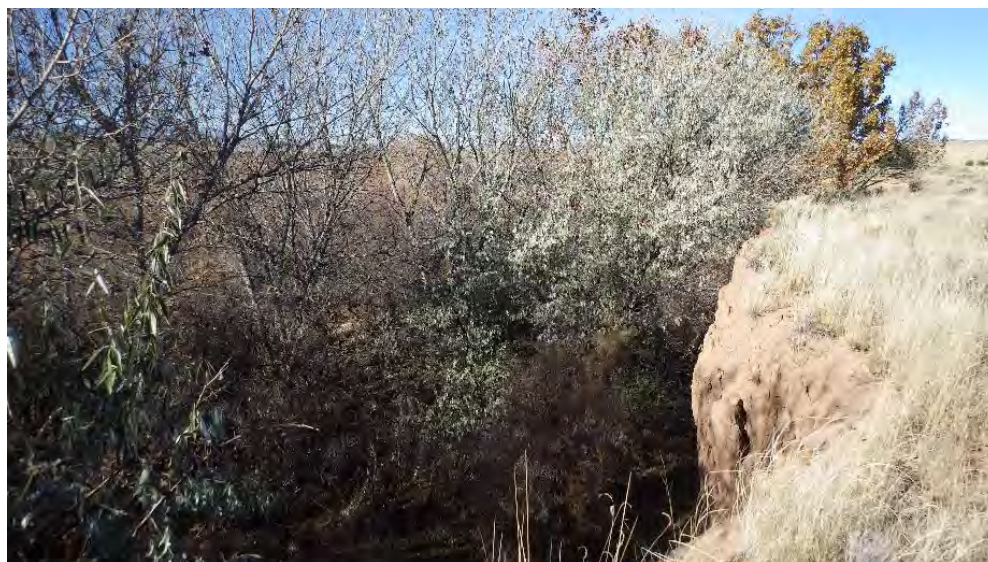
2015: SC5, view of San Cristobal drainage bend – cottonwood, Russian olive, and erosion. Taken facing 285 degrees.

15.21_5_ 285deg	11/17/202 1 12:45pm	100- 0296	35.3872 7085	105.88 15873	285° W	Ericameria spp @15' @285°	Cottonw ood @84' @285°	-	Olymp us Red	CB, RM, AM	Very open , cholla cactus at 250° drop off. Jumo, four- wing saltbush.

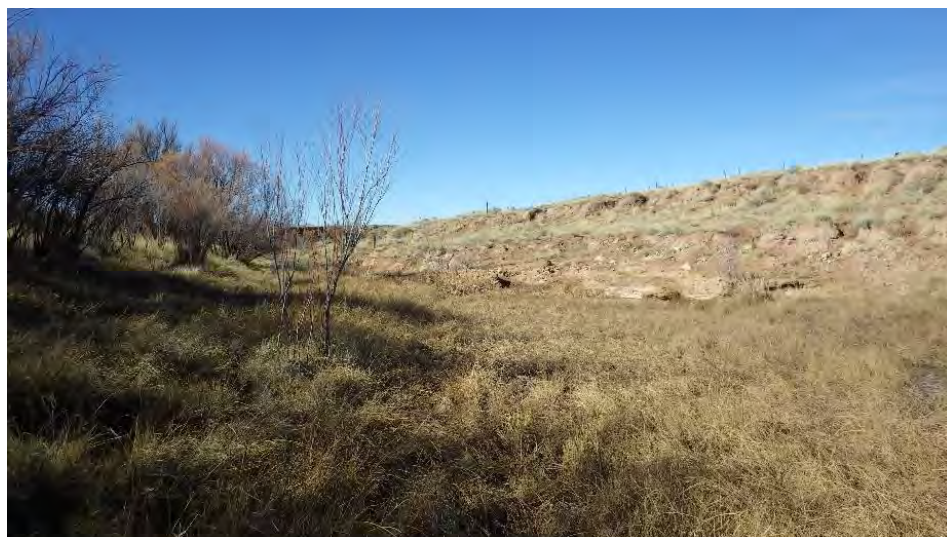
2015: SC7, view of floodplain and erosion; wet area. Taken facing 270 degrees.

15.21_7_ 270deg	11/17/2021 1 1:38pm	100-0298	35.3883 227	- 105.88 8245	270° W	Grassland @843' @270°	Drainage wall @843' @270°	-	Olympus Red	CB, RM, AM	In drainage area, very grassy. A few salt cedar.
15.21_8_ 292deg	11/17/2021 1 2:00pm	100-0299	35.3877 6549	- 105.88 97211	292° W	Four-wing saltbrush @35' @300°	Drainage wall @425' @292°	-	Olympus Red	CB, RM, AM	On top of hill, close to edge. Four-wing salt bush. Very open, blue grama grass

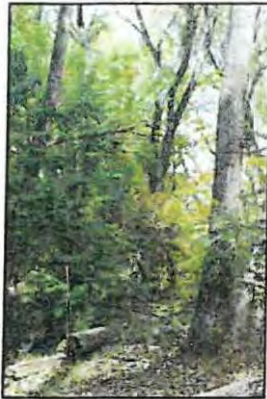
Type 1 –High Structure Forest with a well-developed understory.

Tall mature to intermediate-aged trees (>5 m [>15 feet]) with canopy covering >25% of the area of the community (polygon) and understory layer (0-5 m [0-15 feet]) covering >25% of the area of the community (polygon). Substantial foliage is in all height layers. (This type incorporates Hink and Ohmart structure types 1 and 3.) Photograph on Gila River by Y. Chauvin, 2012.

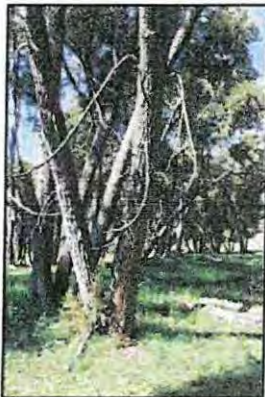
Type 2 –Low Structure Forest with little or no understory.

Tall mature to intermediate-aged trees (>5 m [>15 feet]) with canopy covering >25% of the area of the community (polygon) and understory layer (1-5 m [3-15 feet]) covering <25% of the area of the community (polygon). Majority of foliage is over 5 m (15 feet) above the ground. (This type incorporates Hink and Ohmart structure types 2 and 4.) Photograph on Diamond Creek by Y. Chauvin, 2012.

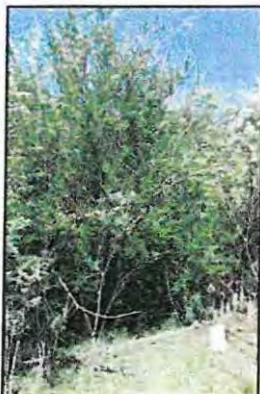
Type 5 –Tall Shrub Stands.

Young tree and shrub layer only (15-5 m [4.5-15 feet]) covering >25% of the area of the community (polygon). Stands dominated by tall shrubs and young trees, may include herbaceous vegetation underneath the woody vegetation. Photograph on San Francisco River by Y. Chauvin, 2012.

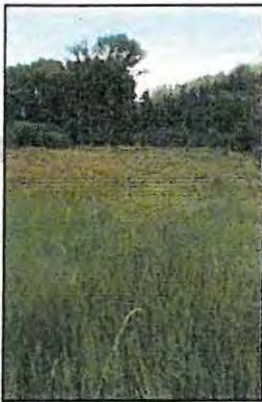
**Type 6W-Herbaceous Wetland.**

Herbaceous wetland vegetation covering >10% of the area of the community (polygon). Stands dominated by obligate wetland herbaceous species. Woody species absent, or <10% cover. Photograph of *Carex nebrascensis* meadow on upper Rio Santa Barbara by Y. Chauvin, 2009.
