Grants SE Project 16.12

Post-treatment Monitoring Report

2021

16-12 SE Grants

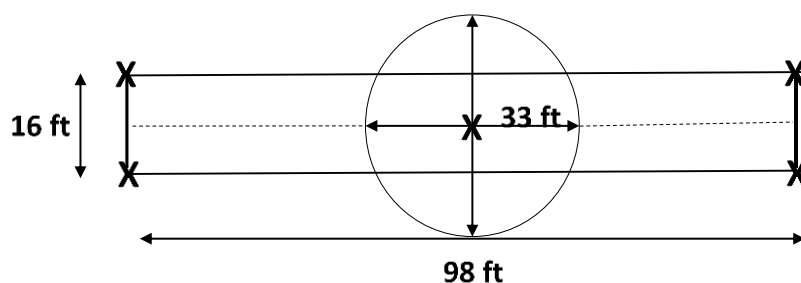
High-intensity monitoring was also done, in part, on this site. We used an adapted Bosque Ecosystem Monitoring Program (BEMP) style plot. These are 16 x 98-foot rectangles, placed approximately parallel to the river. Within these plots, we measure canopy and species, and vegetation and ground cover. We also used Brown's transects to measure surface fuels.

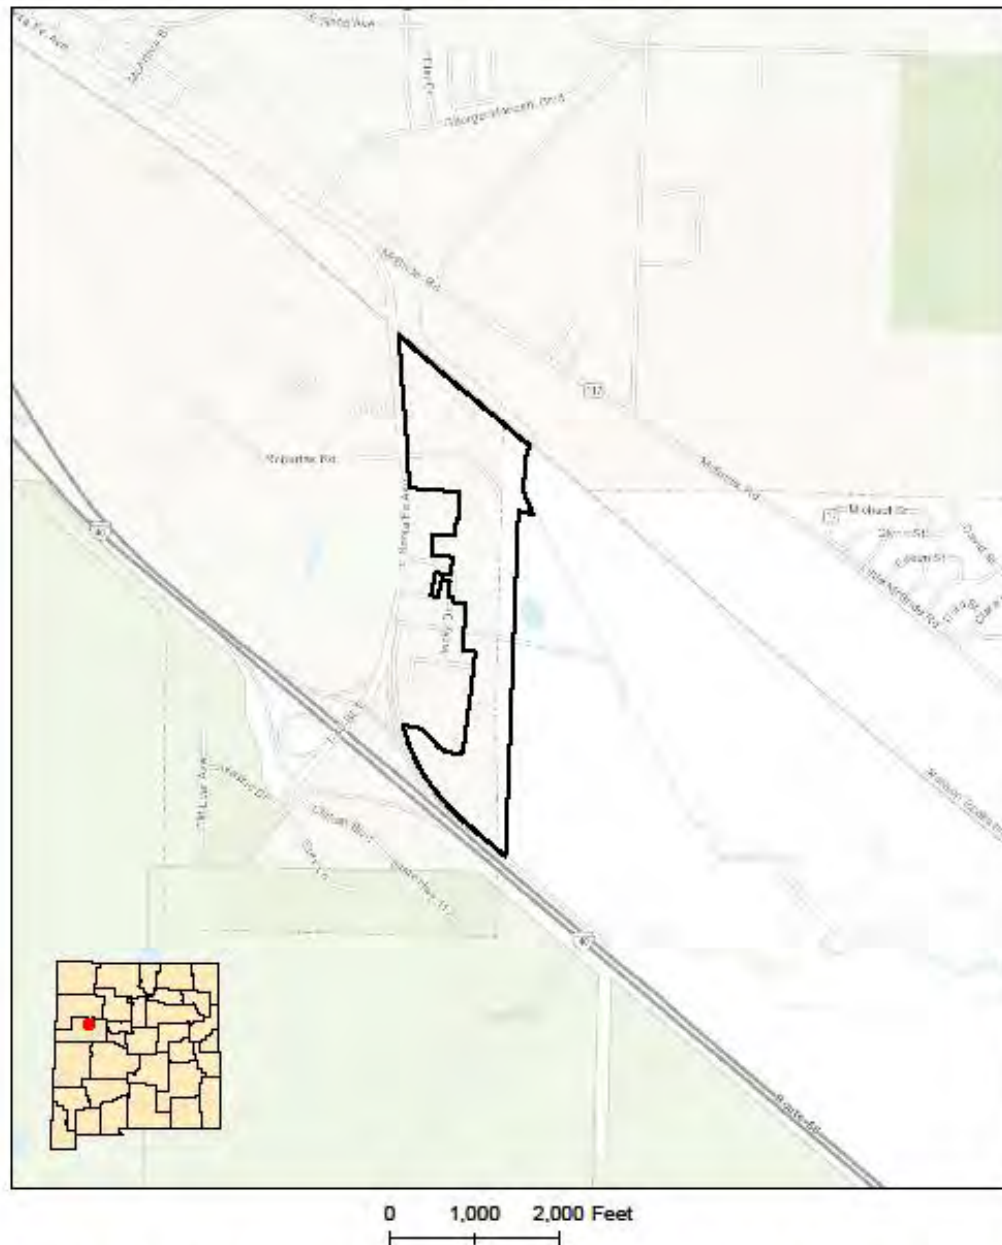
Figure 1. Project 16.12 in geographic context.

Project 16-12 SE Grants is located in a meadow area/drainage basin adjacent to the Rio San Jose channel and drainage. The area is on private and municipal owned lands on the southeast side of the city of Grants, NM. The project is an initial treatment to remove and treat non-native phreatophytes such as salt cedar, Russian olive, Siberian elm trees and down, dead fuels.

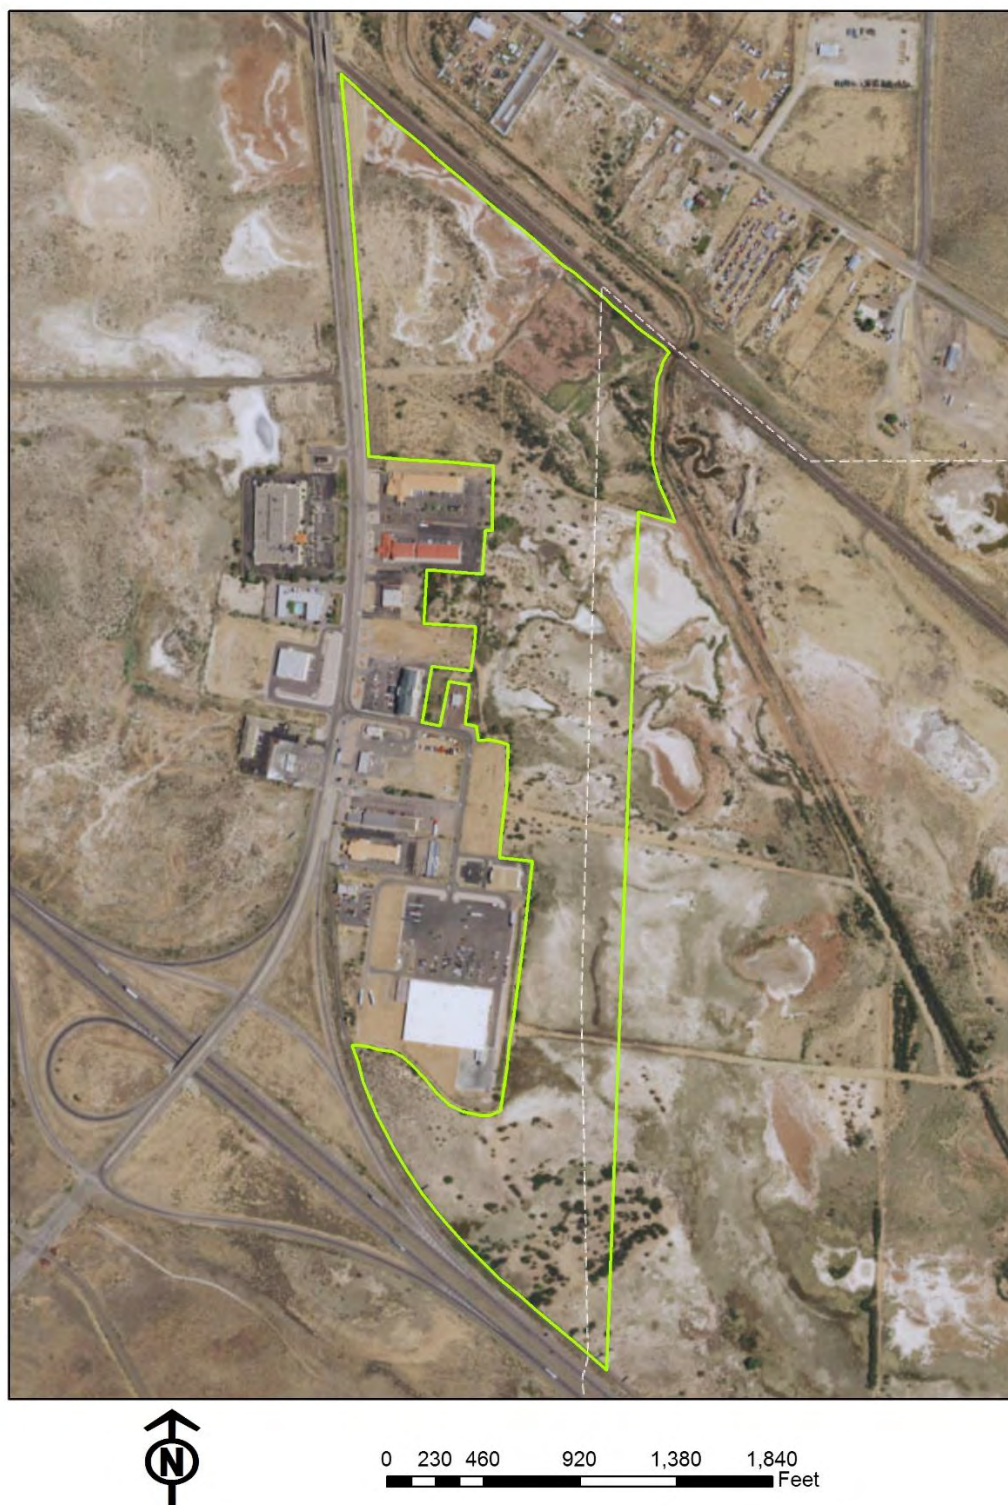
Figure 2. 16.12 Grants project outline.

Access to the project is possible through various point including a frontage road and hotel parking lots. There are multiple landowners, fence lines, roads, powerlines and structures; construction debris and trash were present throughout the site at the time of the site visits. Exotic species observed during the monitoring visit included salt cedar (of all age classes) and *phragmites* reed grasses. Native plants observed included fourwing saltbush, inland saltgrass, dropseed grass, and bush seepweed (*Suaeda nigra*). Species density varied within the project and was especially sparse around the playas/salt flats.

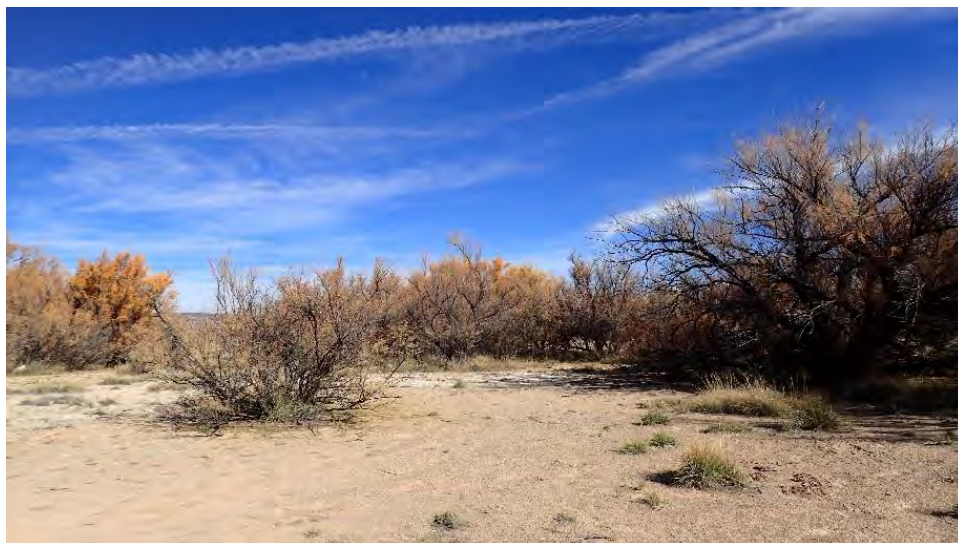
2016: 16.12_1_N.
North view inside of
polygon 1.

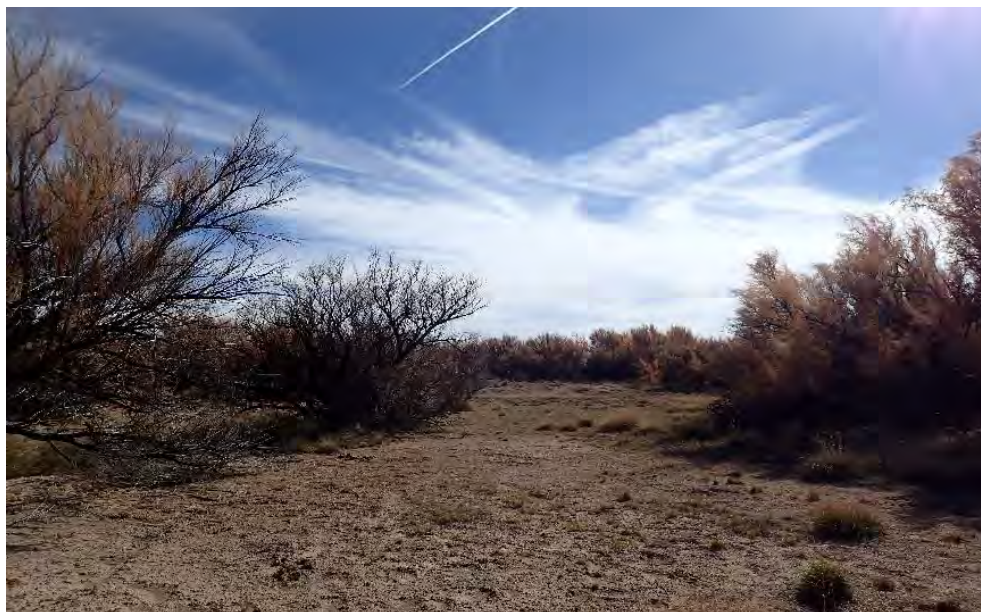
2016:
16.12_1_E. East
view inside of
polygon 1.

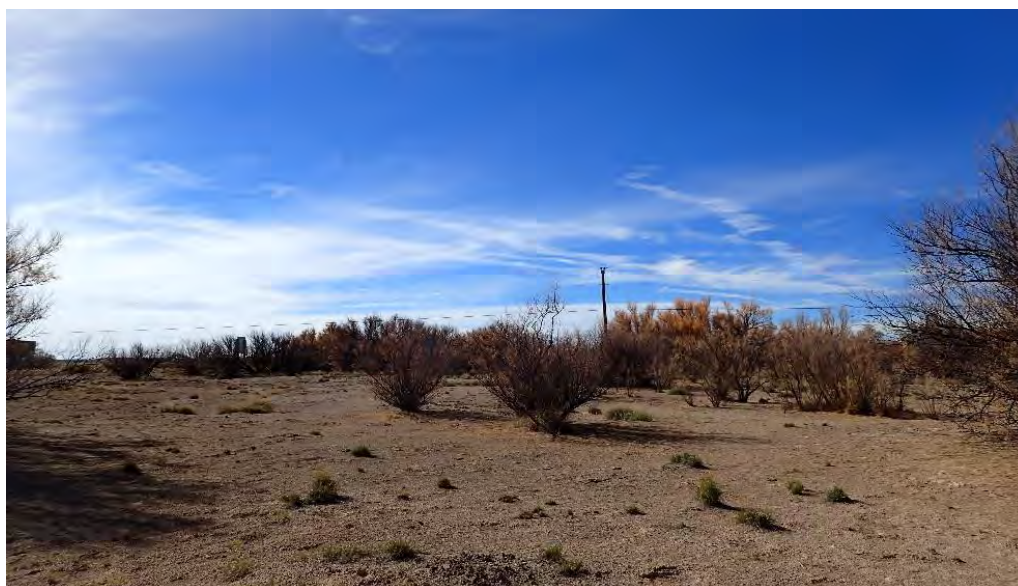
2016: 16.12_1_S.
South view inside of
polygon 1.

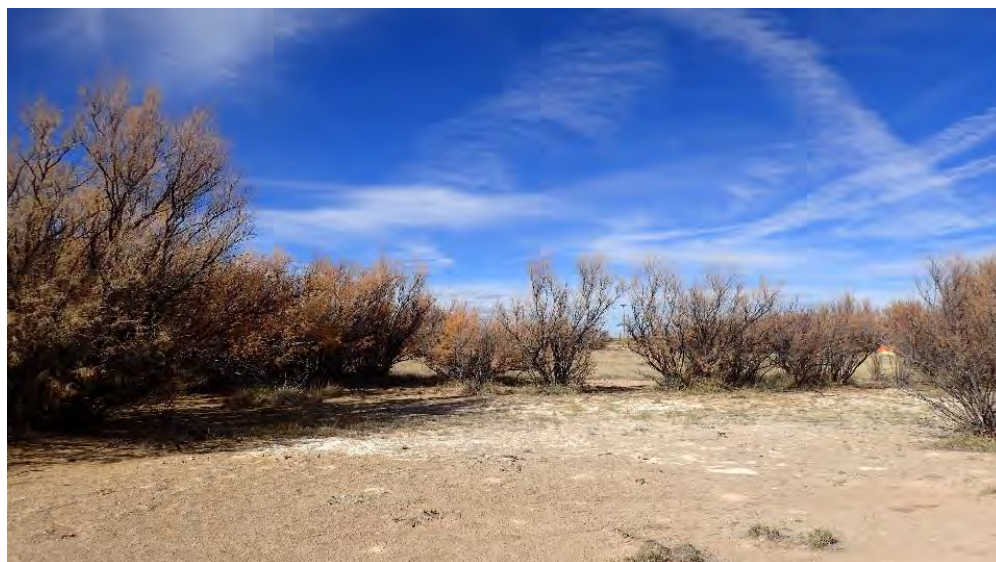
2016:
16.12_1_W.
West view
inside of

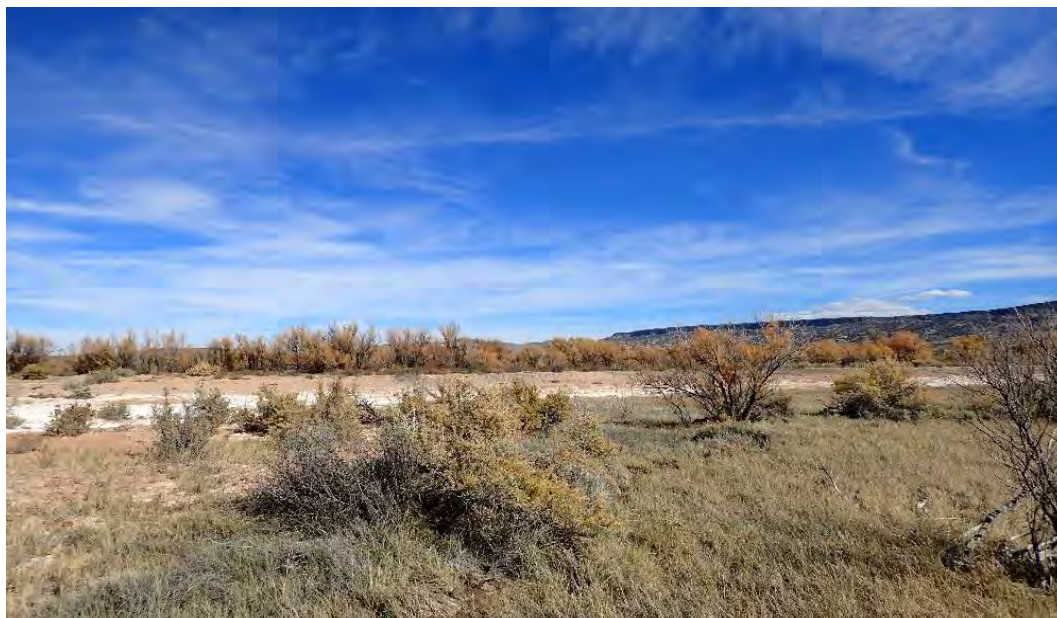
2016:
16.12_2_N
. North
view from
polygon 1,
looking
into
polygon 3.

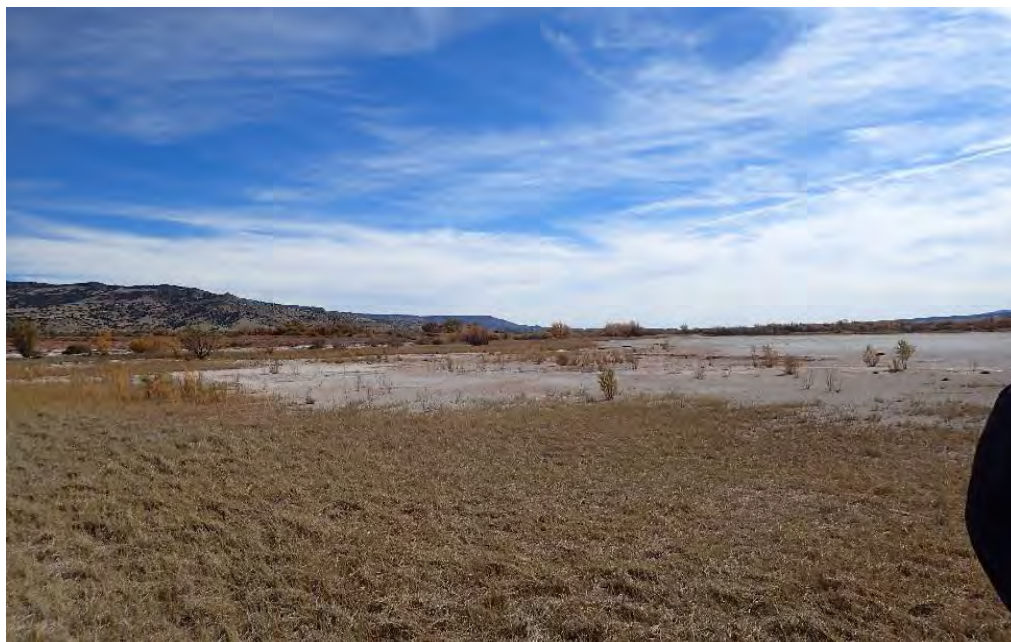
2016:
16.12_2_E.
East view
inside of
polygon 1.

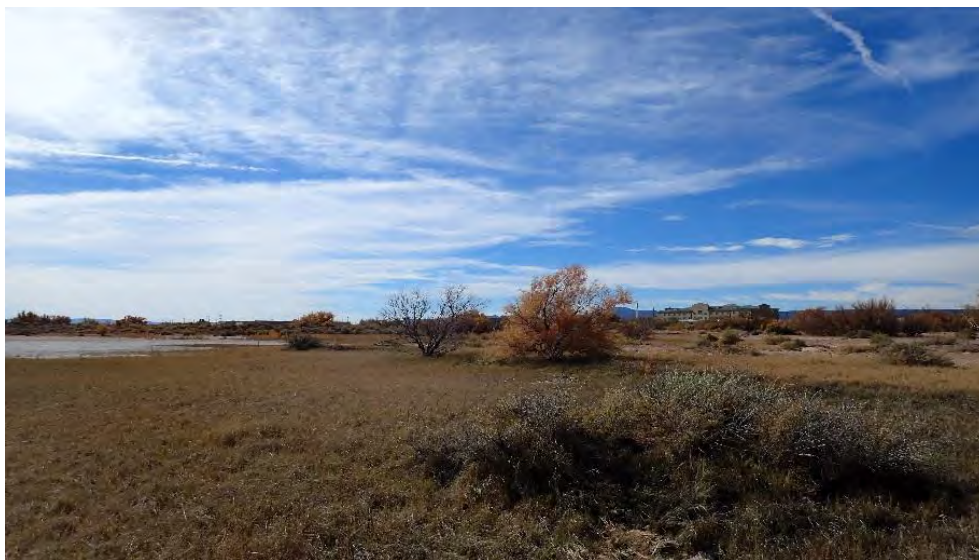
2016:
16.12_2_S.
South view
inside of
polygon 1.

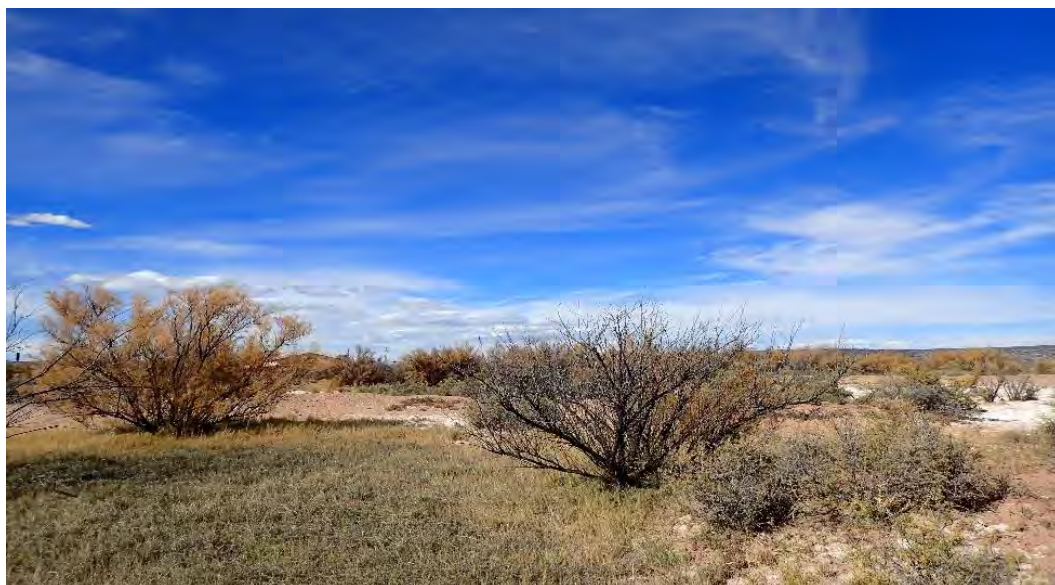
2016:
16.12_2_W.
West view
inside of
polygon 1.
