Grants SE Project 16-12

Pre-treatment Monitoring Report

2016

16-12 SE Grants

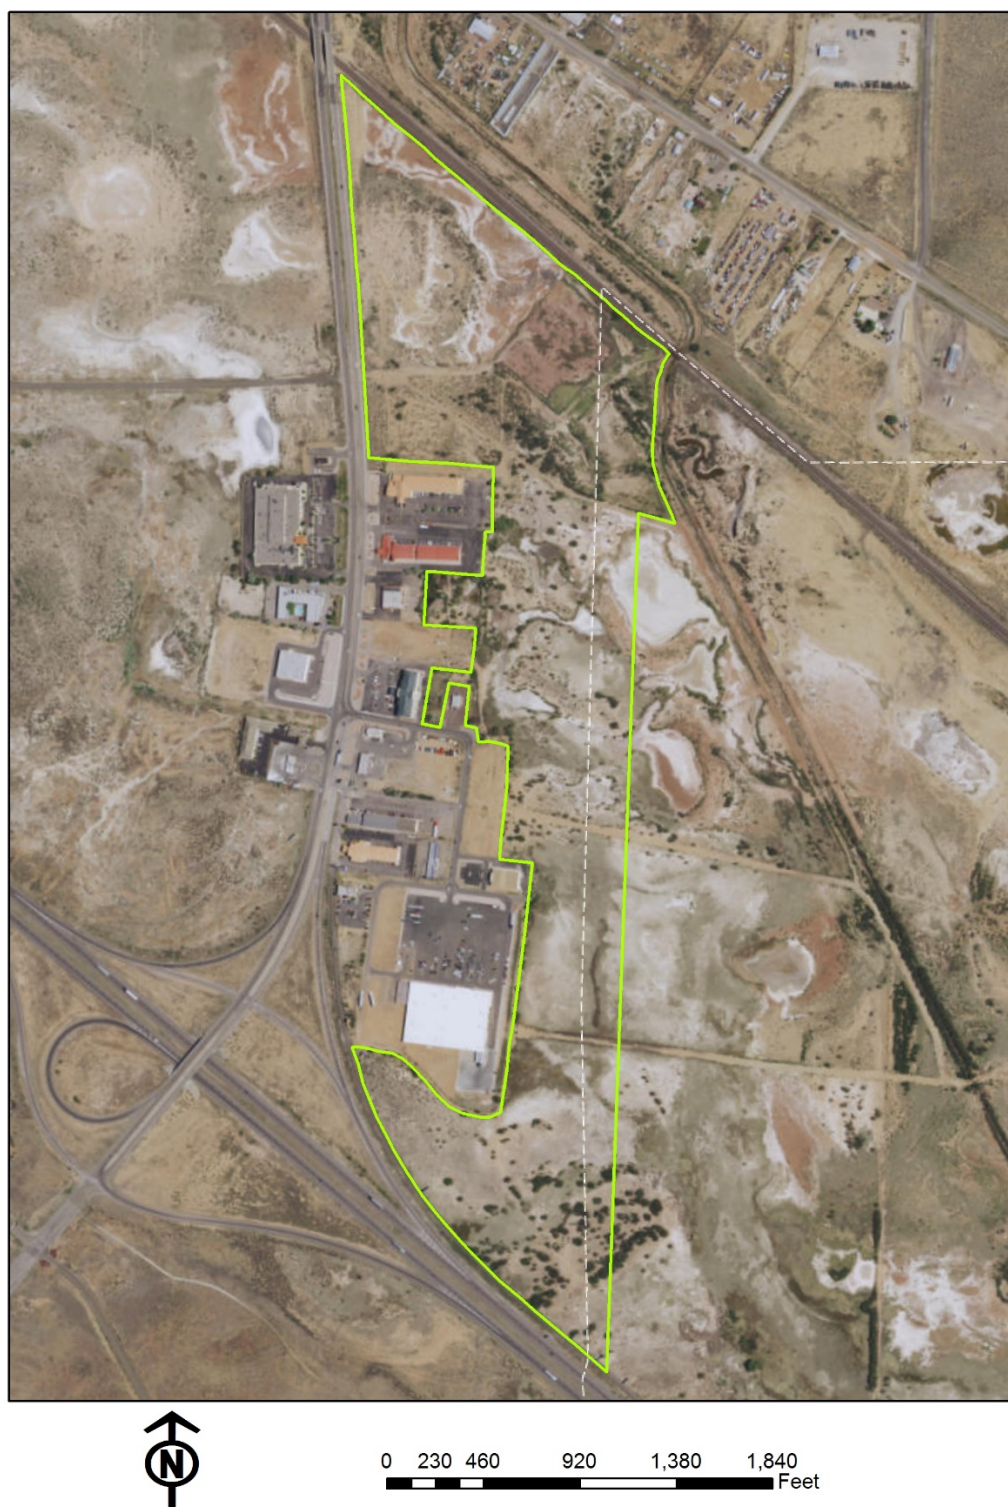
Figure 2. 16-12 Grants project outline.

Access to the project is possible through various point including a frontage road and hotel parking lots. There are multiple landowners, fencelines, roads, powerlines and structures; construction debris and trash were present throughout the site at the time of the site visits. Exotic species observed during the monitoring visit included salt cedar (of all age classes) and *phragmites* reed grasses. Native plants observed included fourwing saltbush, inland saltgrass, dropseed grass, and bush seepweed (*suaeda nigra*). Species density varied within the project and was especially sparse around the playas/salt flats.

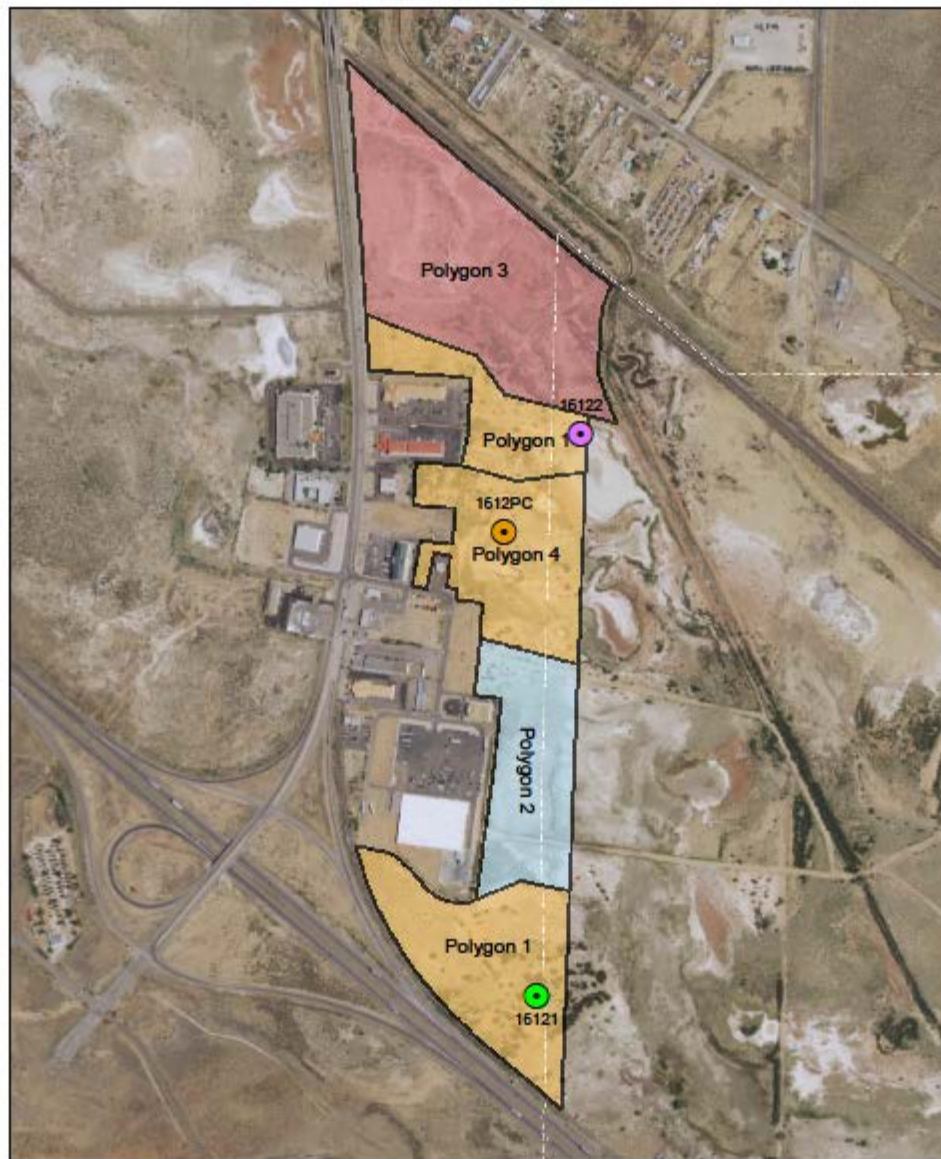
Figure 3. 16-12 Grants project vegetation polygons.

* NESW indicate compass direction of photos taken.
PC is plot center

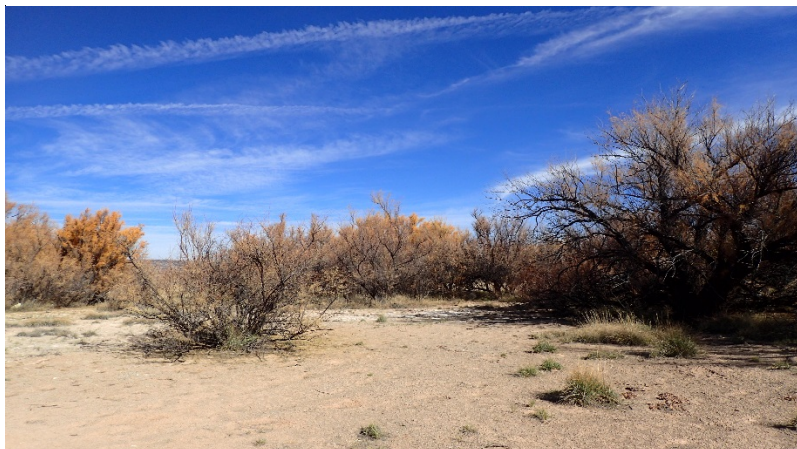
16.12_1_N. North view
inside of polygon 1.

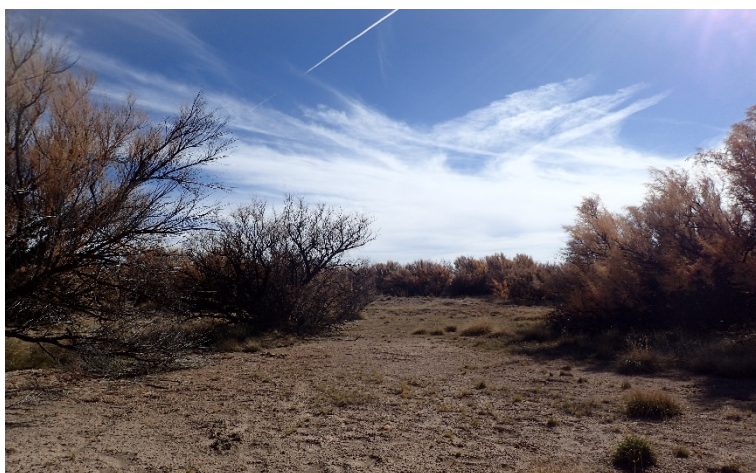
16.12_1_E. East view
inside of polygon 1.

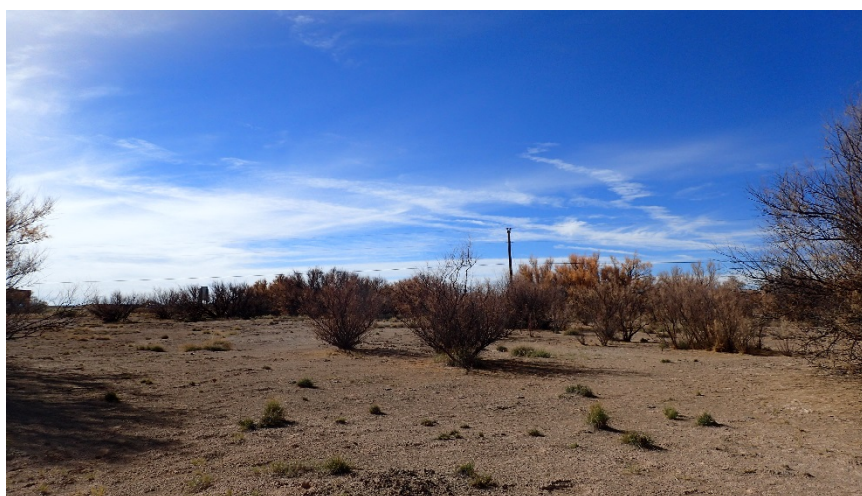
16.12_1_S. South view inside
of polygon 1.

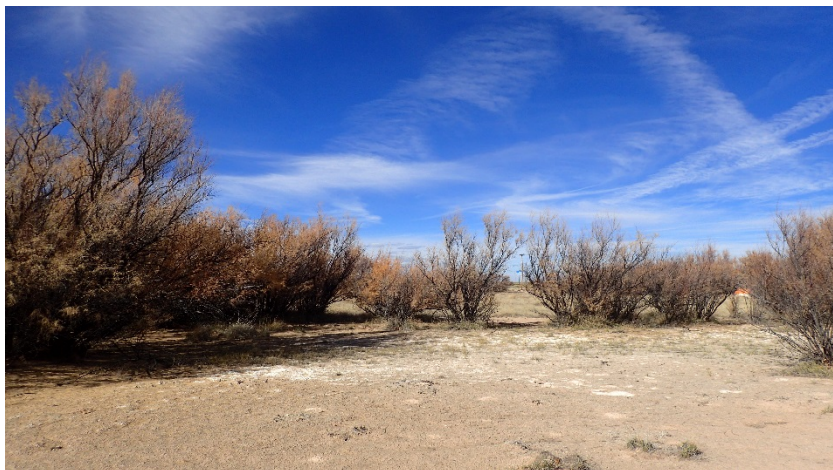
16.12_1_W. West view
inside of polygon 1.

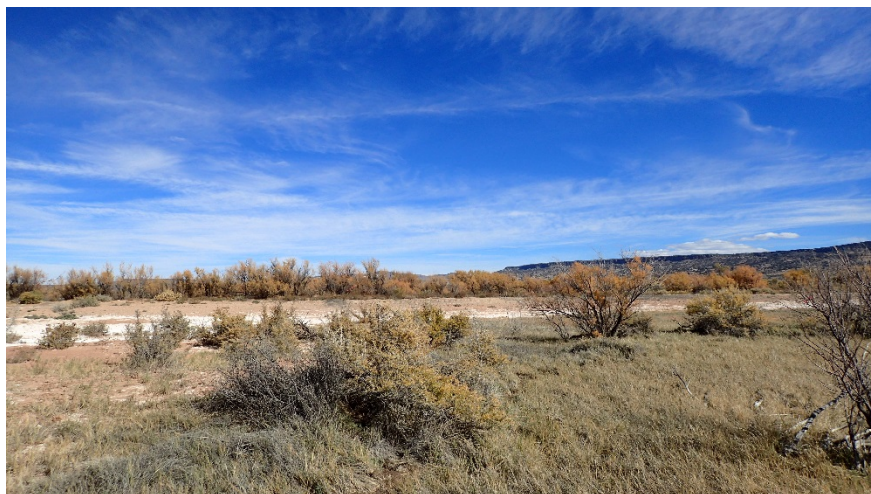
16.12_2_N. North view
from polygon 1, looking
into polygon 3.

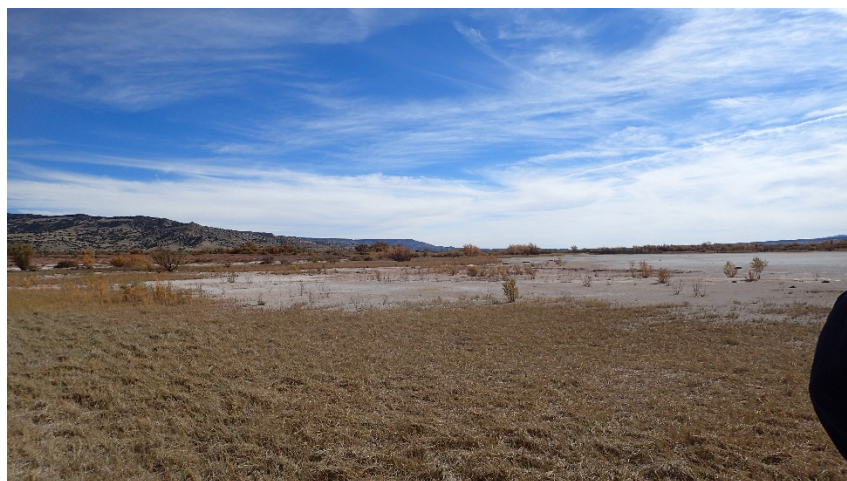
16.12_2_E. East view
inside of polygon 1.

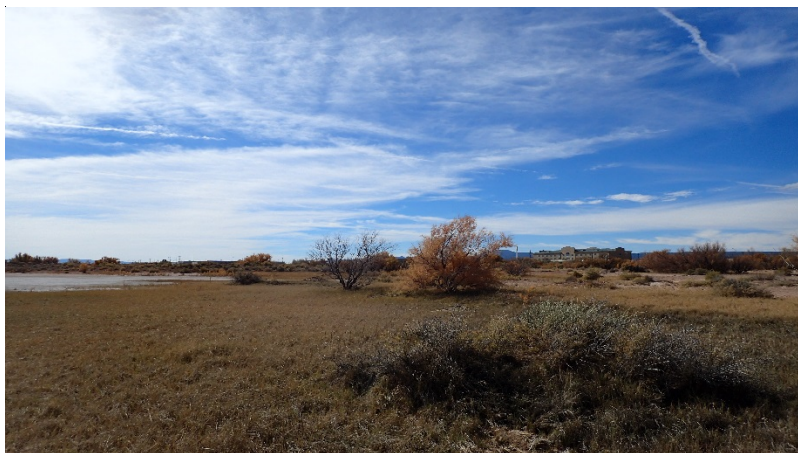
16.12_2_S. South view
inside of polygon 1.

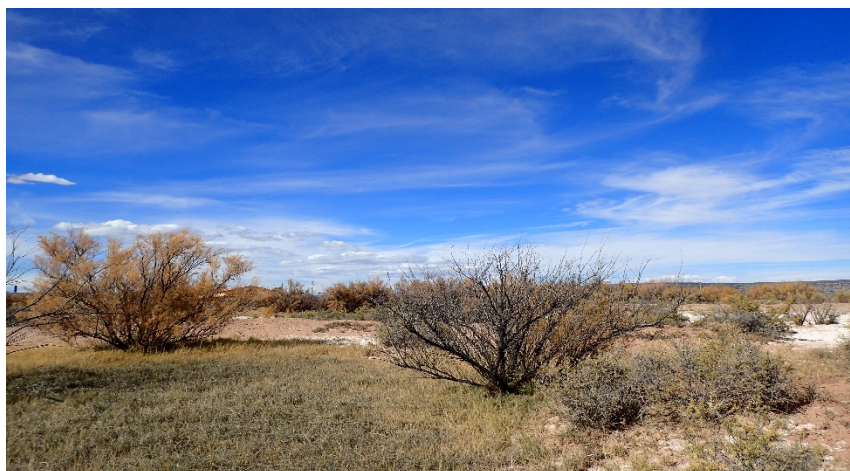
16.12_2_W. West view
inside of polygon 1.
