## San Rafael Project 16.13

### Post-treatment Monitoring Report

2021

## 16-13 San Rafael

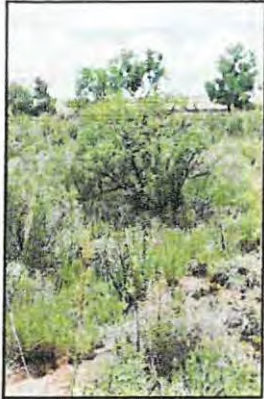
**Type 6S-Short Shrub Stands.**

Short stature shrubs or very young shrubs and trees (up to 1.5 m [up to 4.5 feet]) covering >10% of the area of the community (polygon). Stands dominated by short woody vegetation, may include herbaceous vegetation underneath the woody vegetation. Photograph on Lower Pecos River by E. Lindahl, 2008.
