# San Rafael Project 16-13

## Pre-treatment Monitoring Report

2016

Kathryn R Mahan, Ecological Monitoring Specialist & Daniel Hernandez, Ecological Monitoring  
Technician, New Mexico Forest and Watershed Restoration Institute  
for the Greater Rio Grande Watershed Alliance

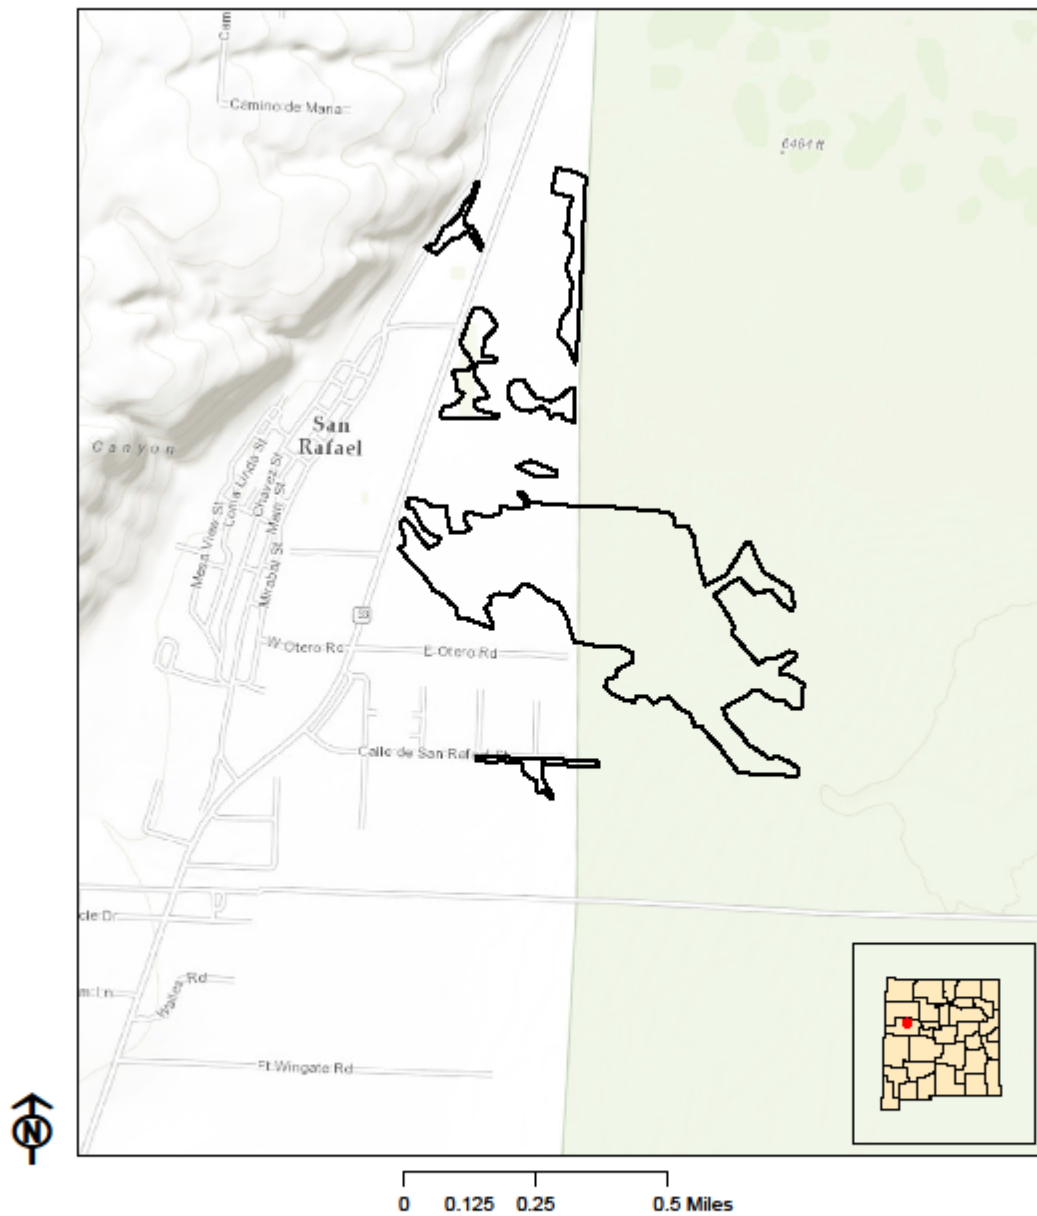
## 16-13 San Rafael

Project 16-13 is located in a shallow drainage and basin area that historically extended to the Rio San Jose, southeast of Grants, NM. The project is on large private land, mostly east of San Rafael, NM. One small 2-acre area is located west of HWY 53. The project is an initial treatment to remove salt cedar, Russian olive, and Siberian elm trees.
