Ojo Caliente Project 16-16

Pre-treatment Monitoring Report

2016

Ojo Caliente Project

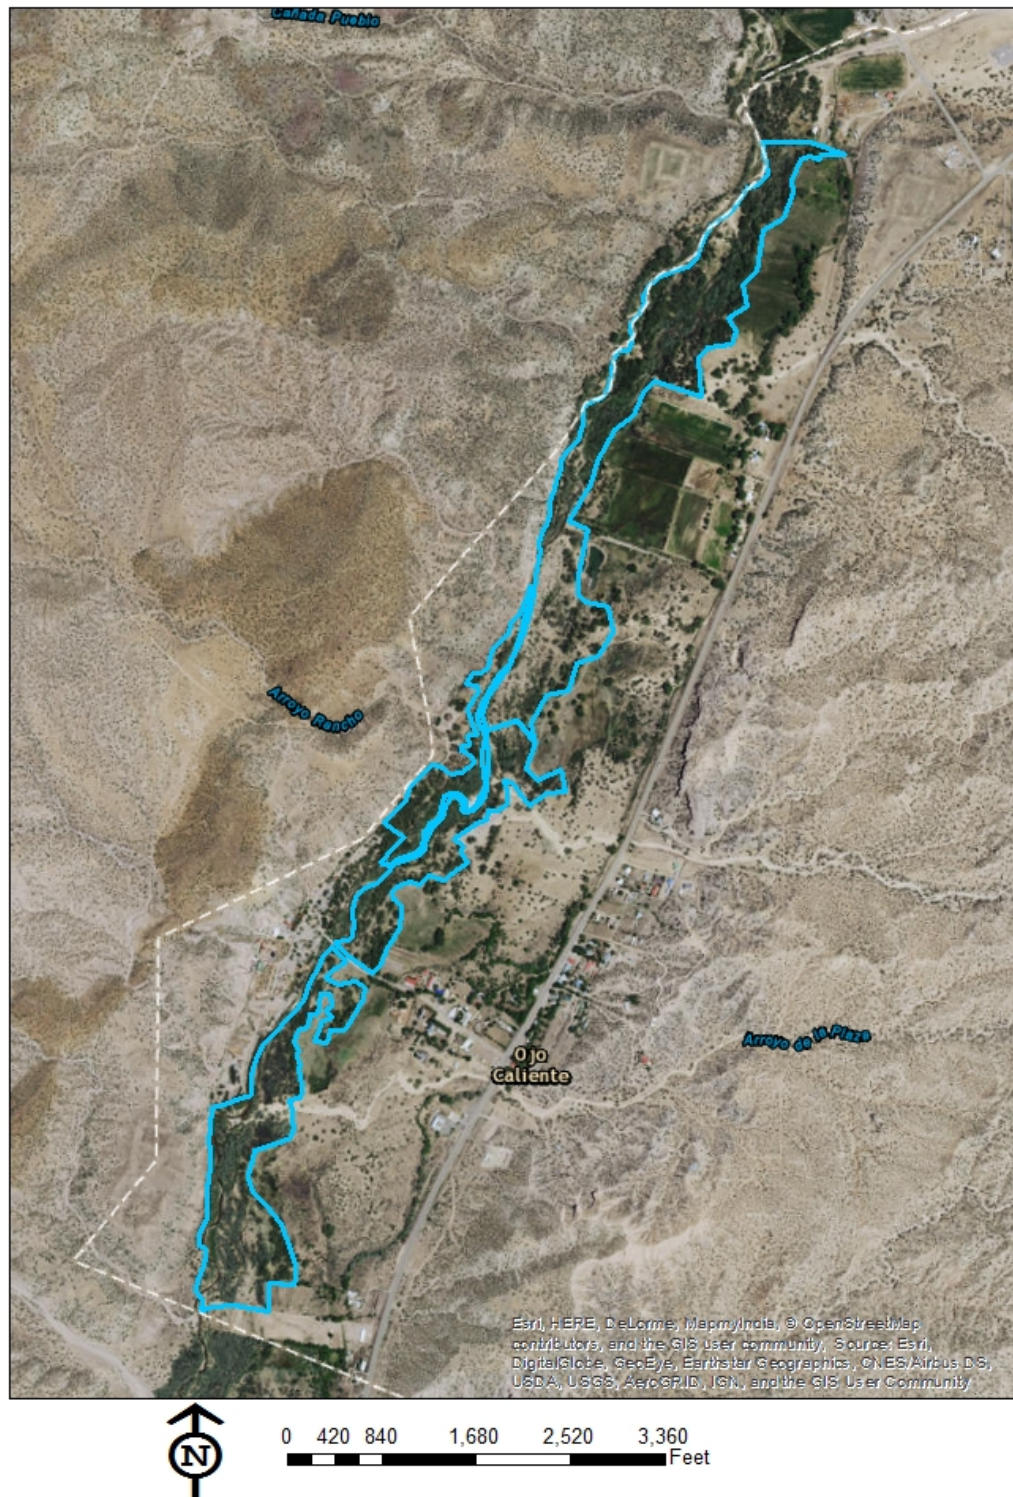
Figure 2. 16-16 Ojo Caliente project outline.

The Rio Ojo Caliente, as visible in the image above, can take different paths depending on the amount of flow. The Rio Ojo Caliente flows from the Tusas and Vallecitos near Lamadera through the Ojo Caliente valley, to join the Rio Chama near Chili, south of Medenales and north of El Duende and Hernandez. The USGS gauge 08289000 measures the Rio Ojo Caliente at Lamadera.

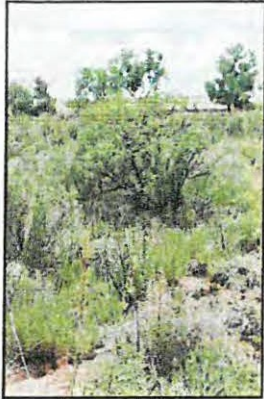
**Type 6S-Short Shrub Stands.**

Short stature shrubs or very young shrubs and trees (up to 1.5 m [up to 4.5 feet]) covering >10% of the area of the community (polygon). Stands dominated by short woody vegetation, may include herbaceous vegetation underneath the woody vegetation. Photograph on Lower Pecos River by E. Lindahl, 2008.

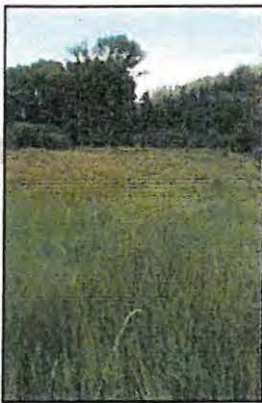
**Type 6W-Herbaceous Wetland.**

Herbaceous wetland vegetation covering >10% of the area of the community (polygon). Stands dominated by obligate wetland herbaceous species. Woody species absent, or <10% cover. Photograph of *Carex nebrascensis* meadow on upper Rio Santa Barbara by Y. Chauvin, 2009.
