**ESTANCIA BASIN WATERSHED HEALTH AND MONITORING PROJECT:
2011 ANNUAL REPORT**

**ESTANCIA BASIN WATERSHED HEALTH, RESTORATION AND MONITORING
STEERING COMMITTEE**

January 2012

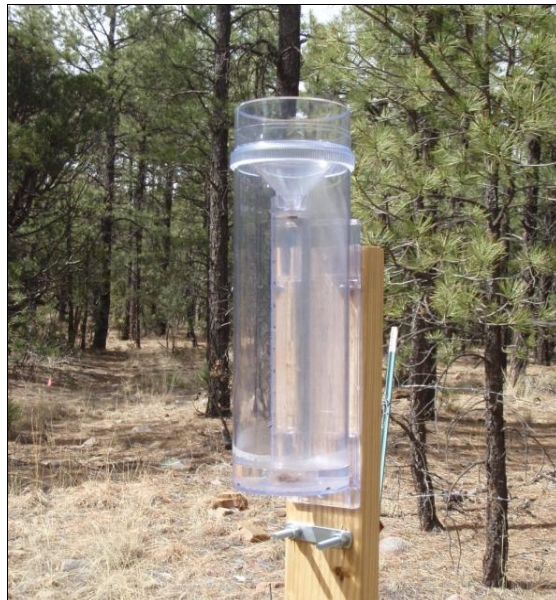
Figure 2.6. Graduated rain gauges are used for backup in the case of failure from one of the WatchDog weather stations.

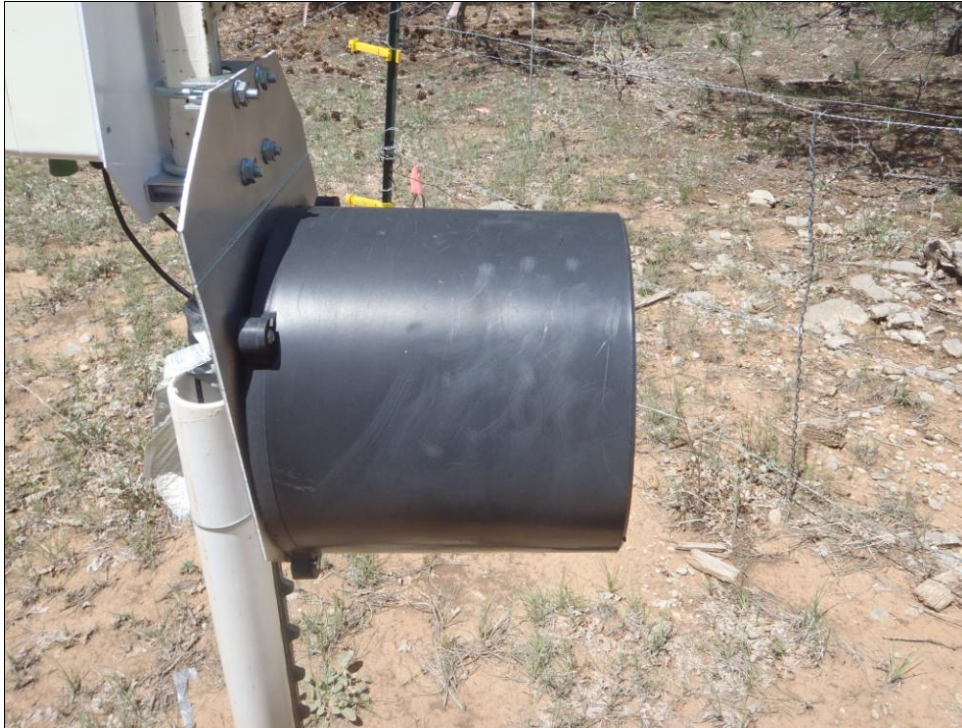
Figure 2.12. Damage to the tipping bucket rain gauge caused by a black bear on Chilili Control Plot.

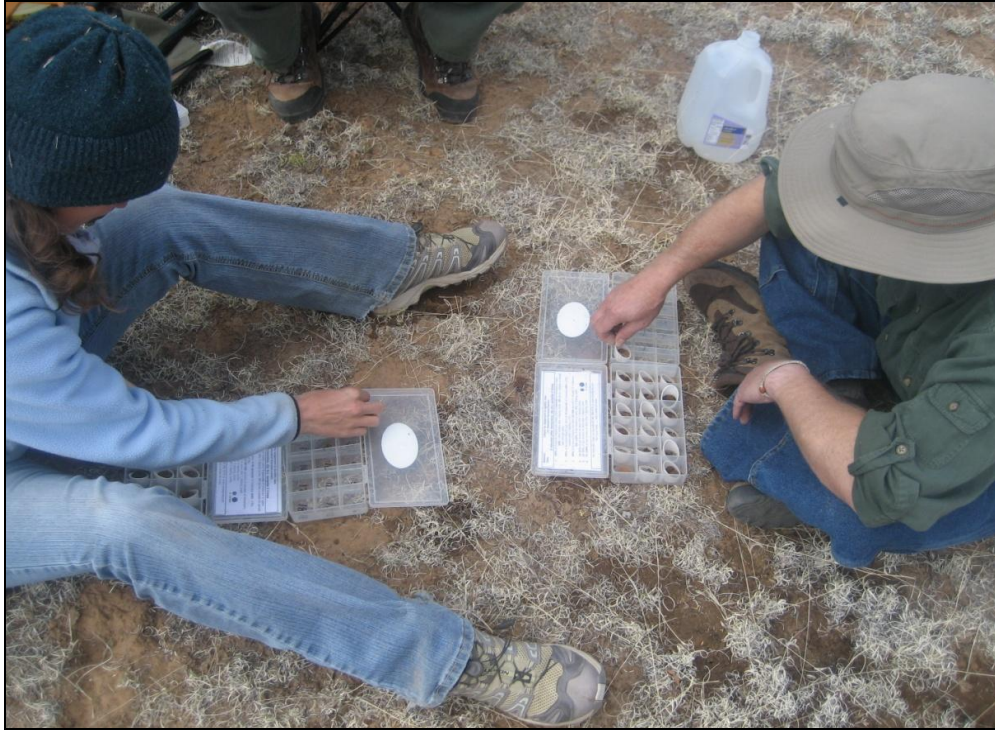
Figure 2.21. Soil stability test in use on the study sites.

Soil surface stability was measured and scored in June 2011 using the Soil Stability Test Kits developed by the USDA Agricultural Resource Service (Herrick et al. 2005) (Figure 2.21). Further details of the measurement methods and a review of the literature can be found in the 2008 Monitoring Plan (SWCA 2008). Figure 2.22 provides average soil surface stability scores for each of the eight subplots for both 2010 and 2011 from the four sites (Chilili, Kelly, Vigil, and Wester). Figure 2.23 provides average subsurface (1 cm below the soil surface, or -1 cm) soil stability scores for each of the eight subplots for both 2010 and 2011 from the four sites (Chilili, Kelly, Vigil, and Wester).

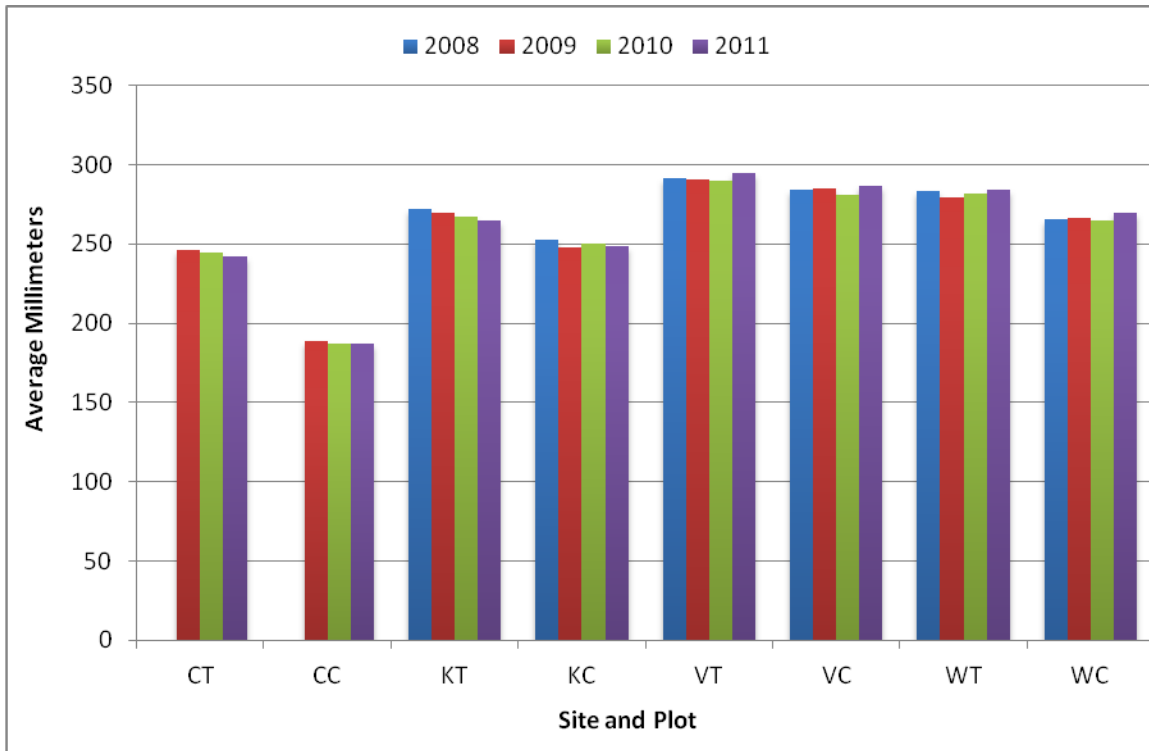
Figure 2.26. Average soil surface profiles, averaged from three soil movement bridges located on each of the paired study plots over the four-year period, 2008–2011.

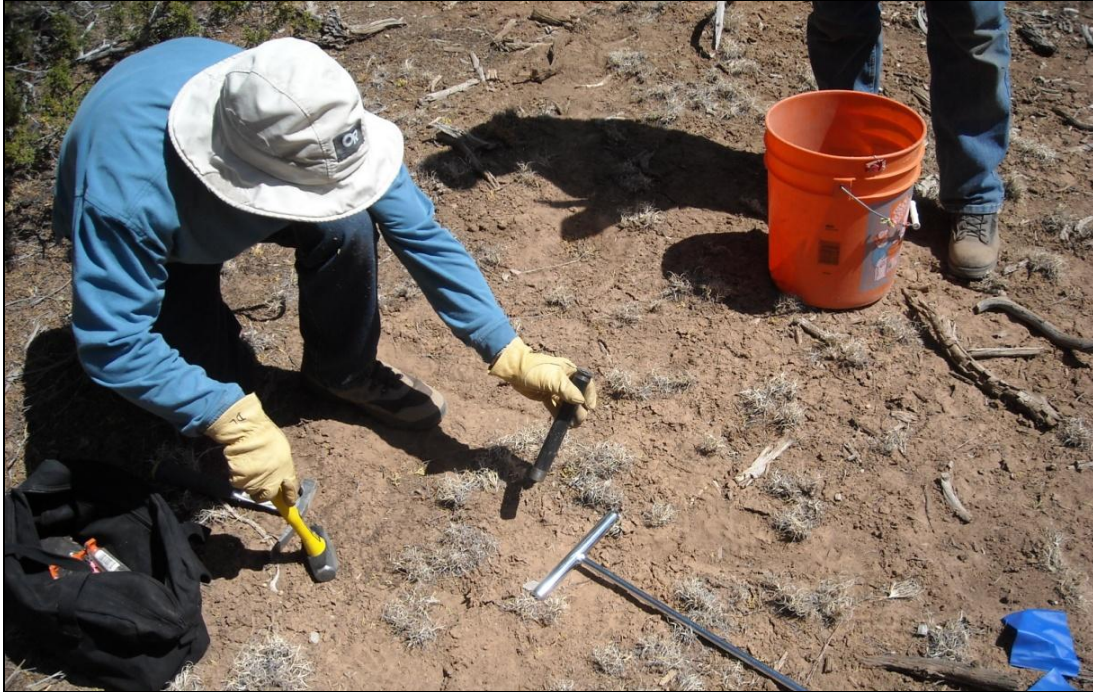
Figure 2.27. Soil cores were taken using an impact corer, shown above, for chemical analysis.

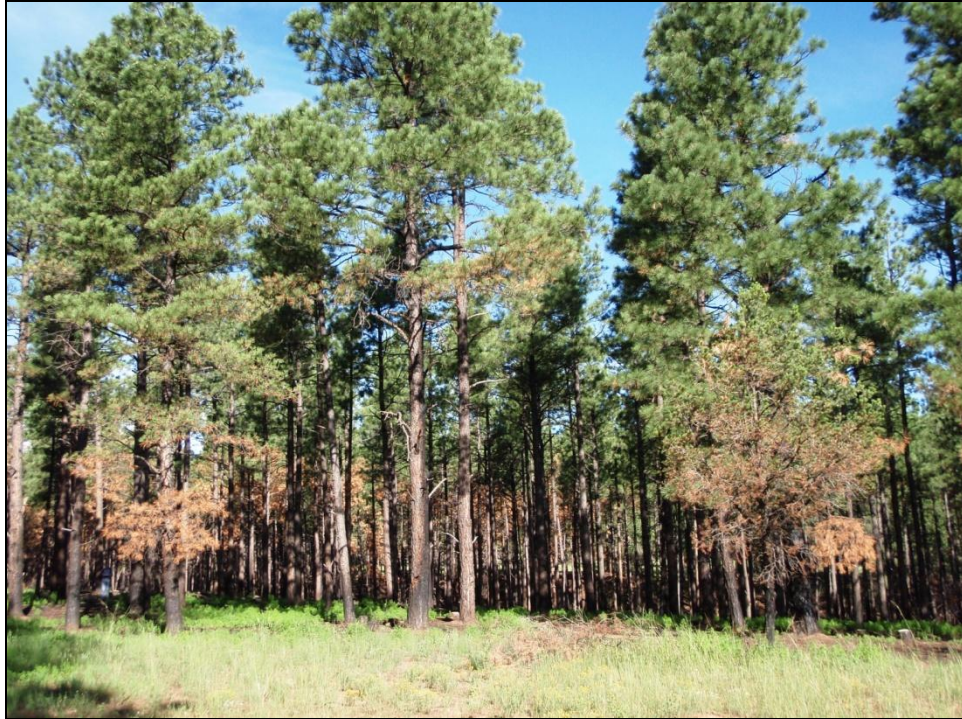
Figure 3.1. Typical low burn severity plot in the Trigo burn area.

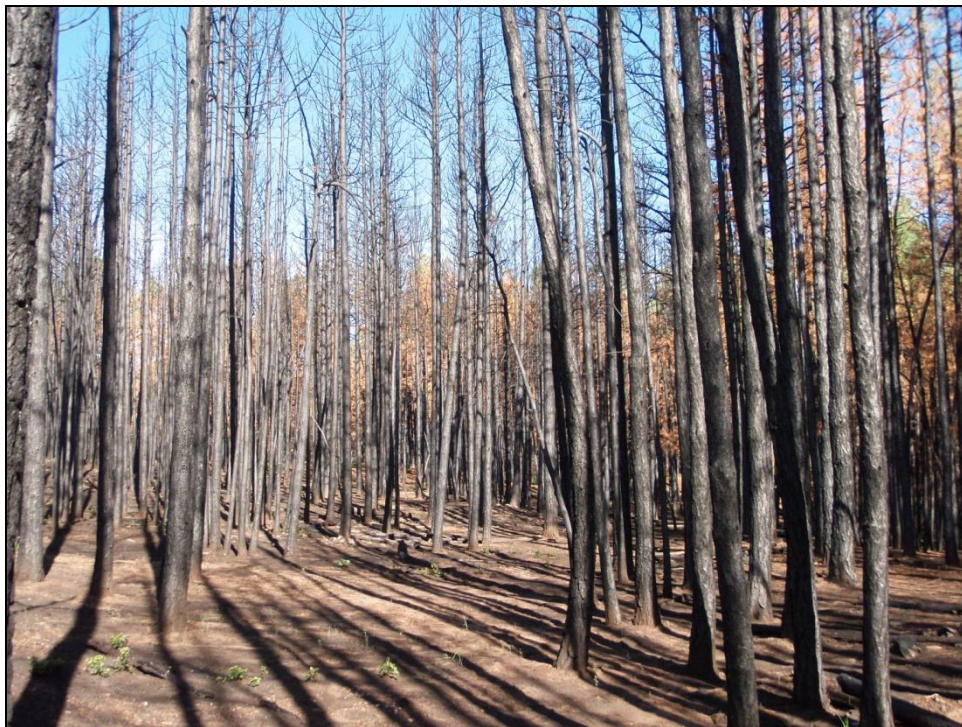
Figure 3.2. Typical high burn severity plot in the Trigo burn area.

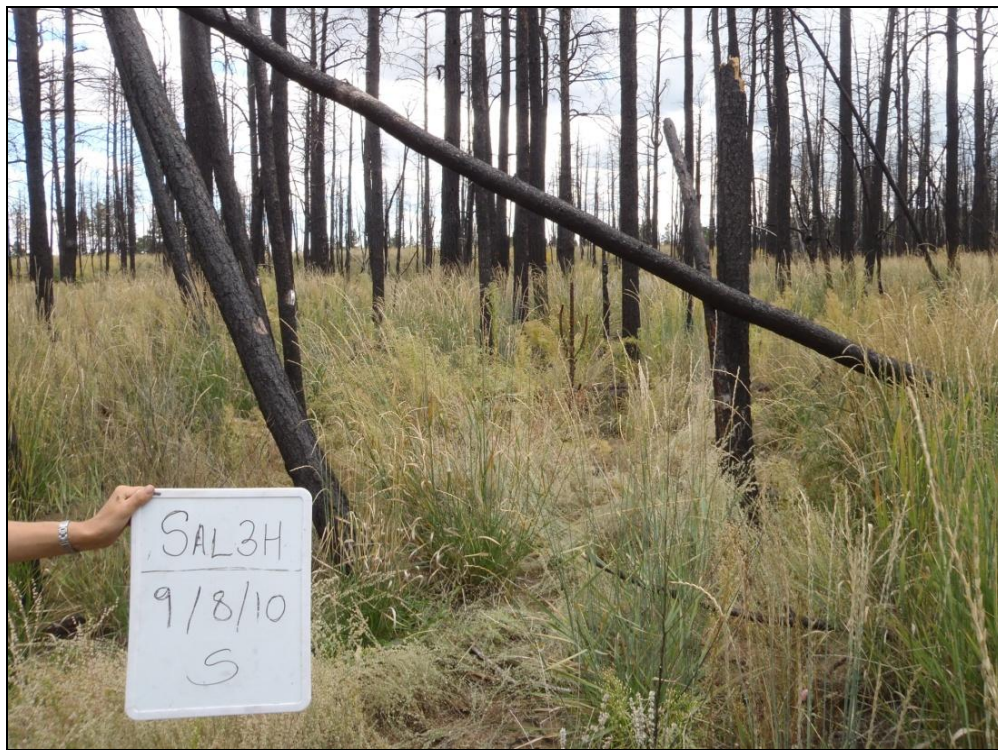
Figure 3.5. Salazar high-severity plot showing fallen tagged trees and trees snapped at mid bole.

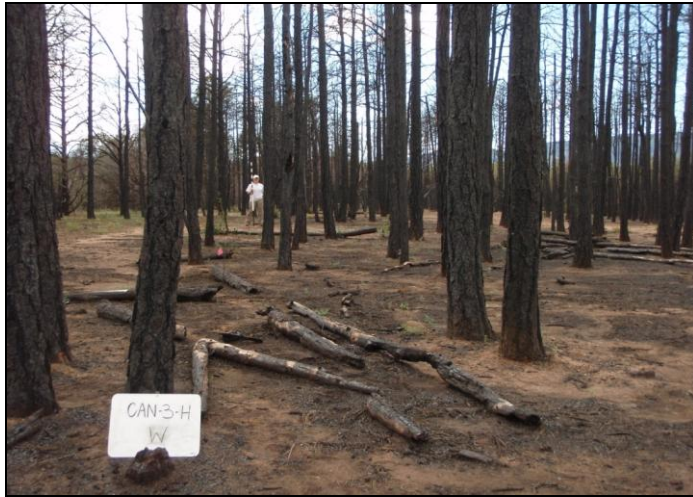
Figure 3.6. CAN 3-H west (fall 2008) showing little to no vegetation cover and considerable bare soil.

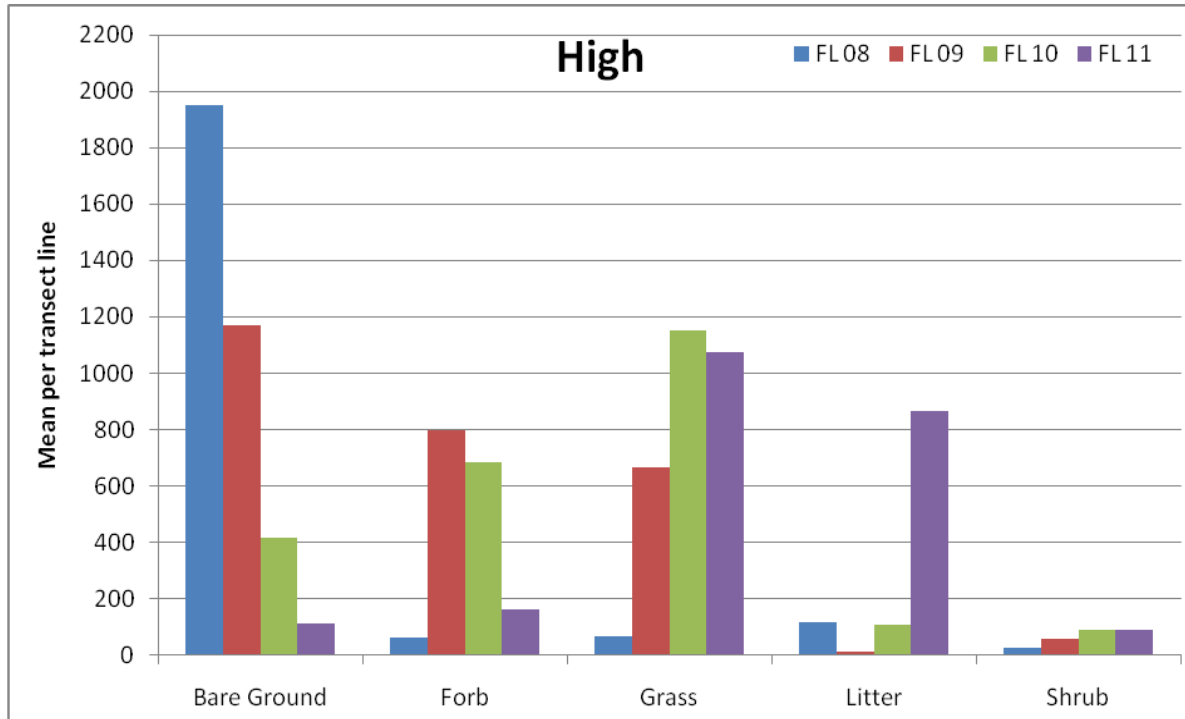
Figure 3.15. Vegetation cover measured along 23-m (75-foot) transects for all high-severity burn plots, fall 2008–2011.

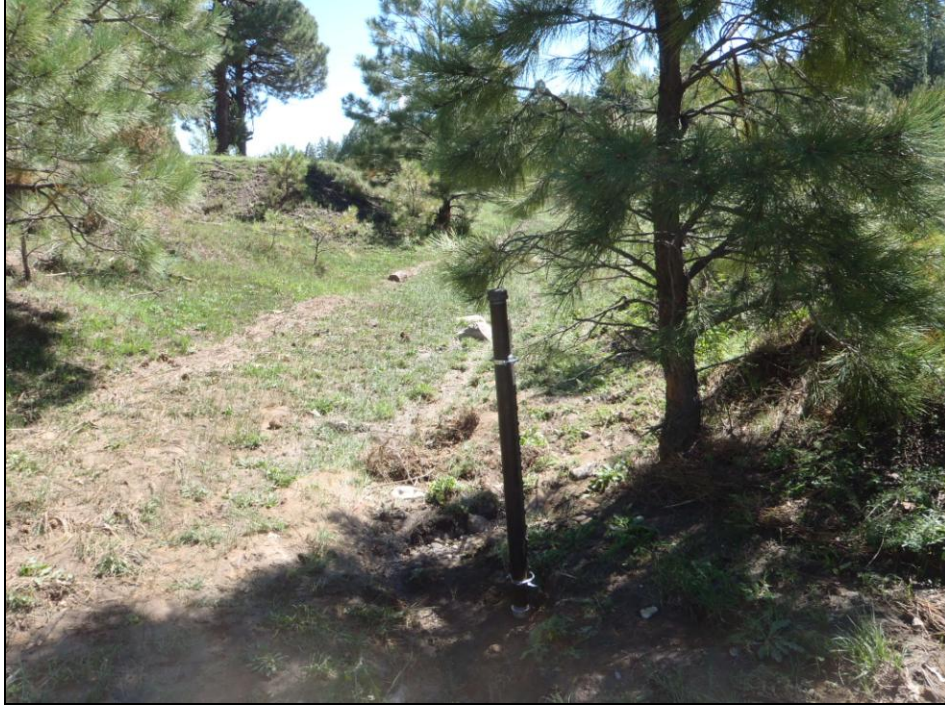
Figure 4.4. The new Chilili piezometer that was installed in the fall of 2011 to replace the storm damaged gauge.
