ESTANCIA BASIN WATERSHED HEALTH AND MONITORING PROJECT: 2012 ANNUAL REPORT

ESTANCIA BASIN WATERSHED HEALTH, RESTORATION AND MONITORING STEERING COMMITTEE

January 2013

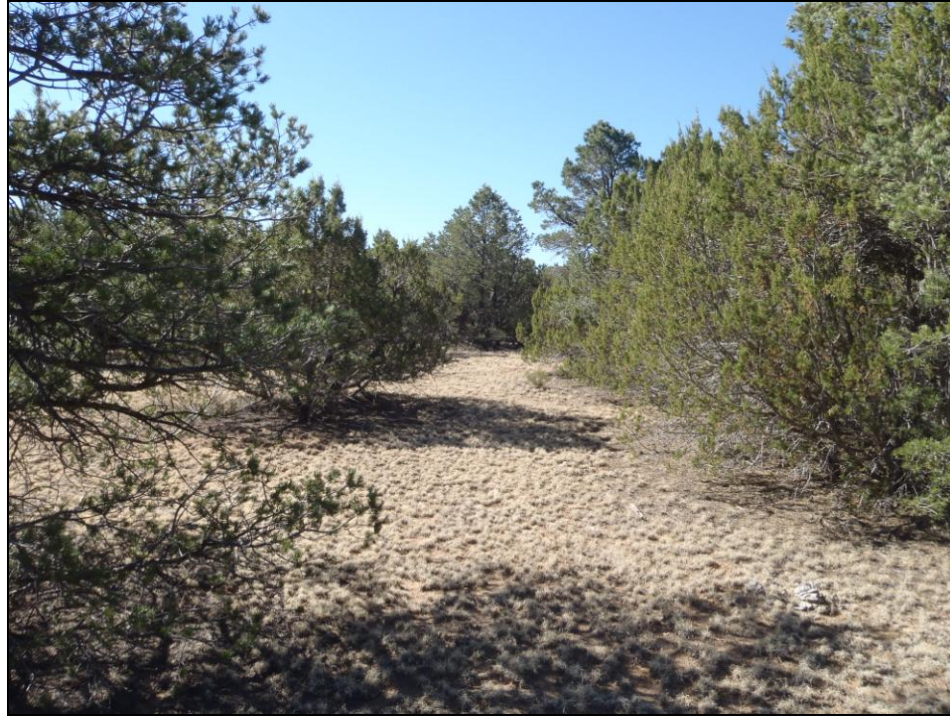
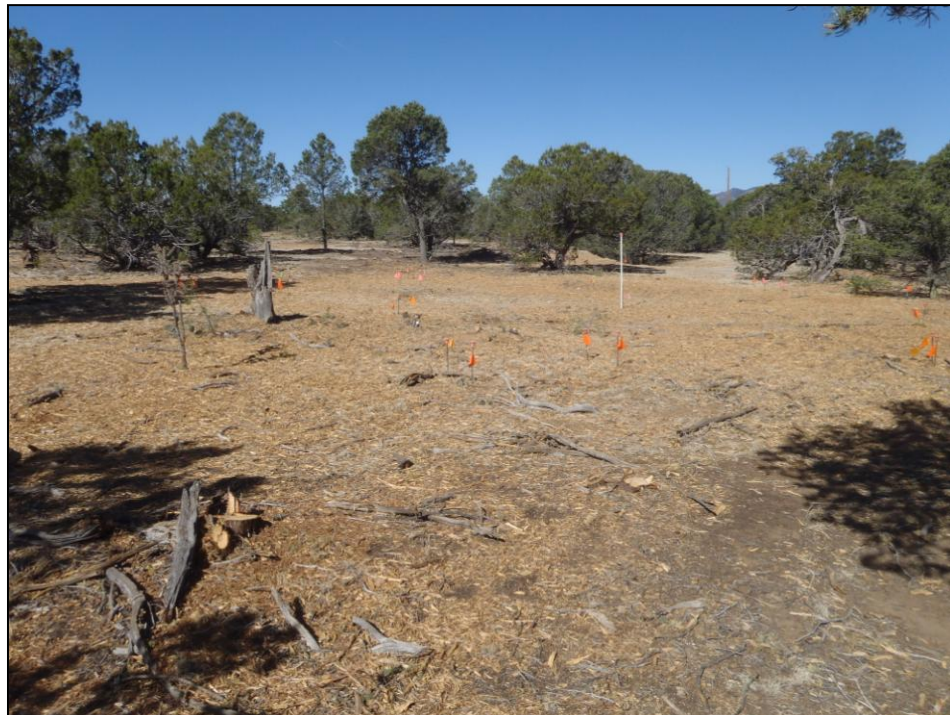
a. Non-thinned control plot (plot C).

b. Thinned treatment plot (plot T).

Figure 2.1. Kelly piñon/juniper site thinning treatment plot after excess trees have been removed in late 2010.

Tree thinning treatments were conducted as planned and were inspected by New Mexico State Forestry to ensure that all protocols were followed and that the thinning was conducted to the agency's standards developed for the region for both ponderosa pine and piñon/juniper woodland. In addition to reducing the density of trees on treatment monitoring plots, the thinning process also required that small branches from cut trees be chipped on-site and spread on the ground surface. Large-diameter wood was removed from the sites for firewood. Figure 2.1 through Figure 2.4 show views of both the non-treated control plots and adjacent treatment plots where trees were thinned from each of the four monitoring sites. Plots were photographed in late fall 2010 and early spring 2011, following tree thinning treatments. Note the open structure of the trees stands and wood chips spread over the ground surfaces of the thinned plots.

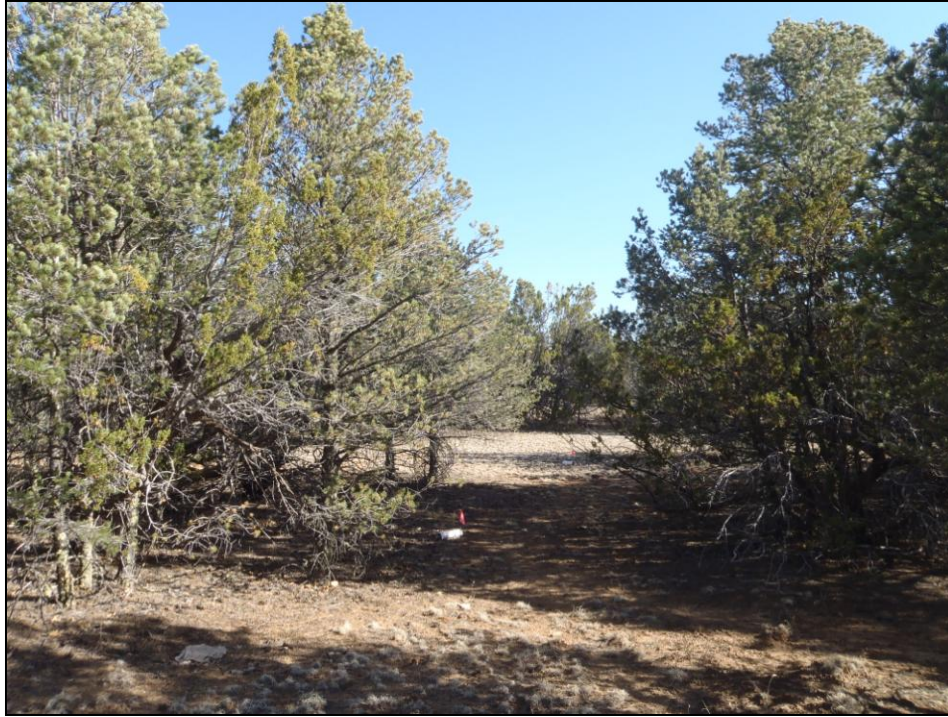
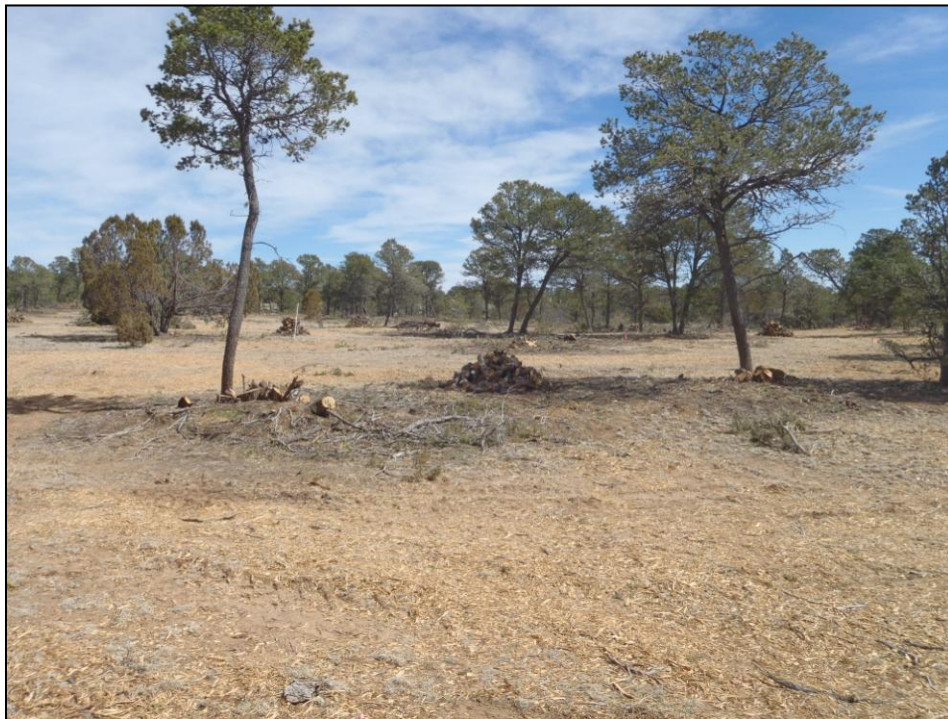
a. Non-thinned control plot (plot C).

b. Thinned treatment plot (plot T).

Figure 2.2. The Vigil piñon/juniper site following tree thinning treatments in late 2010. Note the open stand and wood chips. Stacked wood was removed shortly after the photograph was taken.

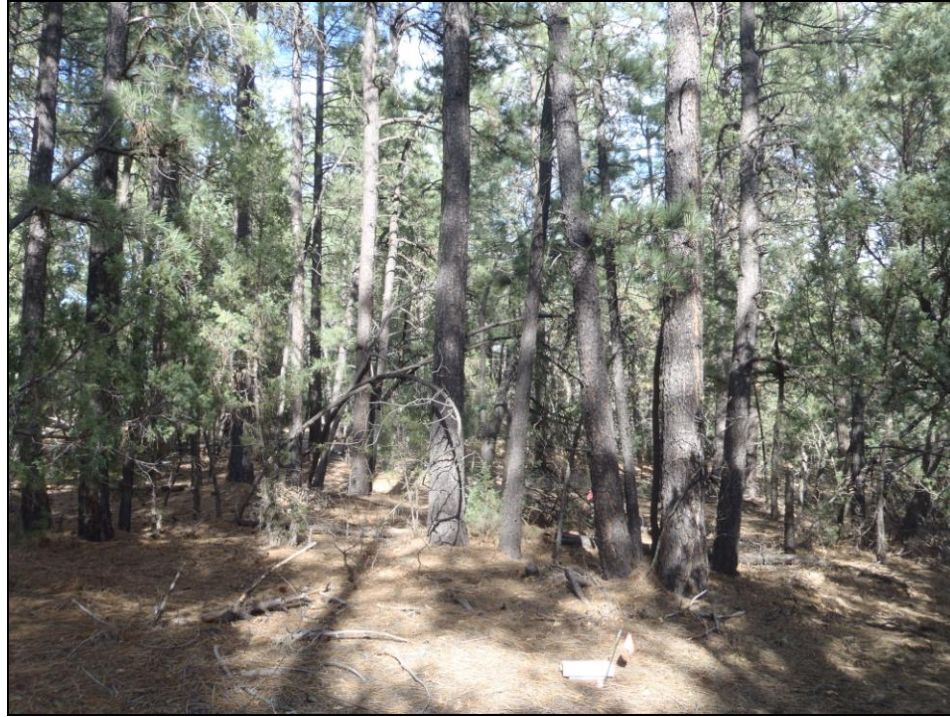
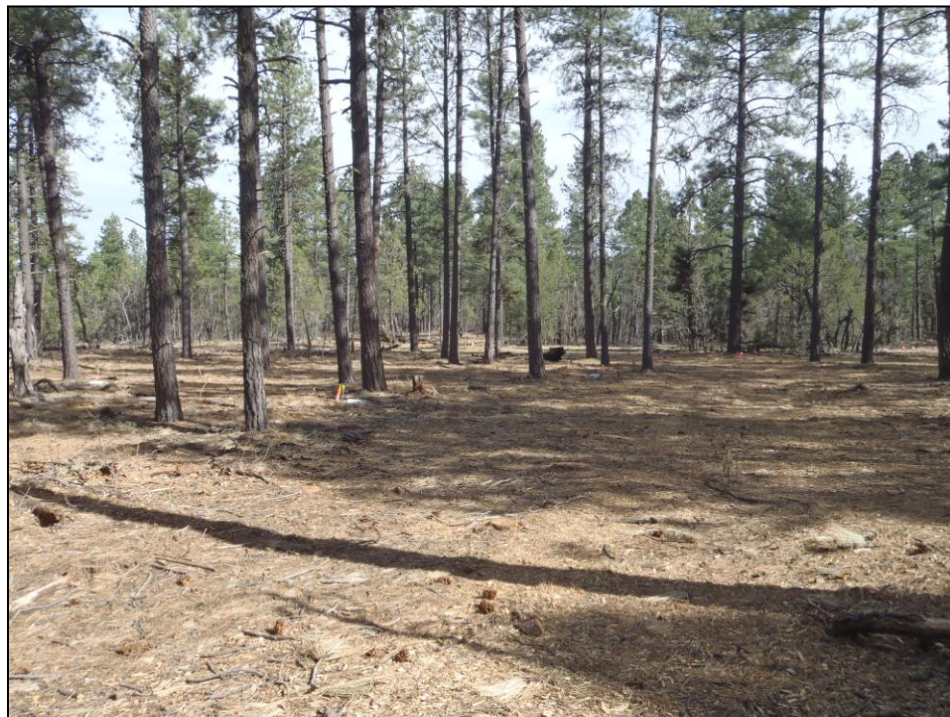
a. Non-thinned control plot (plot C).

b. Thinned treatment plot (plot T).

Figure 2.3. The Chilili ponderosa pine site following tree thinning.

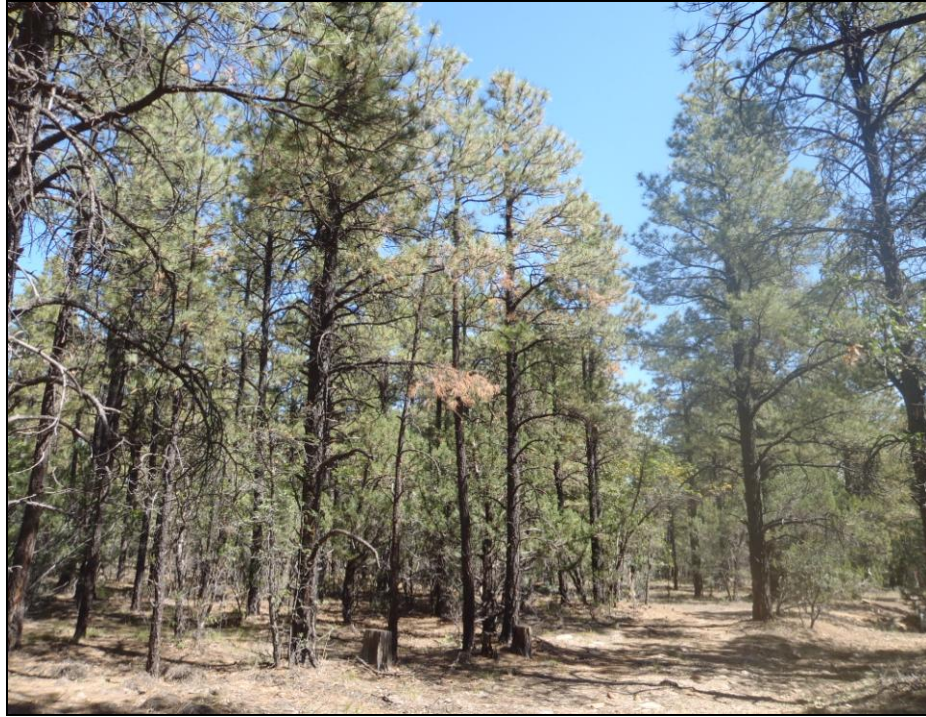
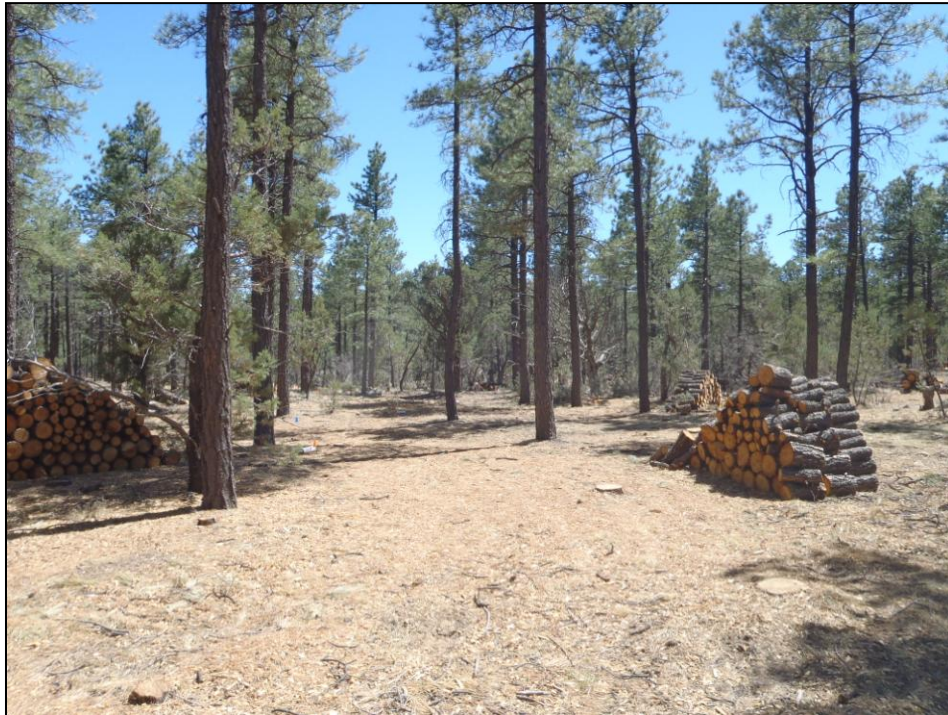
a. Non-thinned control plot (plot C).

b. Thinned treatment plot (plot T).

Figure 2.4. The Wester ponderosa pine site in early spring 2011 following tree thinning. The stacked wood was removed in early summer.

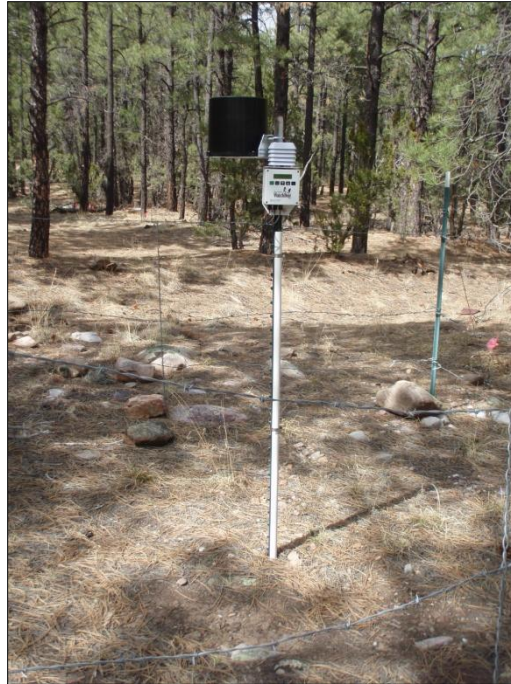
Figure 2.5. WatchDog mini weather station at the Wester ponderosa pine site.

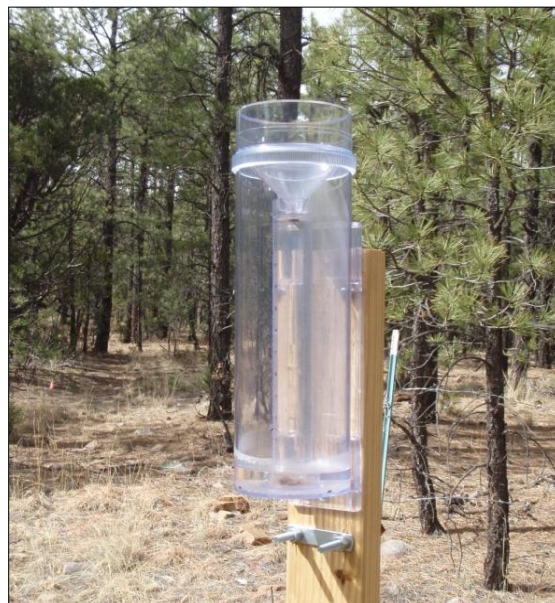
Figure 2.6. Graduated rain gauges are used for backup in the case of failure from one of the WatchDog weather stations.

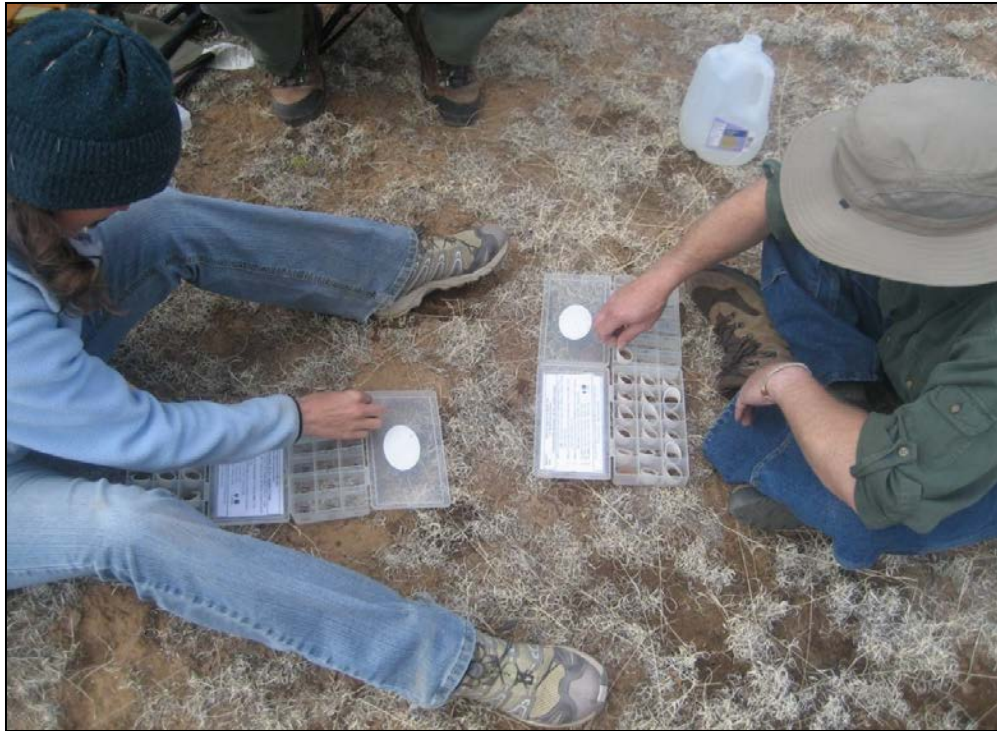
Figure 2.21. Soil stability test in use on the study sites.

Soil surface stability was measured and scored in June 2012 using the Soil Stability Test Kits developed by the U.S. Department of Agriculture Agricultural Resource Service (Herrick et al. 2005) (Figure 2.21). Further details of the measurement methods and a review of the literature can be found in the 2008 Monitoring Plan (SWCA 2008). Figure 2.22 through Figure 2.25 provide average soil surface stability scores for each of the four sample sites for 2008–2012, except for Chilili, which is 2009–2012. Figure 2.26 through Figure 2.29 provide average subsurface (1 cm below the soil surface, or -1 cm) soil stability scores for each of the four sampling sites for 2008–2012, except for Chilili, which is 2009–2012.

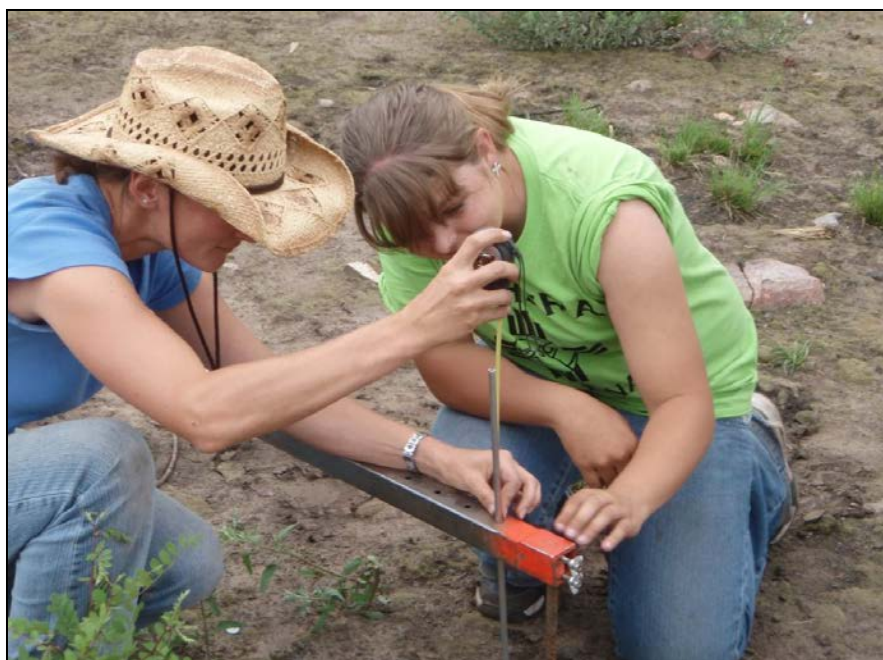
Figure 2.32. Measurement of soil surface topography using a soil movement bridge helps understand the yearly variability associated with soil topography.

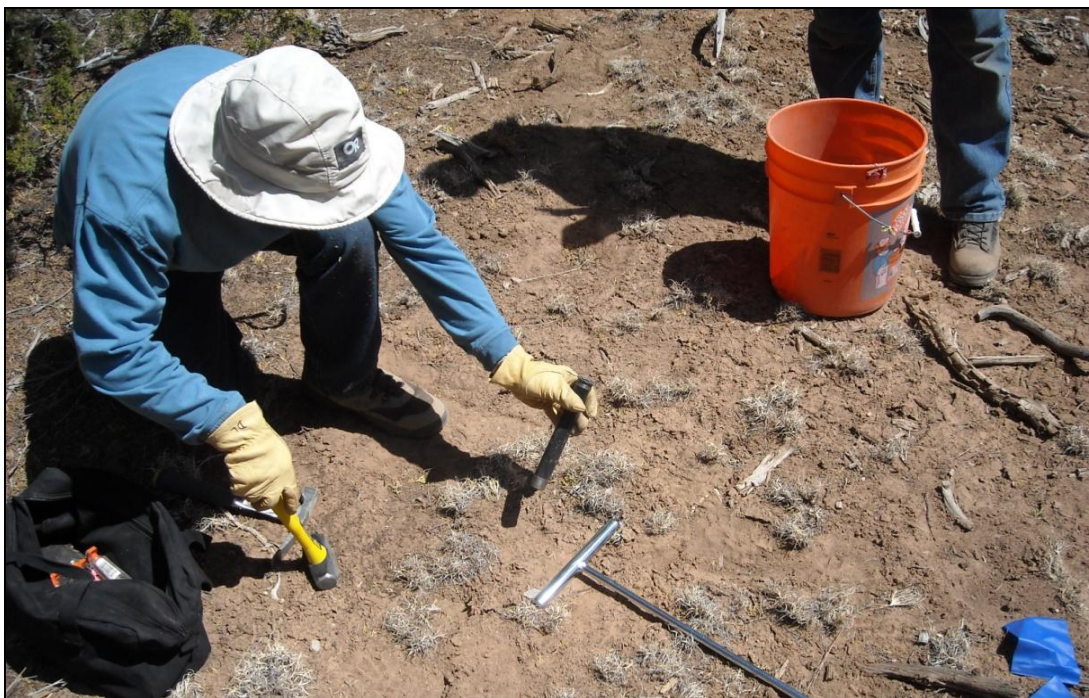
Figure 2.38. Soil cores were taken using an impact corer, shown above, for chemical analysis.

Baseline measurements of soil chemistry were obtained in 2008, 2009, and 2010 before thinning treatments at the Kelly, Vigil, and Wester sites; Chilili was not included until the 2009 sampling because this plot had yet to be established. The purpose of taking these measurements is to quantify changes to soil chemistry potentially caused by thinning activities. The methods used in 2008, however, were slightly different than those used in 2009 and 2010 and can be a reason for any large differences seen between years. The soil samples were obtained using a 4-cm-diameter (1.6-inch-diameter), 20-cm-deep (8-inch-deep) impact soil corer at the four corners of the three established vegetation plots (Figure 2.38). In 2008 the 12 subsamples were placed in labeled separate bags in order to attempt in house analysis with Cardy soil kits. The variability associated with these kits, however, proved to be too great for reliable results, so the subsamples were combined into one bag for each site and sent to the New Mexico State University Soils and Water Testing (SWAT) laboratory for further analysis. In 2009, 2010, 2011, and 2012 the collection of the 12 subsamples was combined into the same bag at the time of sampling. These pooled samples were considered to be representative of the study areas. The 2009, 2010, and 2011 samples were sent to the SWAT laboratory for analysis. The New Mexico State University SWAT laboratory closed in early 2012, so the 2012 samples were sent to the Soil, Water, and Plant Testing Laboratory at Colorado State University (CSU). These methods followed the USFS Forest Inventory and Analysis Guide procedures (USFS 2005).

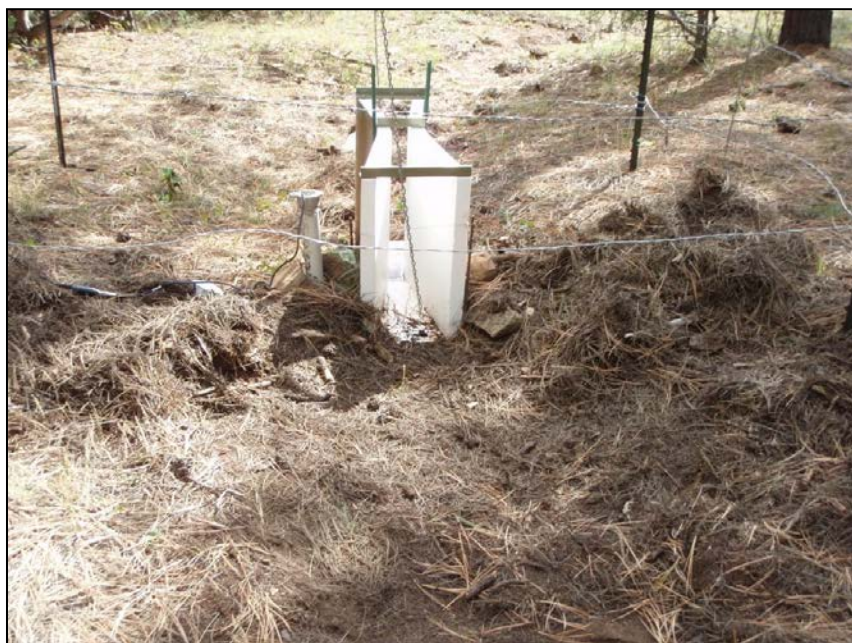
Figure 2.47. Parshall flume located at the thinned Chilili site.

Monitoring flumes (Parshall flumes) complete with pressure transducers were installed at all four study sites in order to study impacts of tree thinning to surface flow (Figure 2.47). For more detailed information on the methodology, site location and relevant background information, please refer to the 2008 Monitoring Plan (SWCA 2008).

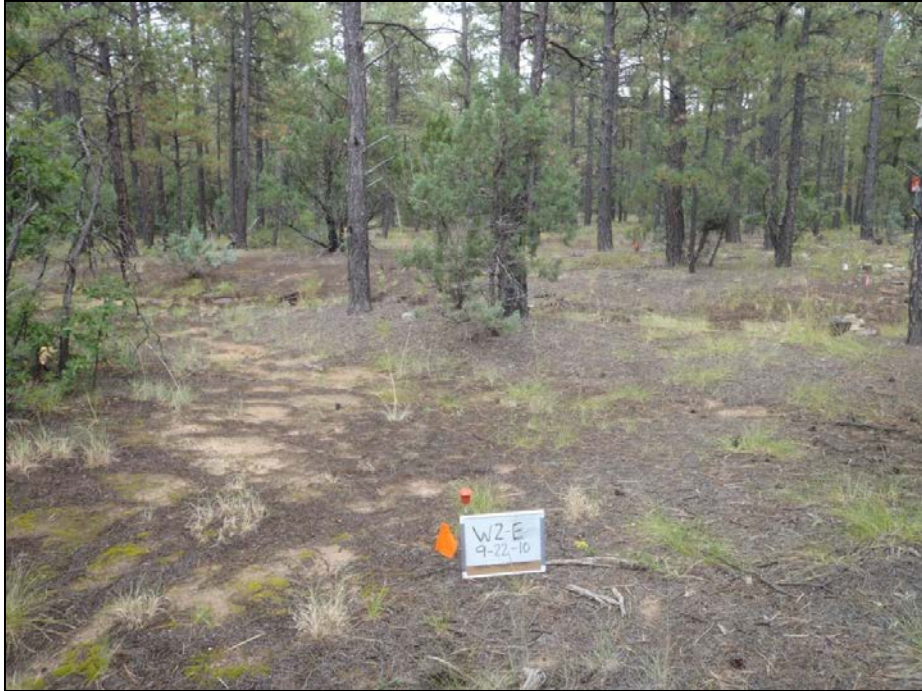
Figure 2.63. Wester control, showing the low fuel loading on the plot and lack of large-diameter dead and downed fuels.

Figure 2.62 shows the tons/acre of woody dead and downed fuels at each site. The piñon/juniper sites had relatively low fuel loading compared to the ponderosa sites, because the piñon/juniper sites tended to have fewer large-diameter woody fuels. The piñon/juniper sites exhibited greater fine fuel loading, however, likely due to lower canopy cover that permits the growth of graminoids and forbs (Figure 2.63 and Figure 2.64). Shrub cover was limited at both piñon/juniper sites. The Wester plots also had low loading compared to the Chilili plots (see Figure 2.64); this site was relatively open, with fewer 1,000-hour fuels consequently lowering the tons/acre totals. Chilili treatment and control plots have noticeably higher fuel loadings than all other sites; these are dense plots with many more 1,000-hour fuels (many downed trees and stumps) (see Figure 2.64), which raised their total tons/acre. The fuel loading at the Chilili treatment site increased considerably in 2012, while the control site had lower fuel loading than 2011 levels; this can be attributed to a reduction in 1,000-hour fuels on the control plot from 2011 to 2012. The high levels for the Chilili control in 2012 are likely due to heavy concentrations of large-diameter fuels that have accumulated at that site.

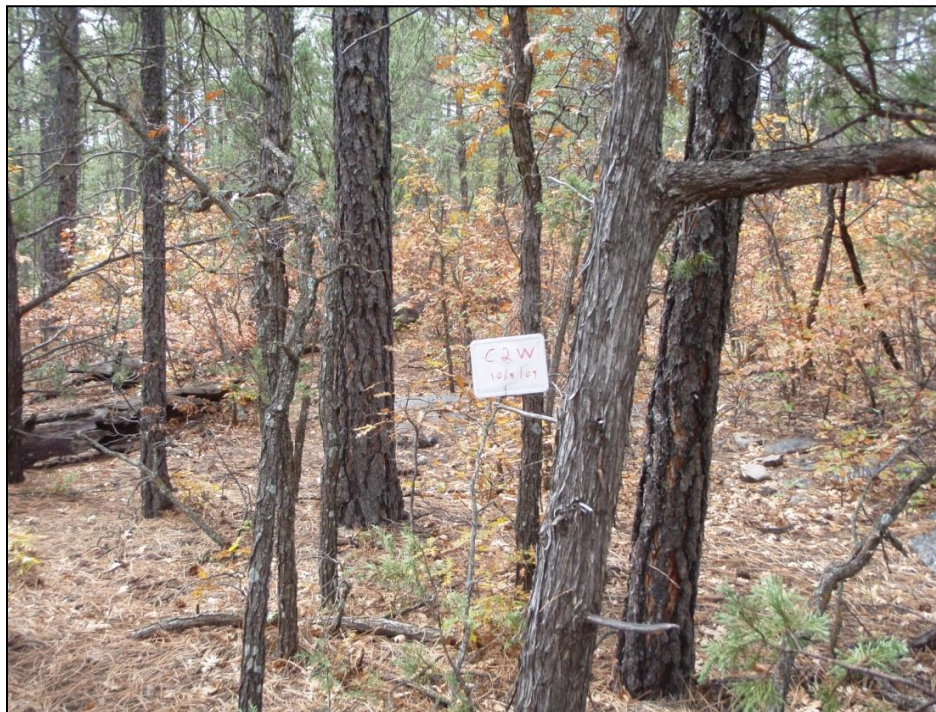
Figure 2.64. Chilili control, showing high fuel loading with evidence of large-diameter dead and downed fuels.

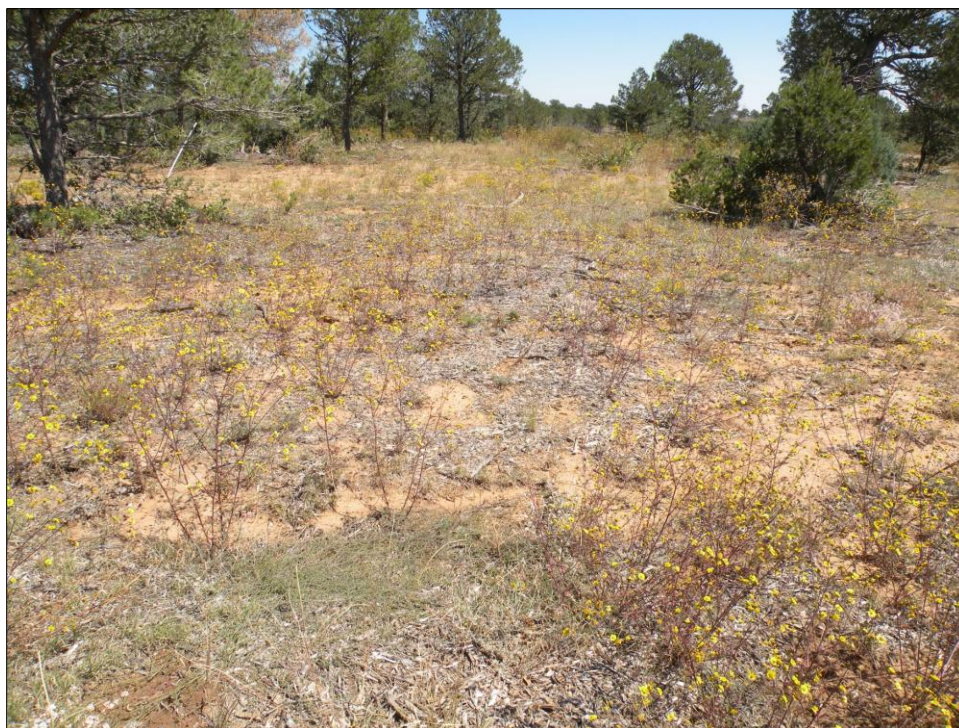
Figure 2.68. Forbs growing on disturbed soils and wood chips at the Vigil site, October 2012. Dominant species include ragleaf bahia with yellow flowers.

Forb canopy cover was significantly higher on the treated plots at both of the piñon/juniper sites in 2012, but not at either of the ponderosa pine sites (Figure 2.67, a–d). Forb cover at the Vigil site was considerably higher in 2012 than before thinning treatments in 2010 and after treatments in 2011, while forb cover on control plots remained relatively the same over the three-year period. Forb cover on the Kelly site treatment plot increased dramatically in 2011 following treatments and declined slightly in 2012, but remained significantly higher on the treated plot following treatments in 2011. The majority of forb species were summer annual plants that grew on disturbed soils and wood chips. All of the dominant species were native; no exotic invasive forb species were found. An example of the forb growth at the Vigil treatment plot in 2012 is provided in Figure 2.68.

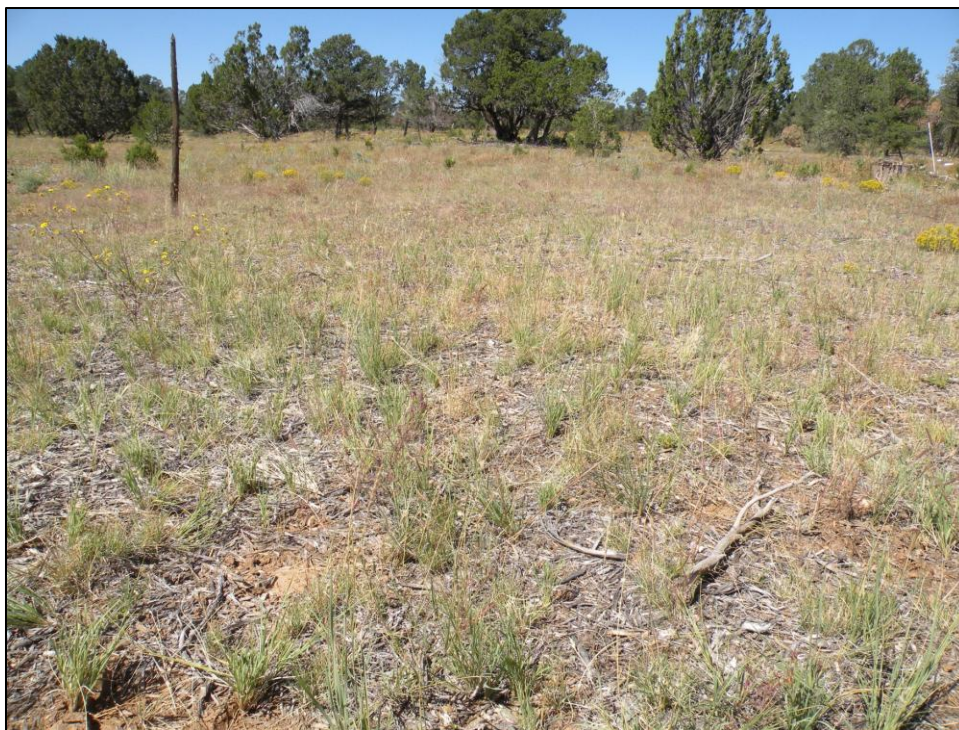
Figure 2.69. Perennial blue grama growing through wood chips at the Vigil piñon/juniper site treatment plot in 2012.

Grass cover was significantly higher only on the treated plot at the Vigil piñon/juniper site (see Table 2.12, Figure 2.67, e–h). Grass cover increased on the treated plot at the Vigil site from 2010 and 2011 on the treated plot, but remained similar on the control plot. Grass cover also was significantly higher on the treated plot at the Wester ponderosa site, but grass cover on the treatment plot there had always been significantly higher than the control plot, even before treatments in 2010. Therefore, grass cover at the Wester site did not respond differently on the treatment plot relative to tree thinning. Dominant grasses at the two piñon/juniper sites that responded positively to tree thinning were perennial species such as blue grama (*Bouteloua gracilis*) and James' galleta (*Pleuraphis jamesii*). Those grasses grew through the wood chips from existing individual plants that were in place prior to thinning treatments, unlike annual forbs that colonized the disturbed soils and wood chips. Blue grama growing through wood chips at the Vigil site is shown in Figure 2.69.

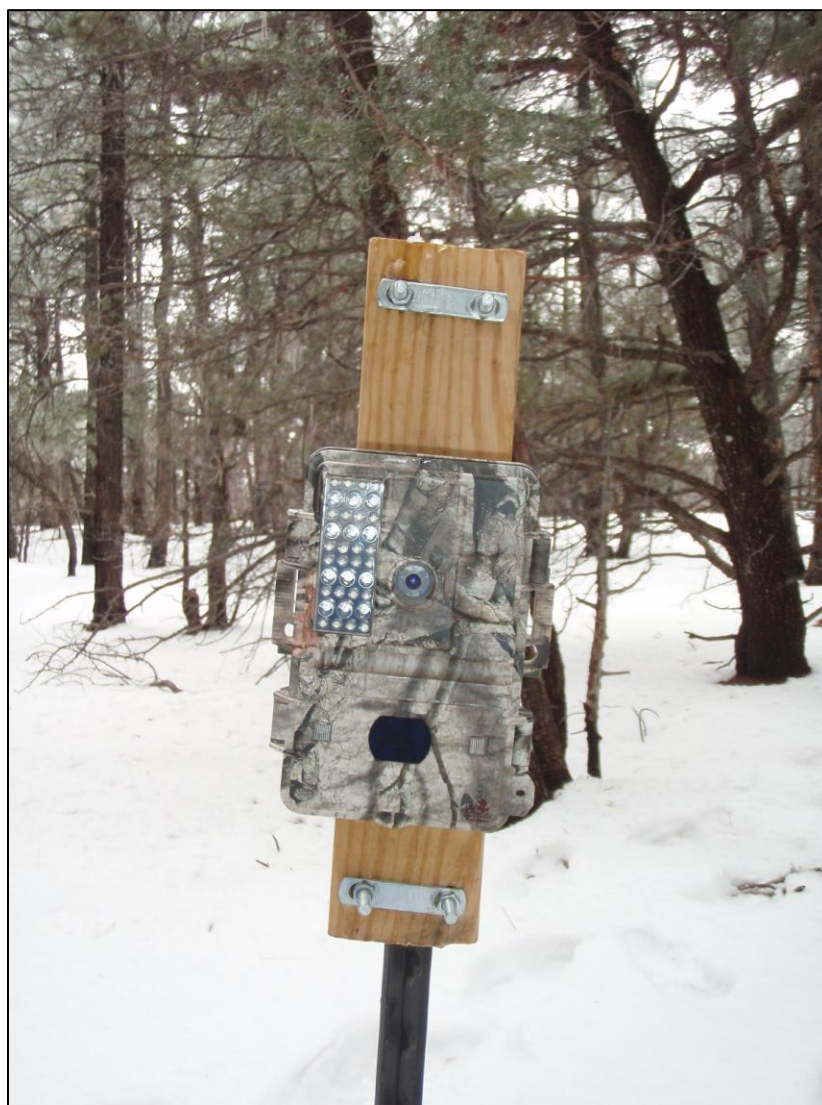
Figure 2.80. Automatic wildlife camera.

Wildlife cameras (Figure 2.80) were established on the forest thinning paired control and treatment monitoring plots in February 2012 in order to evaluate how medium and large wildlife species are using the control versus treated study plots. The cameras were all Leaf River IR5 infrared cameras that had a detection sensor up to 21 m (70 feet). One camera was placed on each of the eight control and treatment study plots among the four sites, Chilili, Kelly, Vigil, and Wester. The wildlife cameras were erected near the center of each wildlife monitoring plot, approximately 1.2 m (4 feet) from the ground and oriented toward open areas free of trees up to 20 m (66 feet) away from each camera. The cameras operate during day and night using a movement sensor infrared flash. Camera photograph cards were offloaded each month.

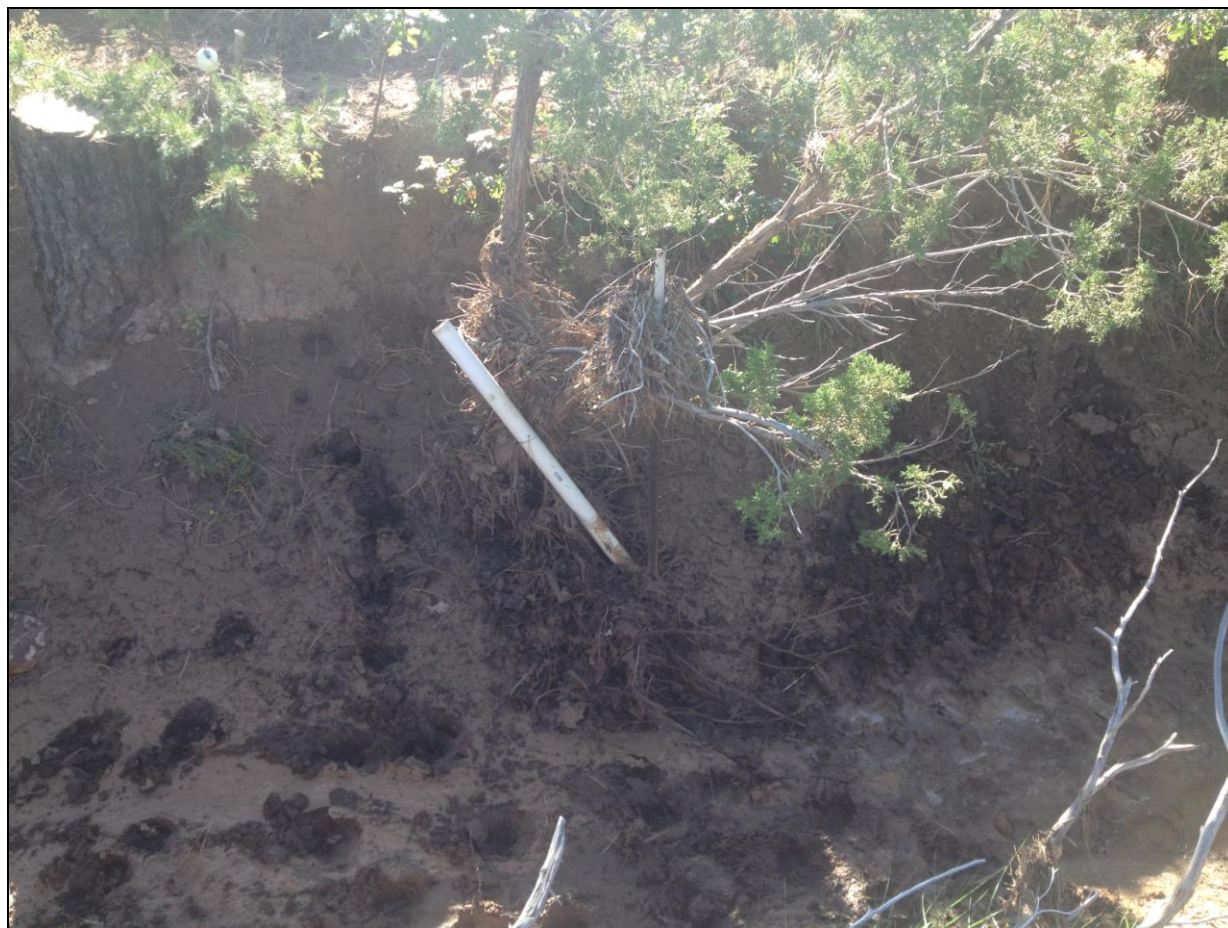
Figure 3.2. The Vigil piezometer in the fall of 2012 after a storm event destroyed the gauge.

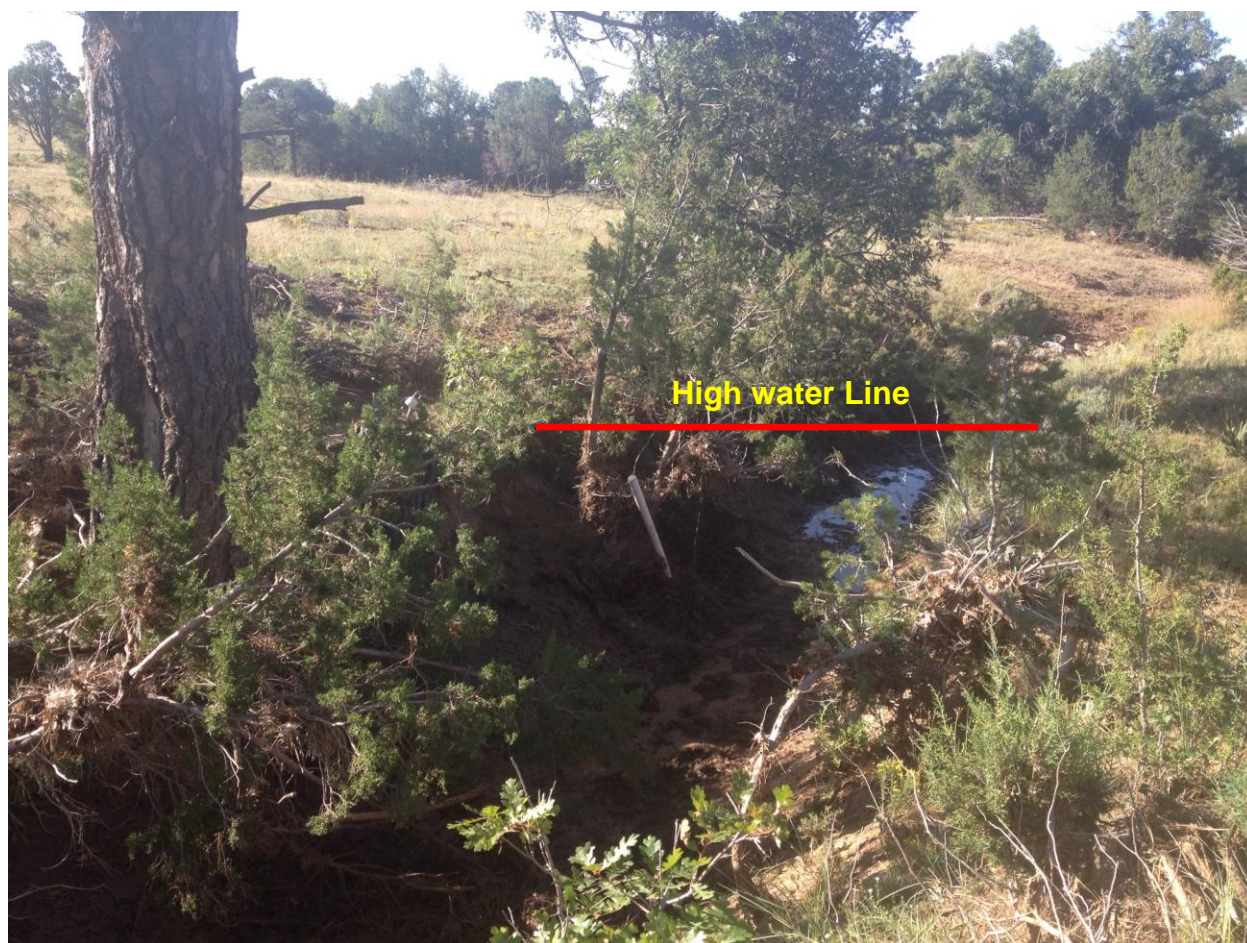
Figure 3.3. View of the Vigil piezometer facing downstream showing the high water mark (1.5 meters) as a red line above the piezometer.
