ESTANCIA BASIN WATERSHED HEALTH AND MONITORING PROJECT: 2014 ANNUAL REPORT

ESTANCIA BASIN WATERSHED HEALTH, RESTORATION AND MONITORING STEERING COMMITTEE

SWCA ENVIRONMENTAL CONSULTANTS

April 2015

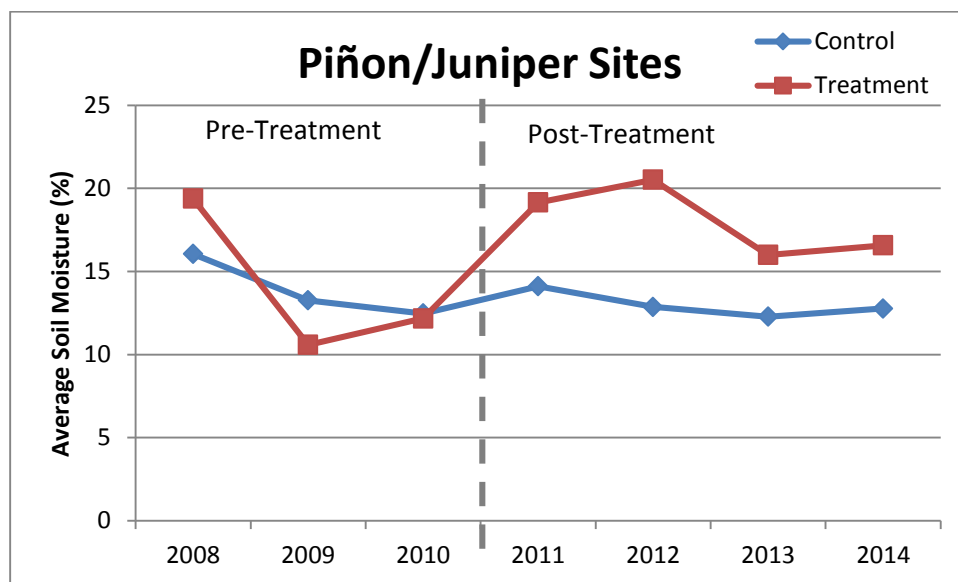
Figure 2.17. Annual average soil moisture percentage for the piñon/juniper sites, 2008–2014; moisture readings were averaged annually from the monthly readings.

Average percent soil volumetric water content on the piñon/juniper and ponderosa plots from 2008 through 2014 is displayed below in Figure 2.17 and Figure 2.18. These results show that the piñon/juniper and ponderosa sites are acting in similar fashion prior to the thinning treatments completed in 2011, but after 2012 the piñon/juniper sites showed a decrease in average soil moisture on both control and treatment plots while the ponderosa sites show an increase in average soil moisture on control and treatment plots. Average annual soil moisture between the paired plots is presented below for 2008–2014 from all forest thinning plots (Figure 2.19–Figure 2.22). These figures indicate that the treated sites retain on average more soil moisture throughout the year, especially after storm events and during times of drought. However, when looking at the individual sites different trends are starting to become evident. For example, the Vigil control and treatment plot (see Figure 2.21) had similar soil moistures throughout the 2014 season. This can likely be attributed to the decline in chip cover and increase in bare ground cover. The Kelly piñon/juniper sites showed the converse with the treatment plot retaining more soil moisture than the control (see Figure 2.20). The ponderosa pines sites showed the same trends as previous years with the treatment retaining slightly more soil moisture than the controls. Whether these findings continue to persist into the future remains to be seen.

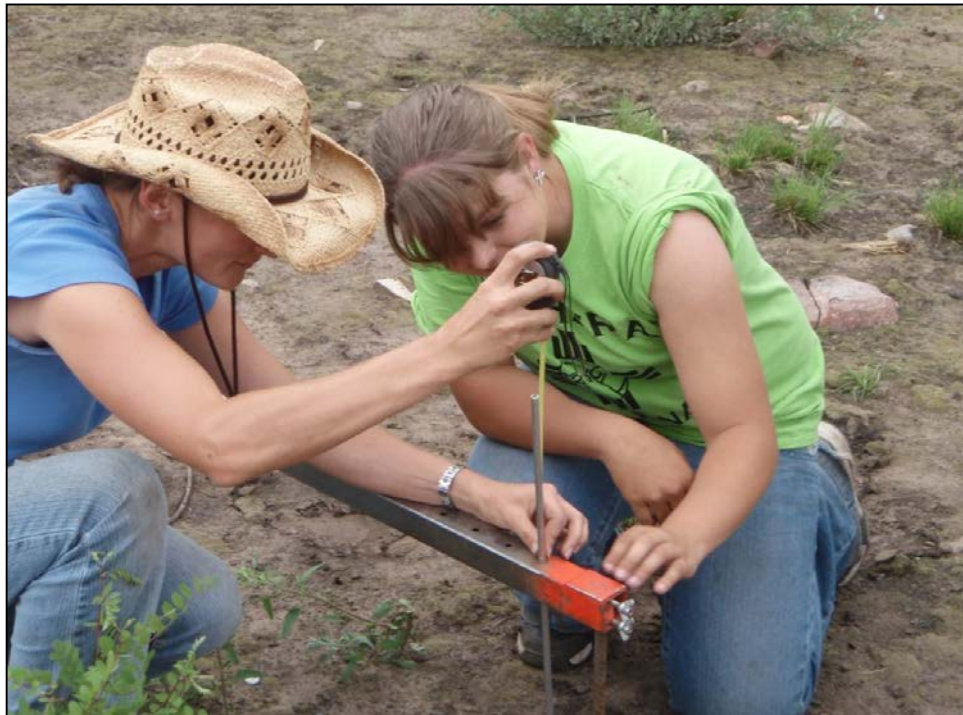
Figure 2.23. Measurement of soil surface topography using a soil movement bridge helps understand the yearly variability associated with soil topography.

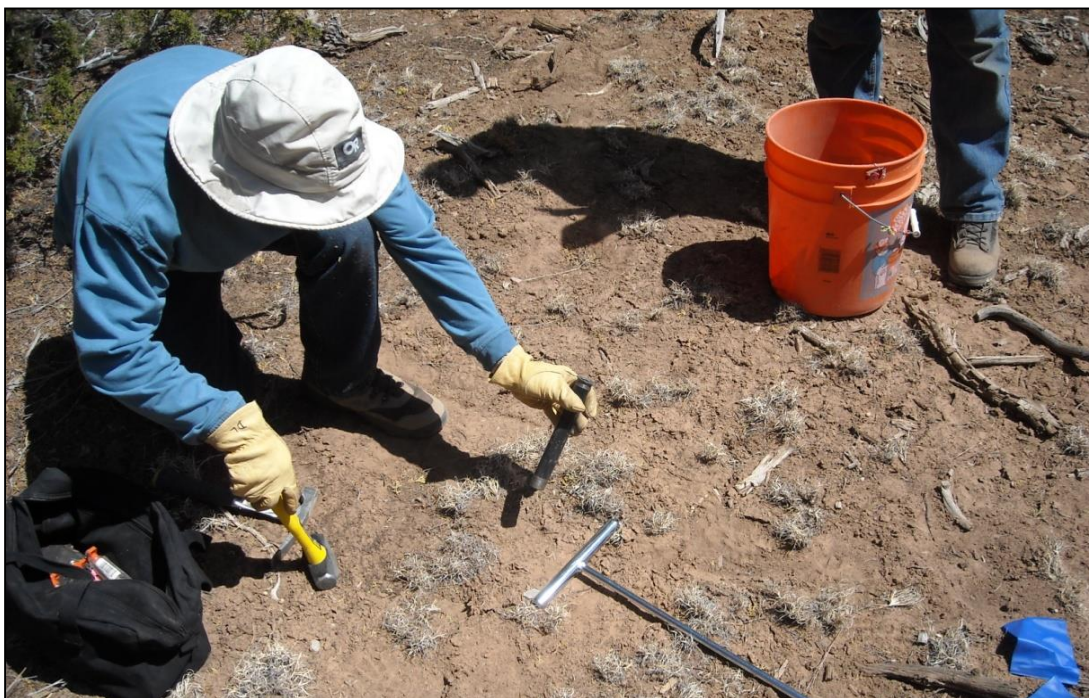
Figure 2.29. Soil cores were taken using an impact corer, shown above, for chemical analysis.

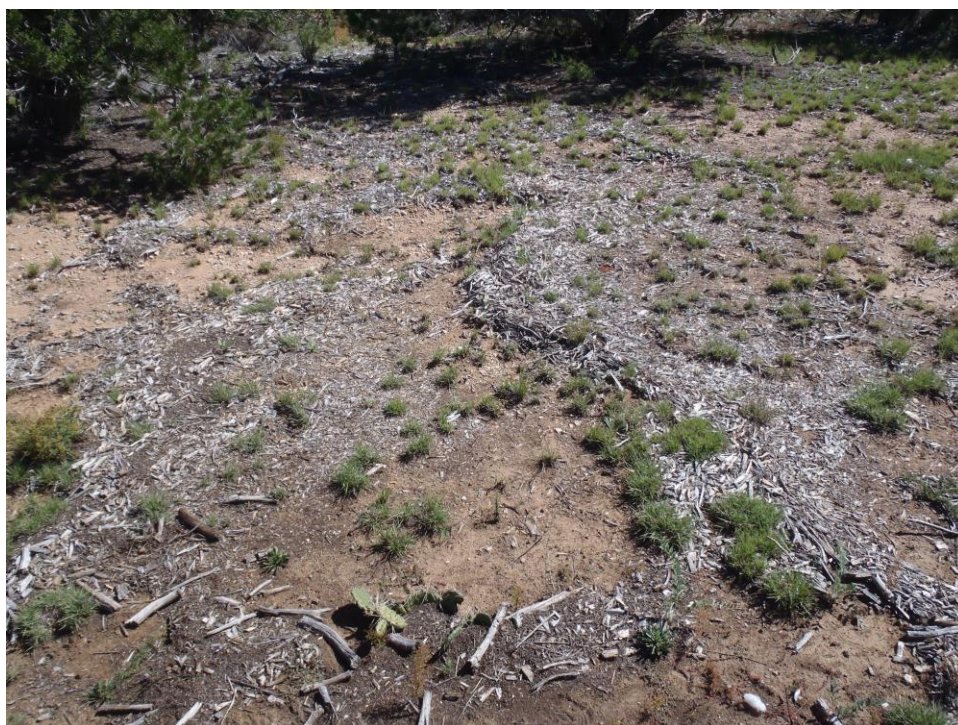
Figure 2.51. Wood chips from tree thinning treatment redistributed over the ground surface by heavy summer rain runoff at the Kelly treatment plot in 2014. The wood chips also formed small debris dams to retain soil surface water runoff, likely increasing infiltration and reducing soil erosion.

Wood chips have remained significantly higher on all treated 2011 following thinning treatments (see Figure 2.48, y–bb; Table 2.10). No wood chips existed prior to thinning treatments in 2010, and they were applied only to the treated plots in late 2010. Wood chip cover on the treated plots declined by about 20% on all plots between 2011 and 2012, indicating some decomposition or redistribution and/or increased herbaceous plant canopy cover over wood chips. Since 2012, wood chip cover has remained fairly constant at the two piñon/juniper sites. In 2014, wood chip cover increased back up to about 20% cover at the two ponderosa pine sites. No new wood chips have been added at those sites. Such fluctuations are believed due to redistribution of chips following heavy rain and runoff events, and shifts in relative ground surface cover with other cover features. Figure 2.51 shows an example of wood chips that have been redistributed on the ground surface from heavy rain and runoff on the Kelly treatment plot in 2014.

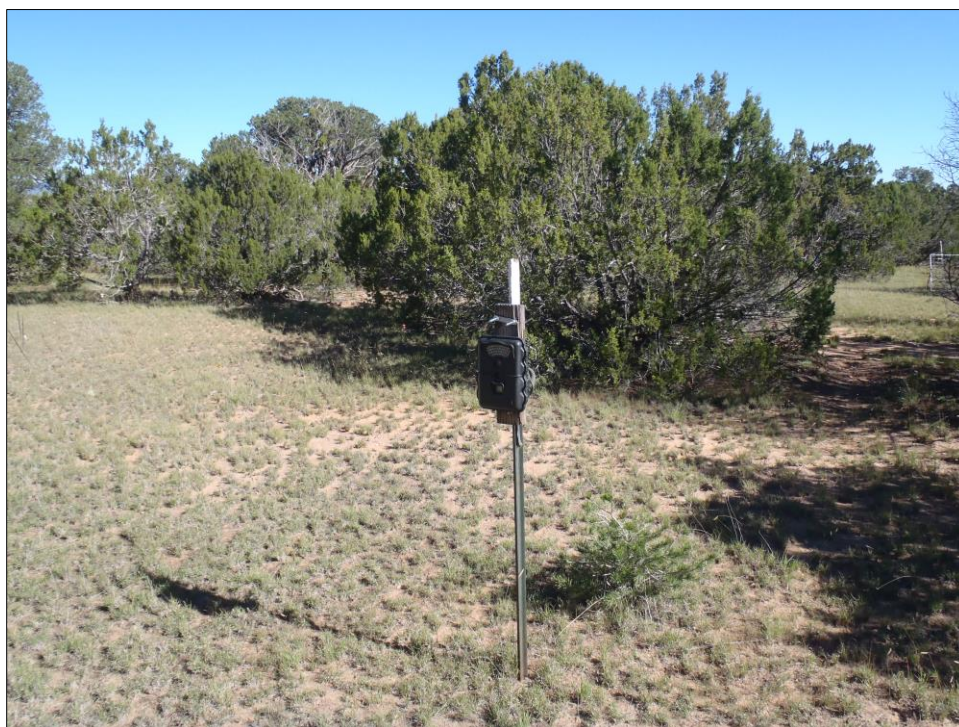
Figure 2.66. Automatic wildlife camera (Truth Cam, model 63010).

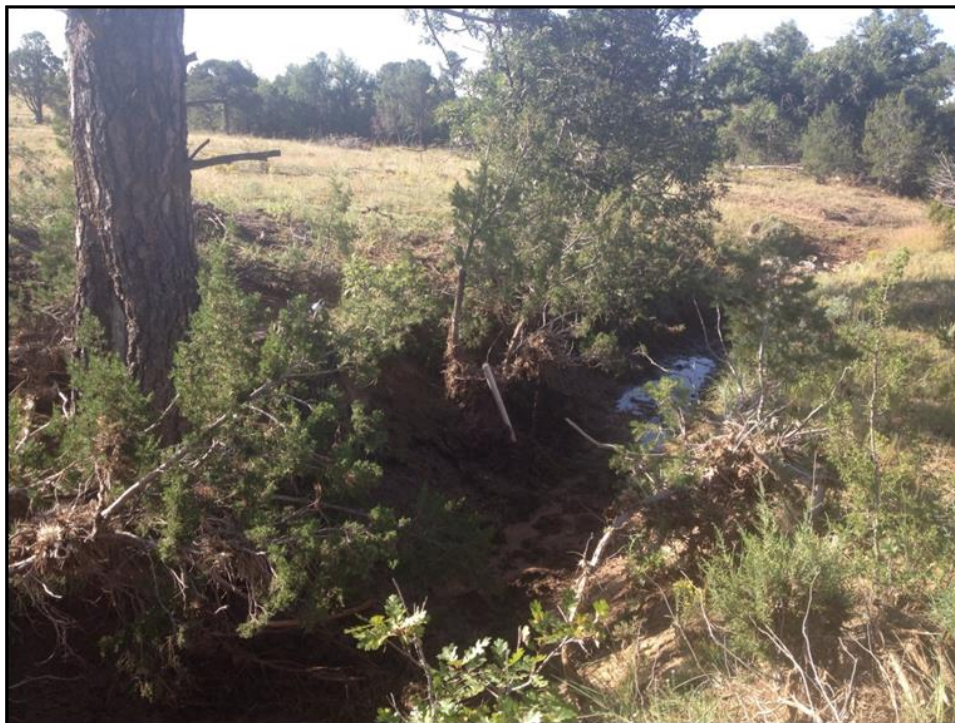
Figure 3.2. The Kelly piezometer in the fall of 2014 after a storm event compromised the gauge.
