**ESTANCIA BASIN WATERSHED
HEALTH AND MONITORING PROJECT:
2015 ANNUAL REPORT**

**ESTANCIA BASIN WATERSHED HEALTH, RESTORATION AND MONITORING
STEERING COMMITTEE**

March 2016

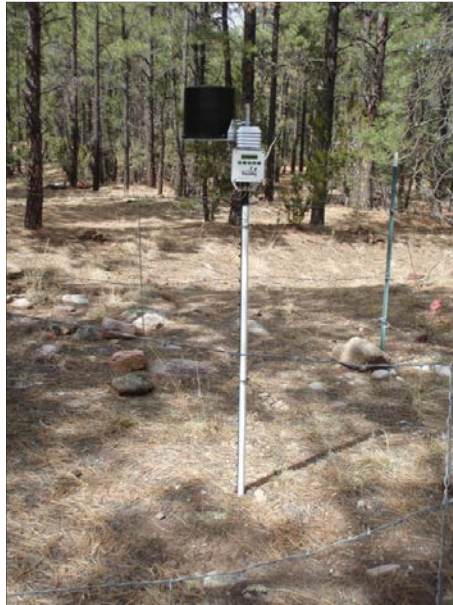
Figure 2.7. WatchDog mini weather station at the Wester ponderosa pine site.

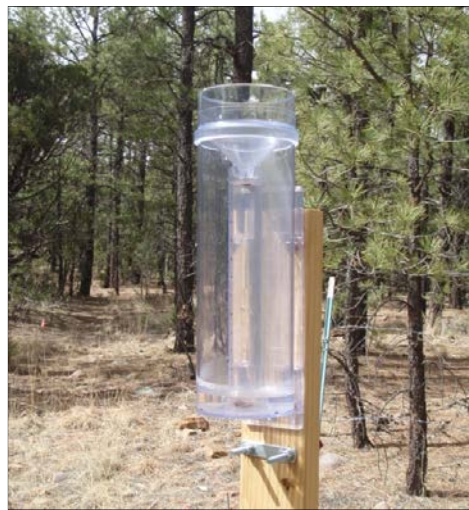
Figure 2.8. Graduated rain gauges are used for backup in the case of failure of one of the WatchDog weather stations.

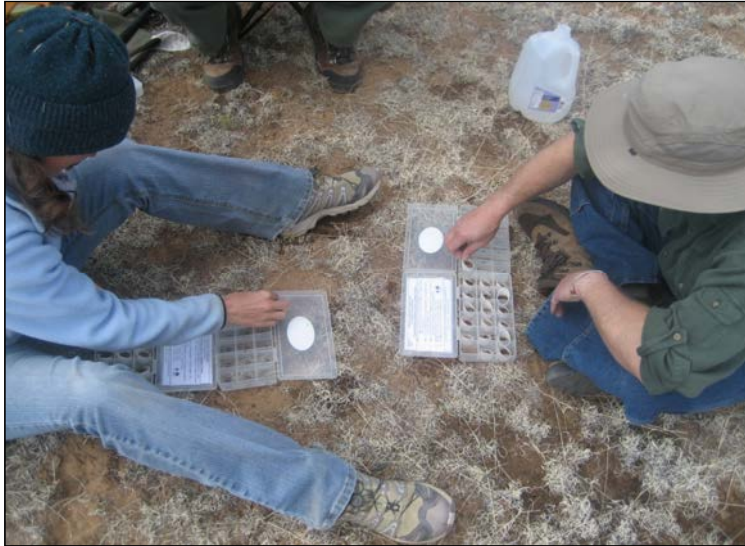
Figure 2.22. Soil stability test in use on the study sites.

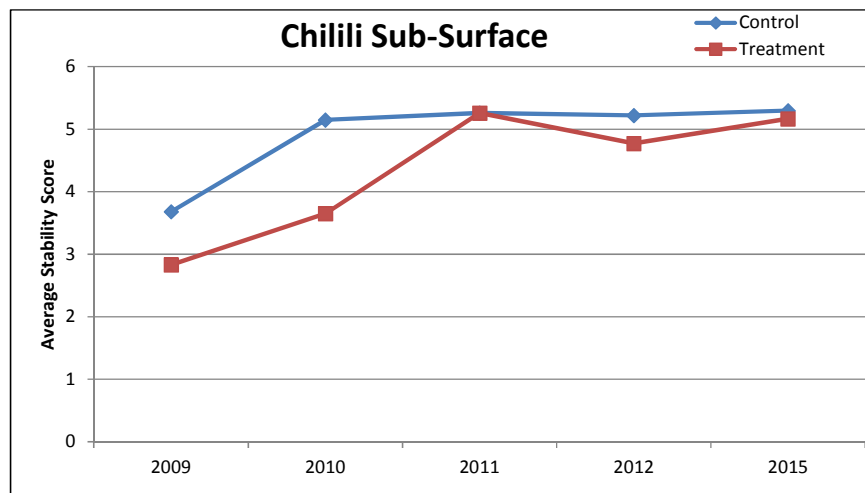
Figure 2.27. Soil subsurface (-1 cm) stability average scores for Chilili, 2009–2015 (18 subsamples/subplot).

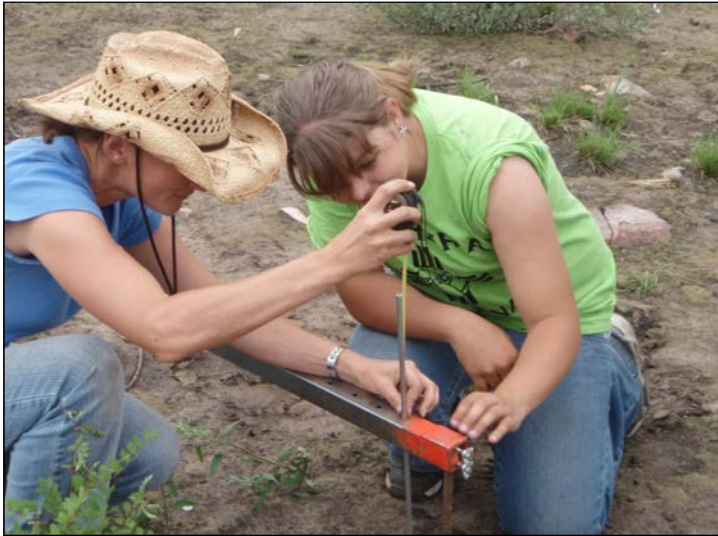
Figure 2.33. Measurement of soil surface topography using a soil movement bridge helps understand the yearly variability associated with soil topography.

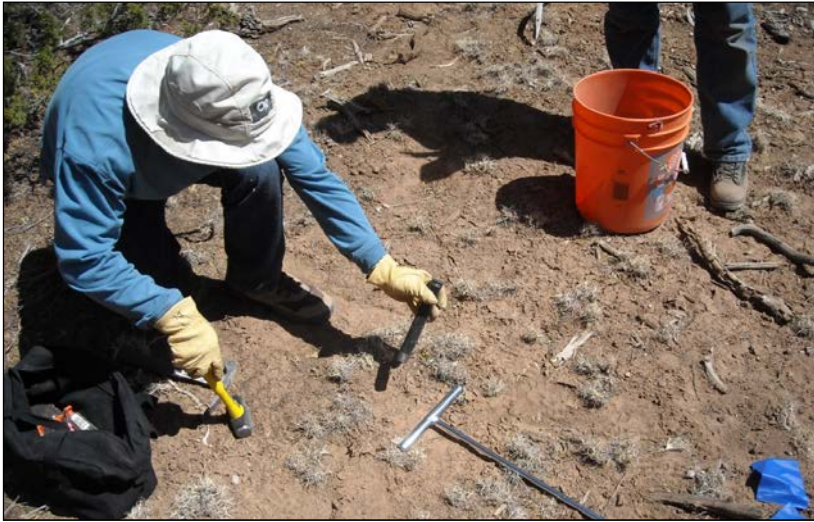
Figure 2.39. Soil cores were taken using an impact corer, shown above, for chemical analysis.

Testing Laboratory at Colorado State University (CSU). These methods followed the USFS Forest Inventory and Analysis Guide procedures (USFS 2005).

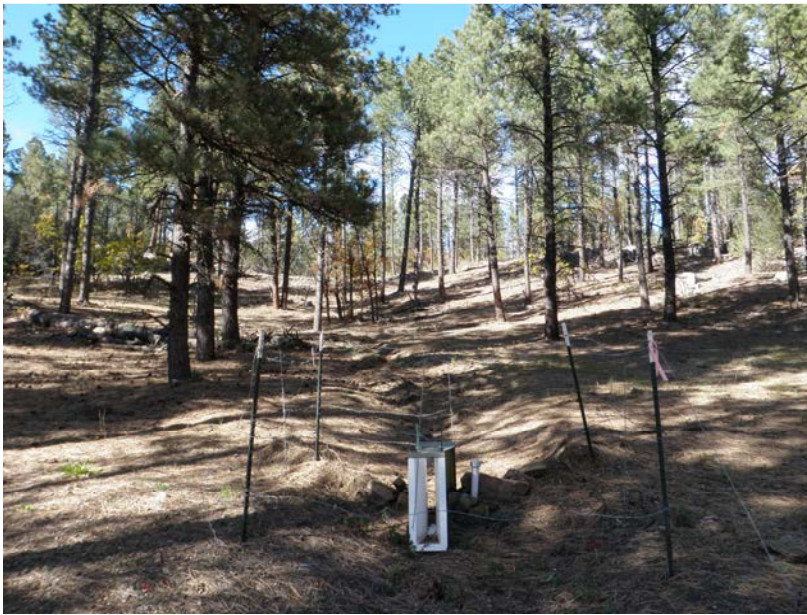
Figure 2.48. Parshall flume located at the thinned Chilili site.

Monitoring flumes (Parshall flumes) complete with pressure transducers were installed at all four study sites to study the impacts of tree thinning to surface flow (Figure 2.48). For more detailed information on the methodology, site location, and relevant background information, please refer to the 2008 Monitoring Plan (SWCA 2008).

All Parshall flumes were functioning properly during the 2015 season.

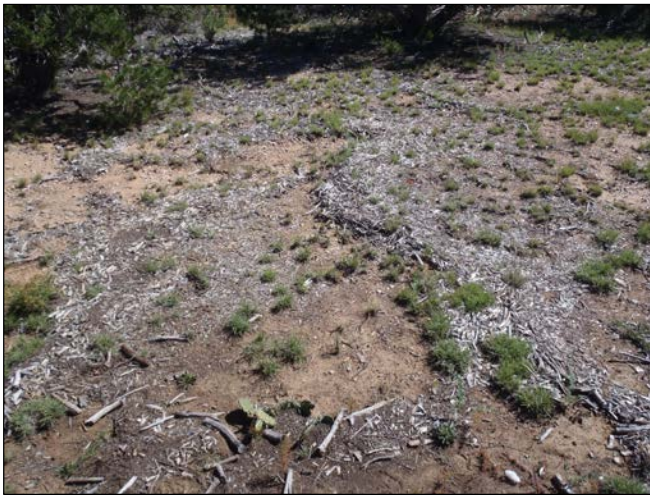
Figure 2.64. Wood chips from tree thinning treatment redistributed over the ground surface by heavy summer rain runoff at the Kelly treatment plot in 2014. The wood chips also formed small debris dams to retain soil surface water runoff, likely increasing infiltration and reducing soil erosion.

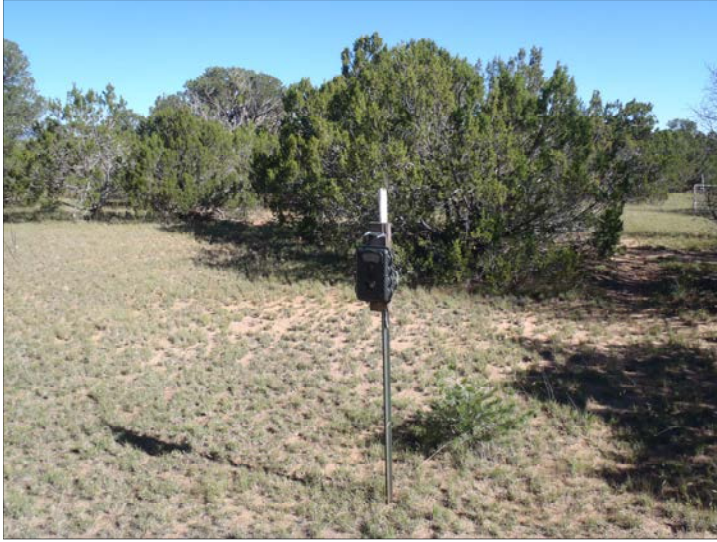
Figure 2.83. Automatic wildlife camera (Truth Cam, model 63010).
