Coronado SWCD Alfredo Baca Project 15.07

Post-treatment Monitoring Report

2022

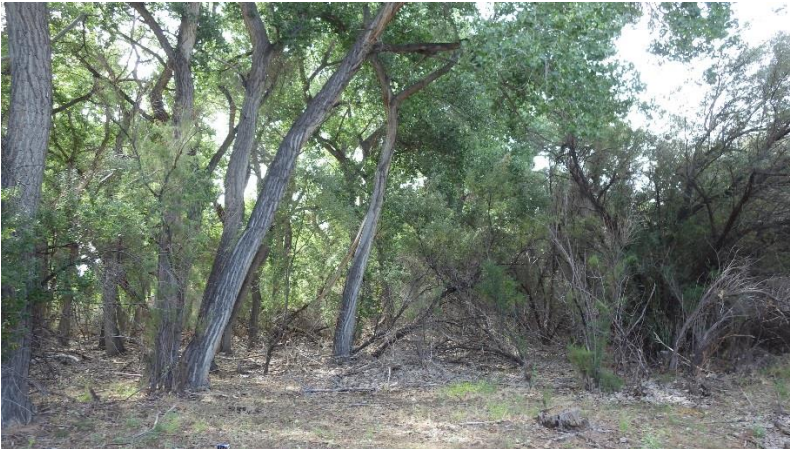
BACA1, view of polygon 6 – cottonwoods, Russian olives and salt cedars. Taken facing 184 degrees.

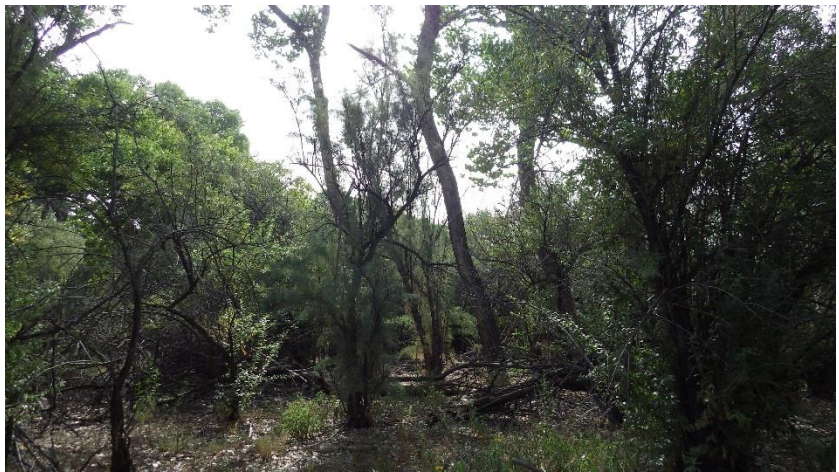
BACA2, view of polygon 5 - cottonwoods, Russian olives and salt cedars. Taken facing 176 degrees.

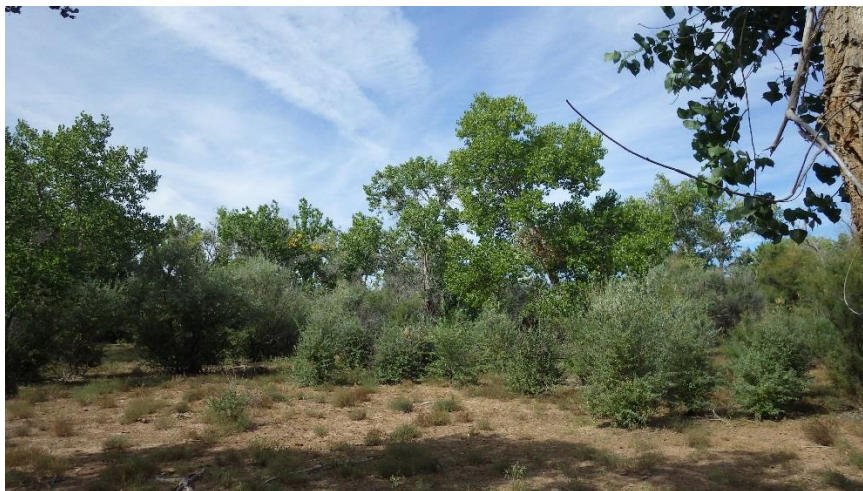
BACA3, view of polygon 1. Taken facing 265 degrees.

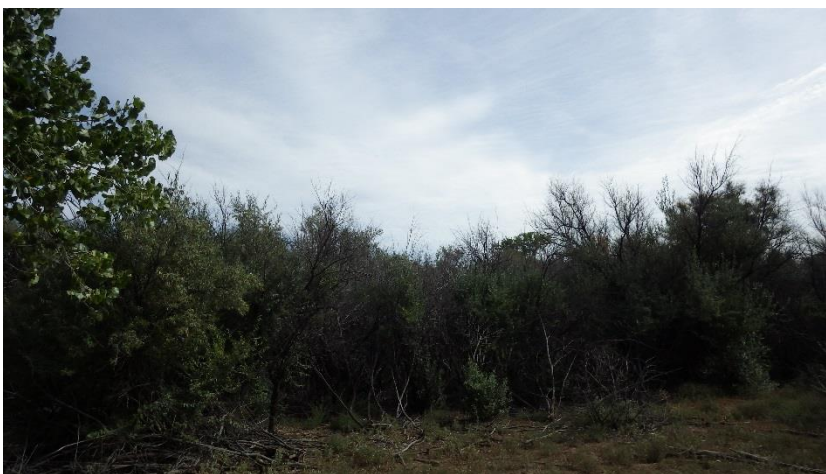
BACA3, view of polygon 2.
Taken facing 160 degrees.

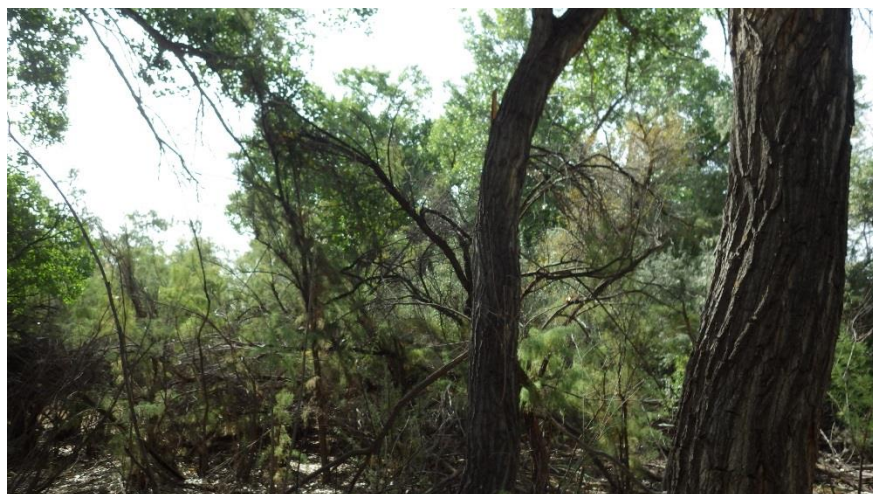
BACA4, view of polygon 4.
Taken facing 160 degrees.

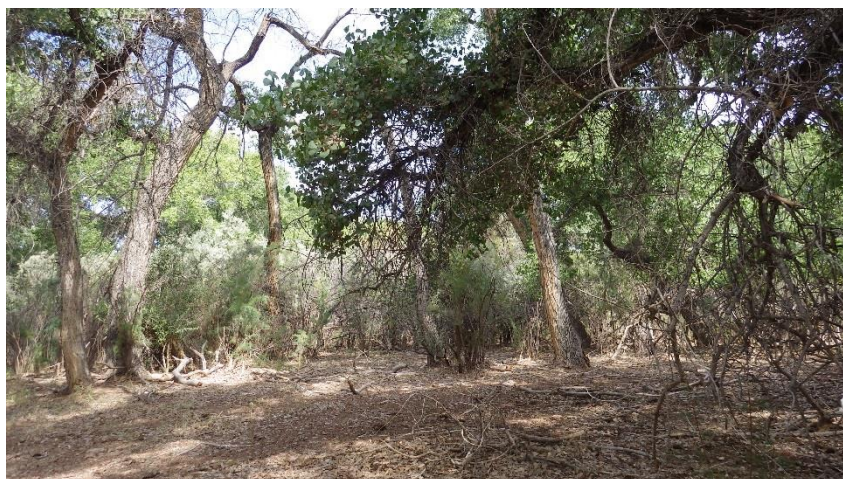
BACA5, view of polygon 5.
Taken facing 322 degrees.

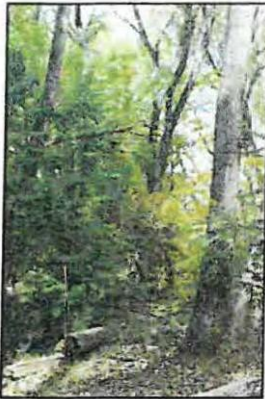
Type 1 - High Structure Forest with a well-developed understory.

Tall mature to intermediate-aged trees (>5 m [>15 feet]) with canopy covering >25% of the area of the community (polygon) and understory layer (0-5 m [0-15 feet]) covering >25% of the area of the community (polygon). Substantial foliage is in all height layers. (This type incorporates Hink and Ohmart structure types 1 and 3.) Photograph on Gila River by Y. Chauvin, 2012.

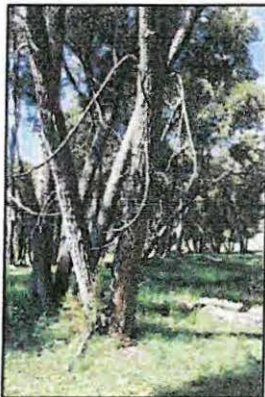
Type 2 - Low Structure Forest with little or no understory.

Tall mature to intermediate-aged trees (>5 m [>15 feet]) with canopy covering >25% of the area of the community (polygon) and understory layer (1-5 m [3-15 feet]) covering <25% of the area of the community (polygon). Majority of foliage is over 5 m (15 feet) above the ground. (This type incorporates Hink and Ohmart structure types 2 and 4.) Photograph on Diamond Creek by Y. Chauvin, 2012.

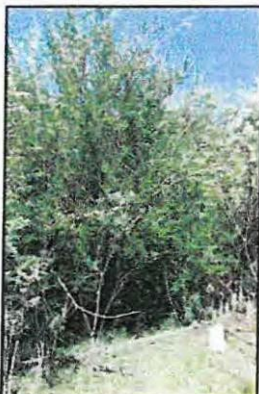
Type 5 - Tall Shrub Stands.

Young tree and shrub layer only (15-5 m [4.5-15 feet]) covering >25% of the area of the community (polygon). Stands dominated by tall shrubs and young trees, may include herbaceous vegetation underneath the woody vegetation. Photograph on San Francisco River by Y. Chauvin, 2012.
