**ESTANCIA BASIN WATERSHED HEALTH AND MONITORING PROJECT:
2009 ANNUAL REPORT**

**ESTANCIA BASIN WATERSHED HEALTH, RESTORATION AND MONITORING
STEERING COMMITTEE**

March 2010

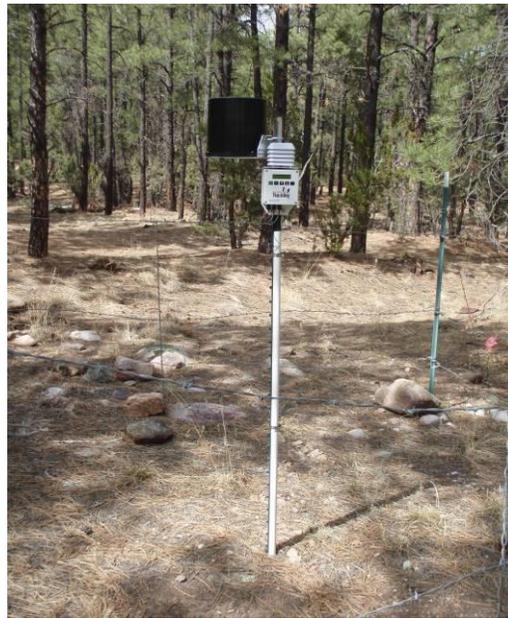
Figure 2.1. WatchDog weather station at the Westponderosa pine site.

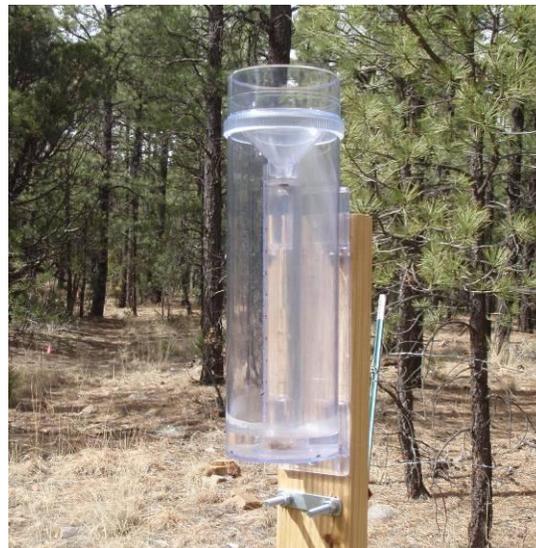
Figure 2.2. Graduated rain gauges are used for backup in the case of failure from one of the WatchDog weather stations.

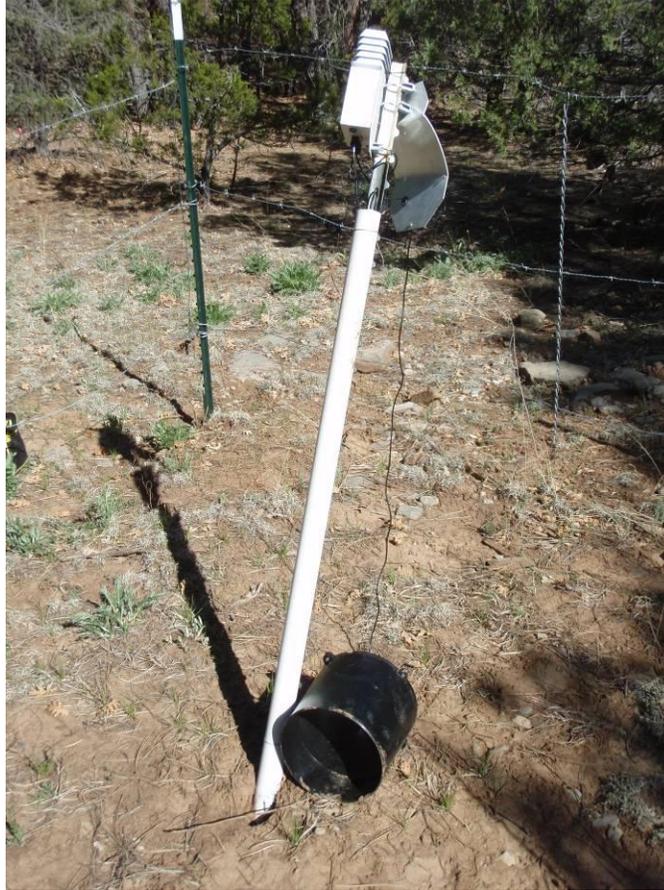
Figure 2.5. Photo taken in April 2009 showing initial bear damage caused to the WatchDog station.

Precipitation was not recorded at the Chilili ponderosa sites on either WatchDog weather station from sometime in December 2008 until November 4, 2009. However, the graduate cylinders that serve as a backups to the WatchDog stations recorded the precipitation events during this period, but only on a monthly basis (not daily), which makes it difficult to analyze flow events. The likely cause of this malfunction was due to black bear (*Ursus americanus*) damage, which occurred throughout 2009. The bear activity resulted in one of the WatchDog rain buckets being removed from the station and subsequently needing replacement (Figure 2.5). Bear activity also managed to unplug the other rain bucket from the unit, causing no precipitation to be recorded. This precipitation bucket, however, was functional once plugged back into the unit.

In order to prevent future damage from bear activity at this site, an electric fence was built around one of the stations during summer 2009 with a “dummy” fence set up around the other (Figure 2.6). Unfortunately, the dummy fence failed to keep a bear out of the station, and sometime in the fall the rain gauge was once again disturbed (Figure 2.7). To further protect the rain gauges, the dummy fence will be equipped with a charging unit in spring 2010 once purchased and should prevent any further damage to the WatchDog stations.

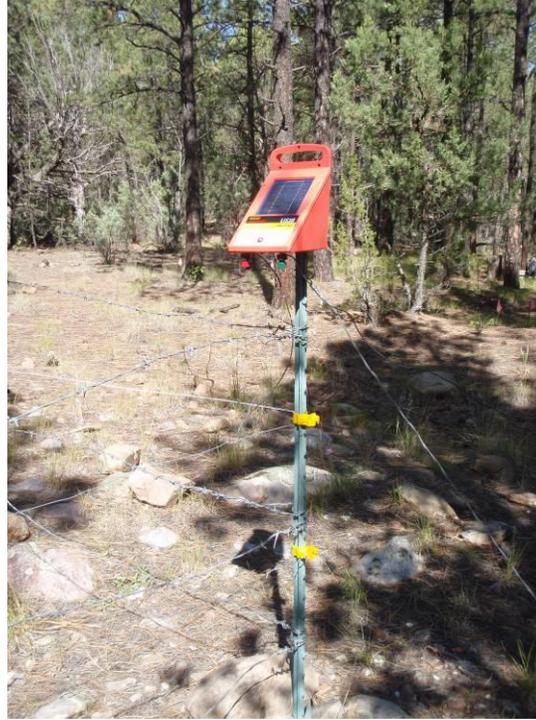
Figure 2.6. Charging station for the electric fence constructed around the WatchDog station at the Chilili ponderosa pine study site in 2009 to combat the bear problems.

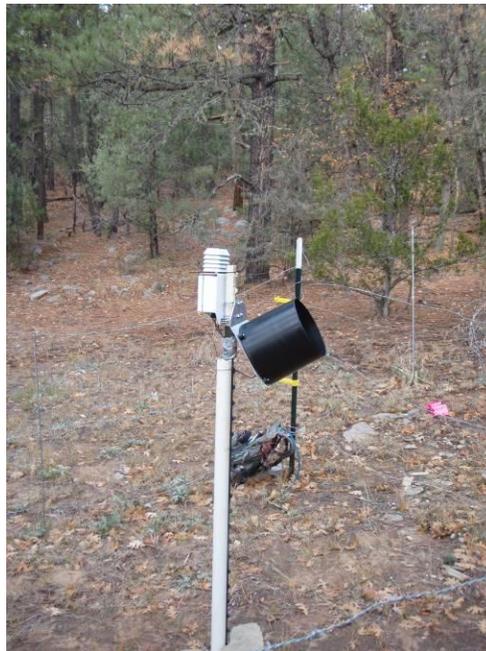
Figure 2.7. Photo taken October 27, 2009, at the Chilili ponderosa pine site showing bear damage to the precipitation bucket causing precipitation not to be recorded.

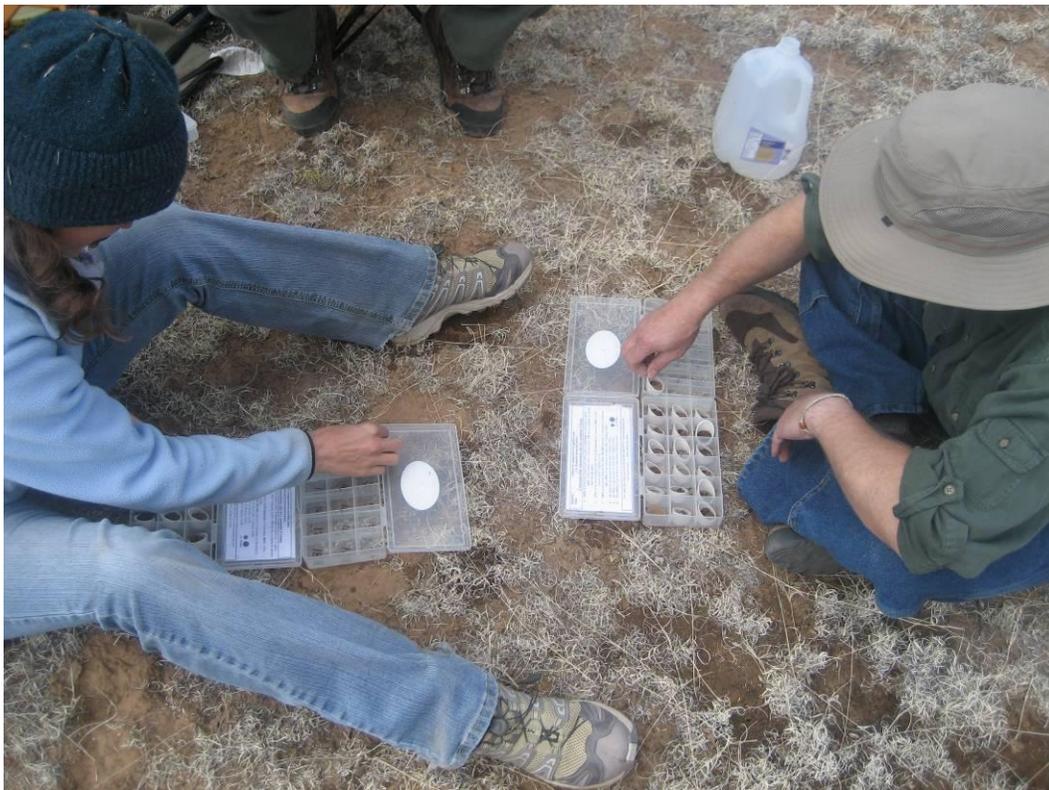
Figure 2.18. Soil stability test in use on the study sites.

Soil surface stability was measured and scored in May 2009 using the Soil Stability Test Kits developed by the USDA Agricultural Resource Service (Herrick et al. 2005) (Figure 2.18). Further details of the measurement methods and a review of the literature can be found in the 2008 Monitoring Plan (SWCA 2008). Figure 2.19 provides average soil surface stability scores for each of the eight subplots representing each of the vegetation and soils sampling plots from the four sites (Chilili, Kelly, Vigil, and Wester). Scores are partitioned by subplot and overstory vegetation canopy type. Figure 2.20 provides average soil subsurface (1 cm below the soil surface, or -1 cm) stability scores for each of the eight subplots.

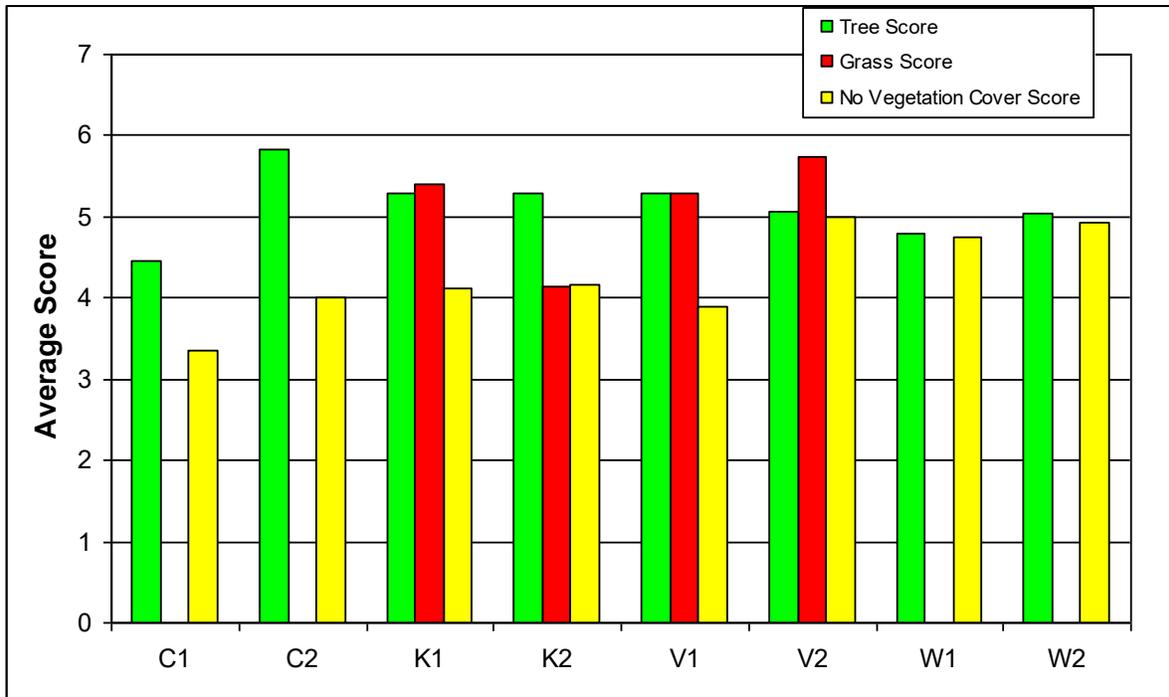
Figure 2.20. Soil subsurface (-1 cm) stability average scores by site, plot, subplot (18 subsamples/subplot), and overstory vegetation canopy type; C= Chilili, K = Kelly, V = Vigil, and W = Wester.

Figure 2.19 and Figure 2.20 display both surface and subsurface stability and show considerable variation in stability scores across plots, subplots, and vegetation types. In general, soils under tree canopies had higher scores than at other sites, which was also the case in 2008. The higher scores here are due largely to the large accumulation of organic matter that occurs underneath tree canopies, especially within the ponderosa pine vegetation type, which can add as much as 2,000 pounds/acre/year of fine fuels (Ffolliott et al. 1968). Most of those soils at the sites measured were underneath litter layers and contained organic material and fungi. Statistical tests will be conducted next year after treatment to see if the restoration treatments have any effect on soil stability scores.

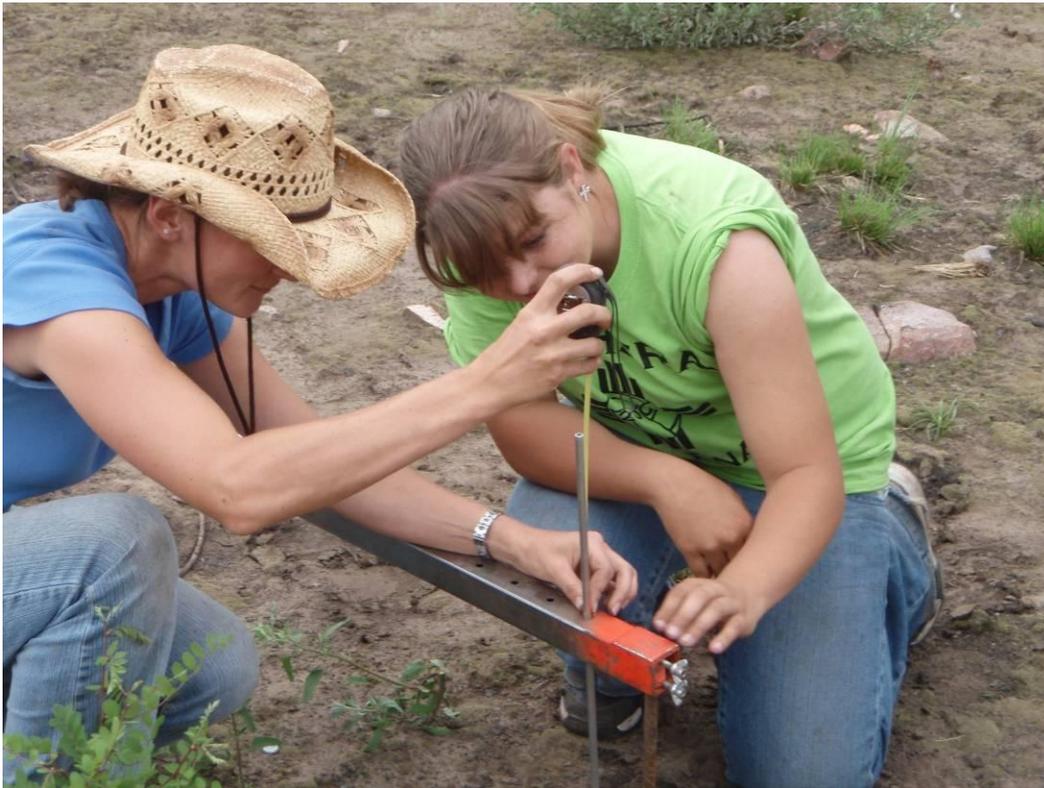
Figure 2.21. Measurement of soil surface topography using a soil movement bridge helps understand the yearly variability associated with soil topography.

Soil movement was monitored using soil movement bridges (called soil erosion bridges in the 2008 report) (Figure 2.21) modeled after White and Loftin (2000). Permanent bridge support posts were installed at consistent, systematically determined, and unbiased locations at one of each of the vegetation and soil subplots for a total of three bridges at each paired plot at all four sites. Please refer to the 2008 Annual Report for detailed monitoring protocols and literature associated with soil movement (SWCA 2009). Figure 2.22 shows the micro-soil topography profile from the Wester ponderosa pine site for both 2008 and 2009. The graph clearly shows the yearly variability associated with soil movement on a plot. The processes of soil erosion and soil deposition can clearly be seen when plotting data from 2008 and 2009. After thinning treatments are completed, post-treatment data will be available to compare with pre-treatment data. These comparisons will allow us to assess the changes in soil movement potentially caused by restoration treatments. Over a series of years, this study will document losses and/or gains to the soil surface profiles at each bridge site and will provide average values for each of the eight plots in this study (Chilili, Kelly, Vigil, and Wester).

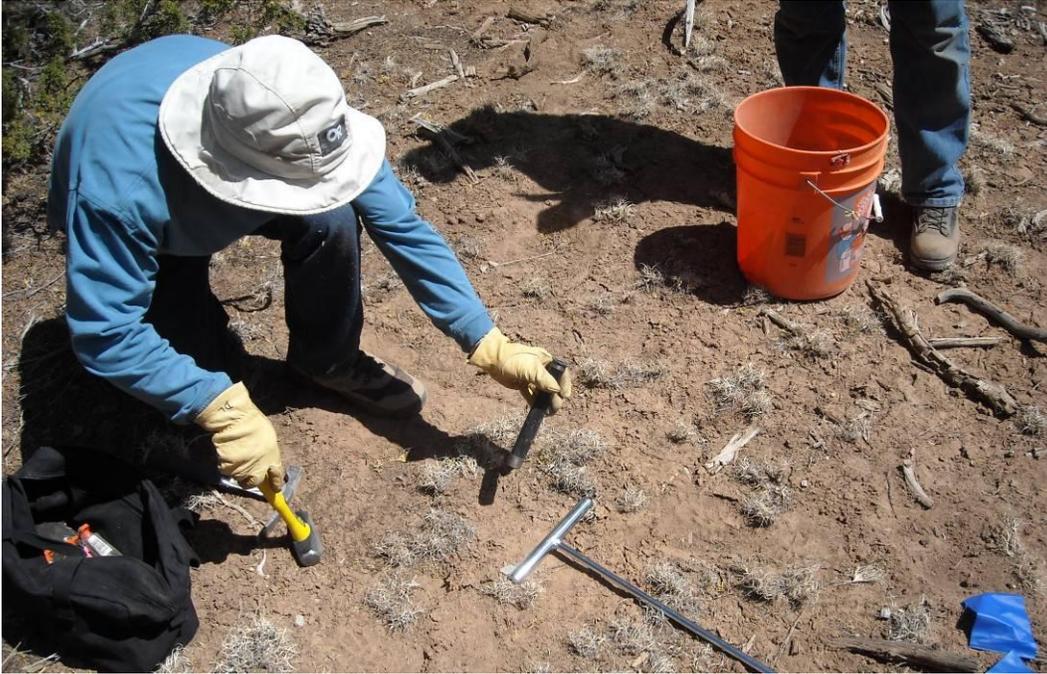
Figure 2.23. Soil cores were taken using an impact corer, shown above, for chemical analysis.

Baseline measurements of soil chemistry were obtained in 2008 and 2009 before thinning treatments at the Kelly, Vigil, and Wester sites; Chilili was not included until the 2009 sampling because this plot had yet to be established. The purpose of taking these measurements is to quantify changes to soil chemistry potentially caused by thinning activities. The methods used in 2008, however, were slightly different than those used in 2009 and can be a reason for any large differences seen between years. The soil samples were obtained using a 4-cm-diameter, 20-cm-deep impact soil corer at the four corners of the three established vegetation plots (Figure 2.23). In 2008 the 12 subsamples were placed in labeled separate bags in order to attempt in house analysis with Cardy soil kits. The variability associated with these kits, however, proved to be too great for reliable results, so the subsamples were combined into one bag for each site and sent to the laboratory for further analysis. In 2009, the collection of the 12 subsamples was combined into the same bag at the time of sampling. These samples were considered to be

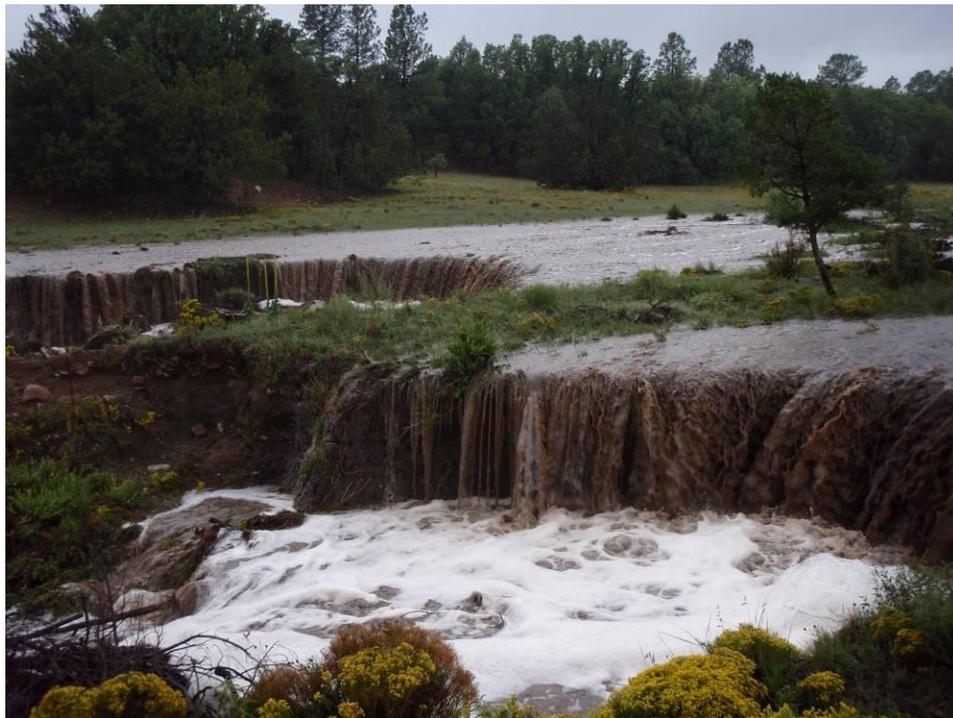
Figure 2.33. The two-day storm event on September 16–17, 2009, caused high flows to occur at the Vigil site, which recorded nearly 2 inches of rain over the course of 36 hours.

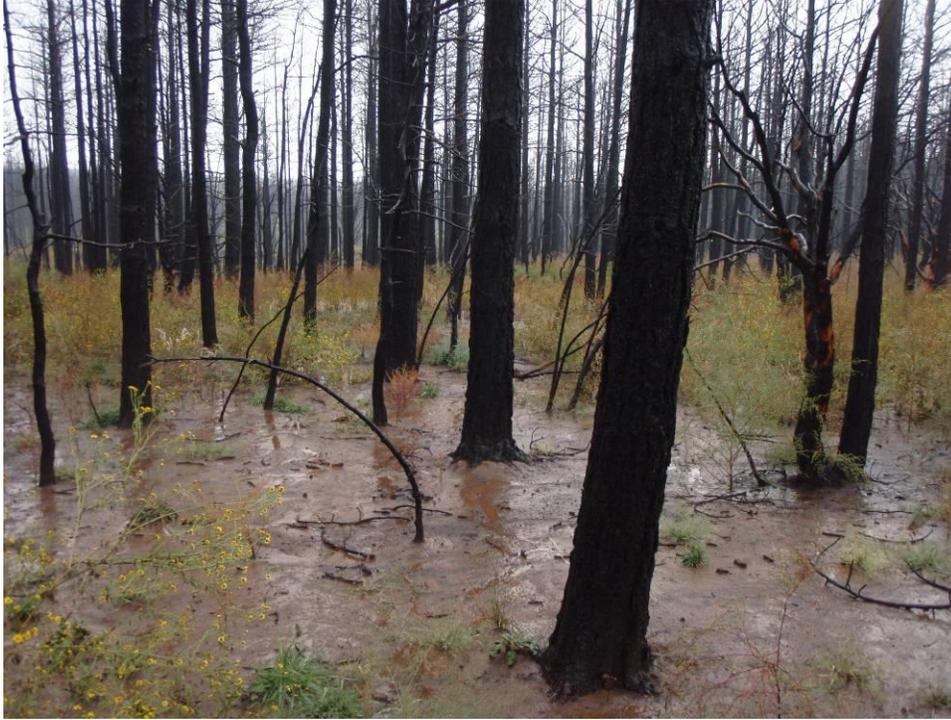
Figure 2.36. Overland flow and erosion occurring at the burned Bouton site, which received more than 1.8 inches of rain on September 16–17, 2009.

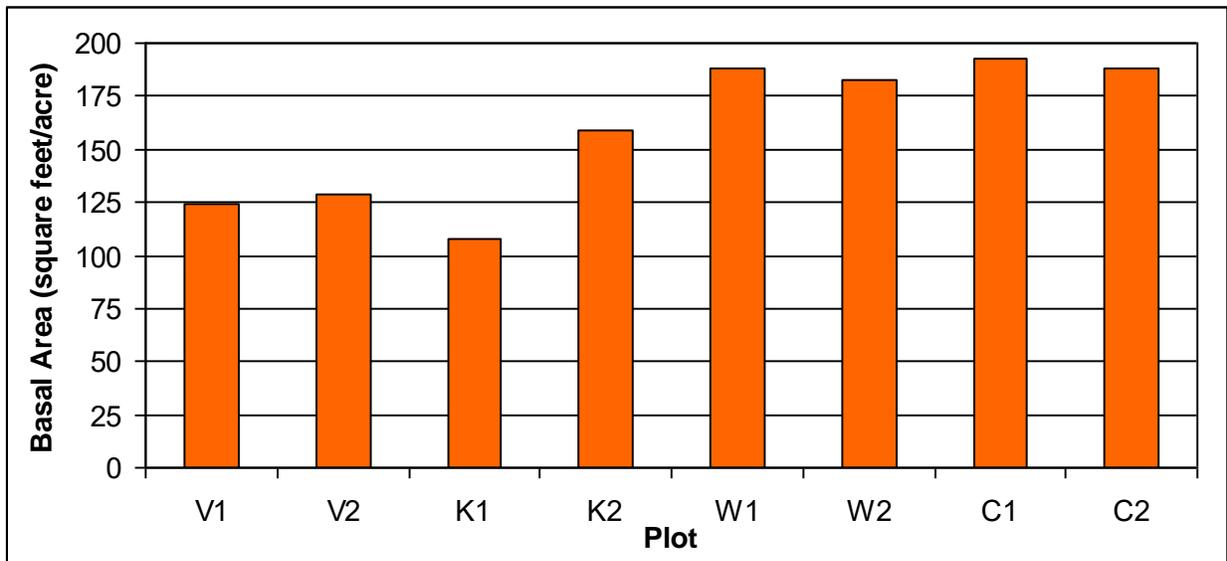
Figure 2.41. Average basal area for each thinning plot for all species of trees combined, measured using the cruisers crutch method; C= Chilili, K = Kelly, V = Vigil, and W = Wester.

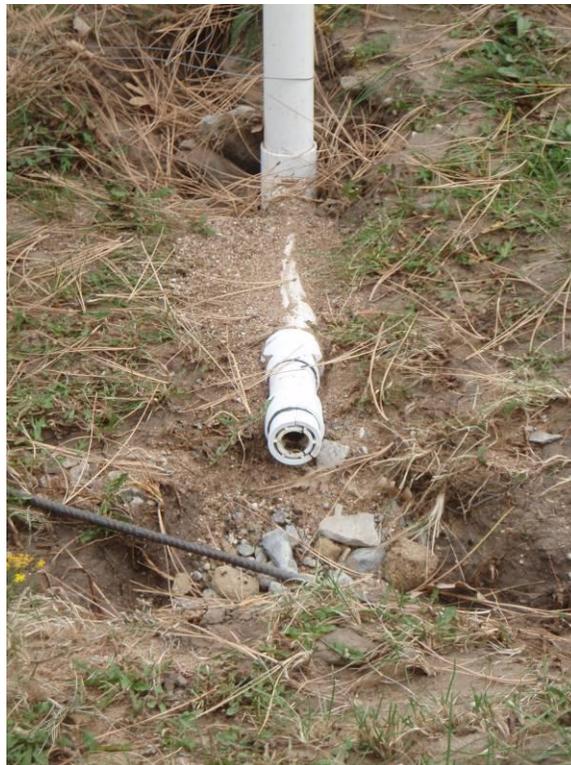
Figure 4.7. Damage to the Chilili piezometer in 2009. Even though the end cap was removed, this piezometer was still able to record flow.
