Grants SE Project 16-12

Post-treatment Monitoring Report

2021

Kathryn R Mahan, Ecological Monitoring Specialist & Alex Makowicki, Ecological Monitoring Technician,
New Mexico Forest and Watershed Restoration Institute
for the Greater Rio Grande Watershed Alliance

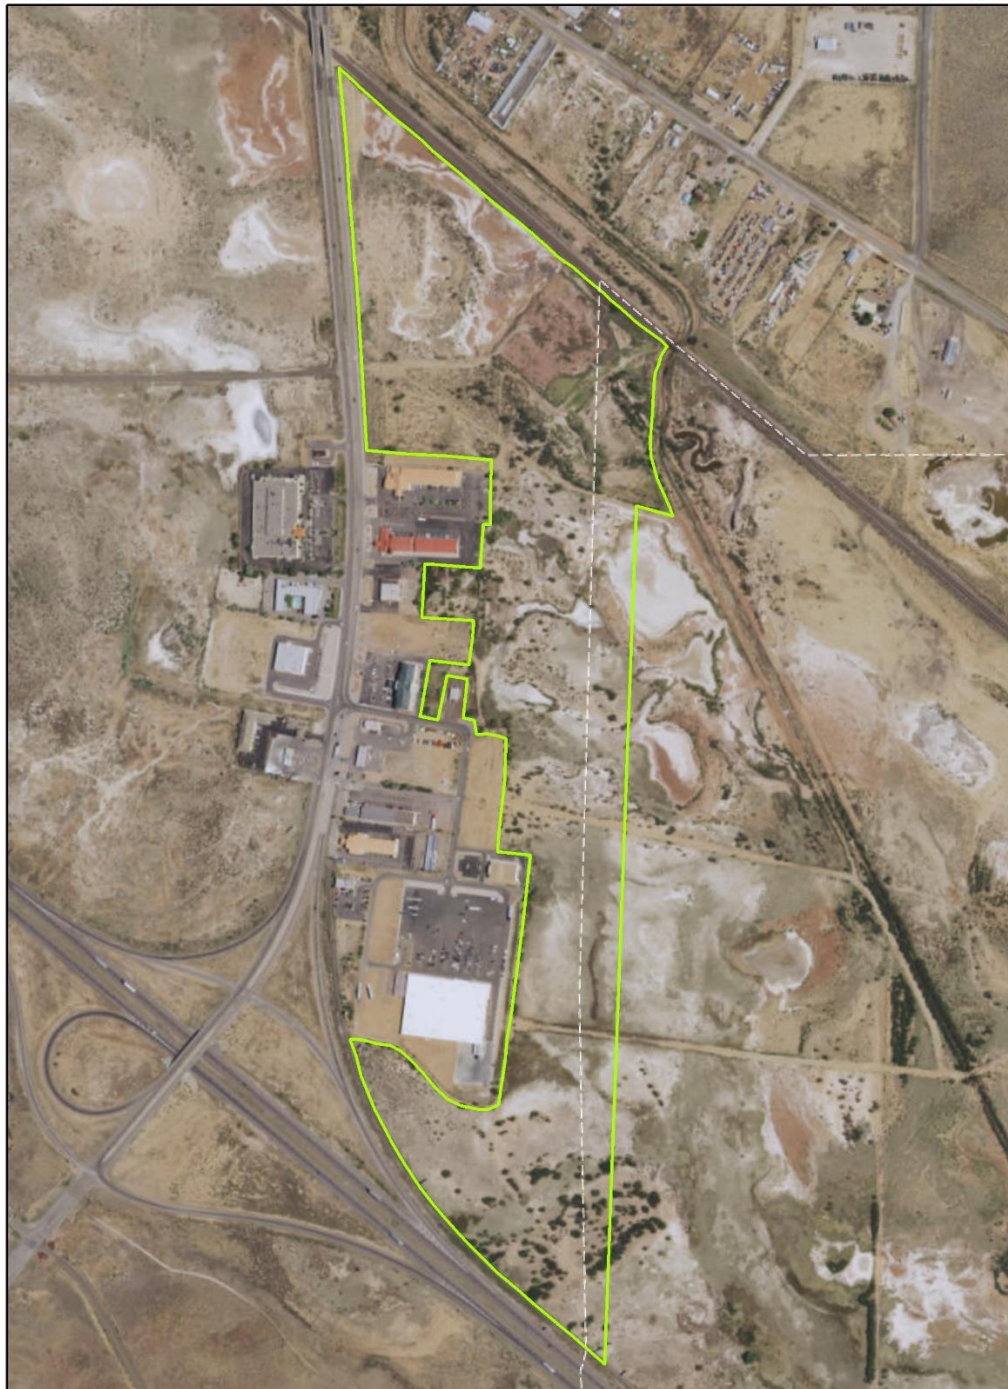
Figure 2. 16-12 Grants project outline.

Access to the project is possible through various point including a frontage road and hotel parking lots. There are multiple landowners, fence lines, roads, powerlines and structures; construction debris and trash were present throughout the site at the time of the site visits. Exotic species observed during the monitoring visit included salt cedar (of all age classes) and *phragmites* reed grasses. Native plants observed included fourwing saltbush, inland saltgrass, dropseed grass, and bush seepweed (*Suaeda nigra*). Species density varied within the project and was especially sparse around the playas/salt flats.

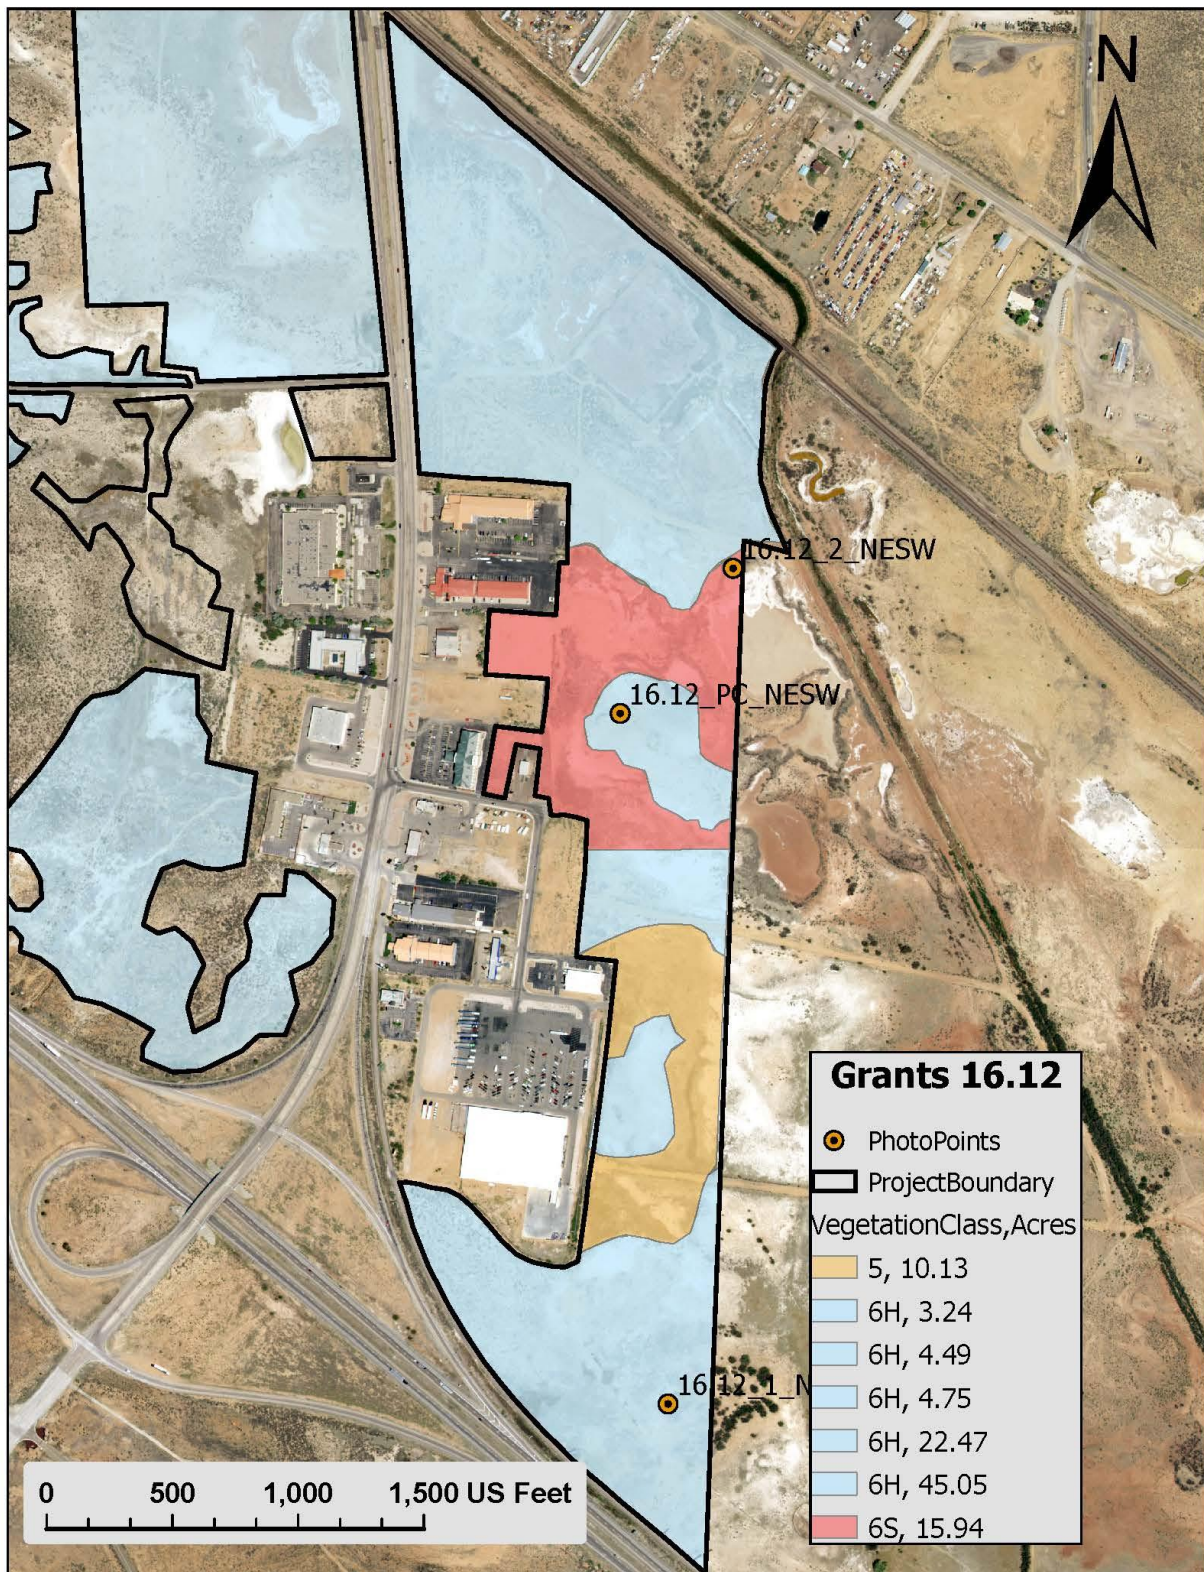
Figure 3. 16.12 Grants project vegetation polygons.

Low scores came in Vegetation Horizontal Structure and Vegetation Vertical Structure due to a lack of vegetation structure diversity. The Vegetation Vertical Structure score dropped in 2021 due to the dominance of herbaceous vegetation on land that was previously dominated by tall shrubs, it should be noted that the loss of some of the tall shrub vegetation structure can be attributed to the removal of invasive woody plants such as Tamarisk and Russian Elm. Overall, the site received a “D” or “Poor”, a 1.5 out of 4

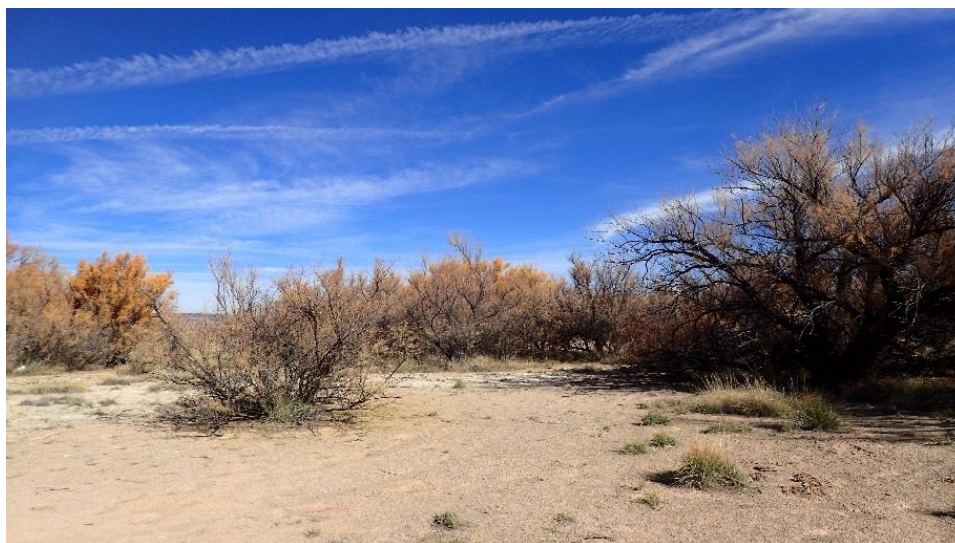
2016: 16.12_1_N.
North view inside of
polygon 1.

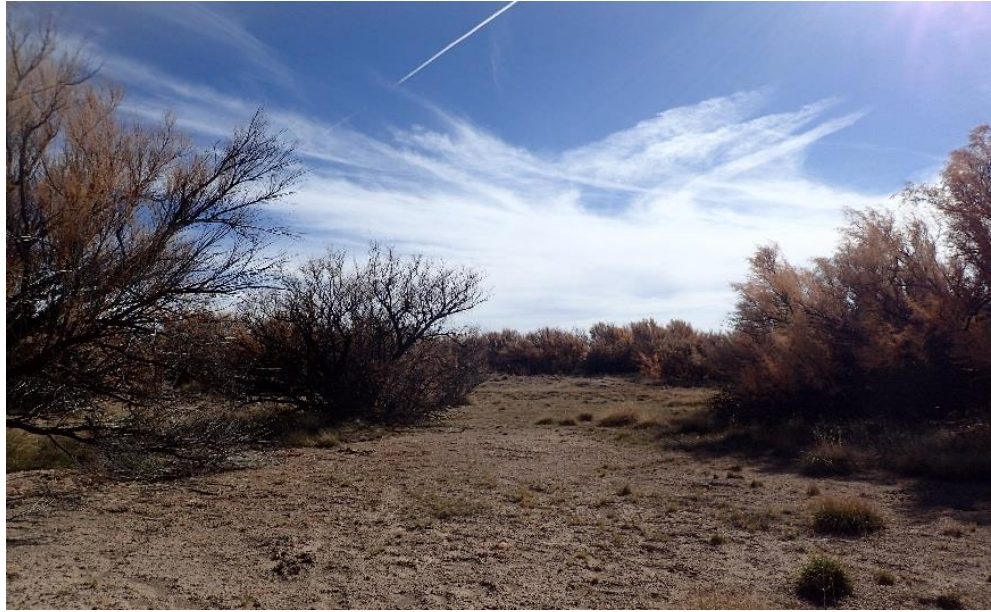
2016:
16.12_1_E. East
view inside of
polygon 1.

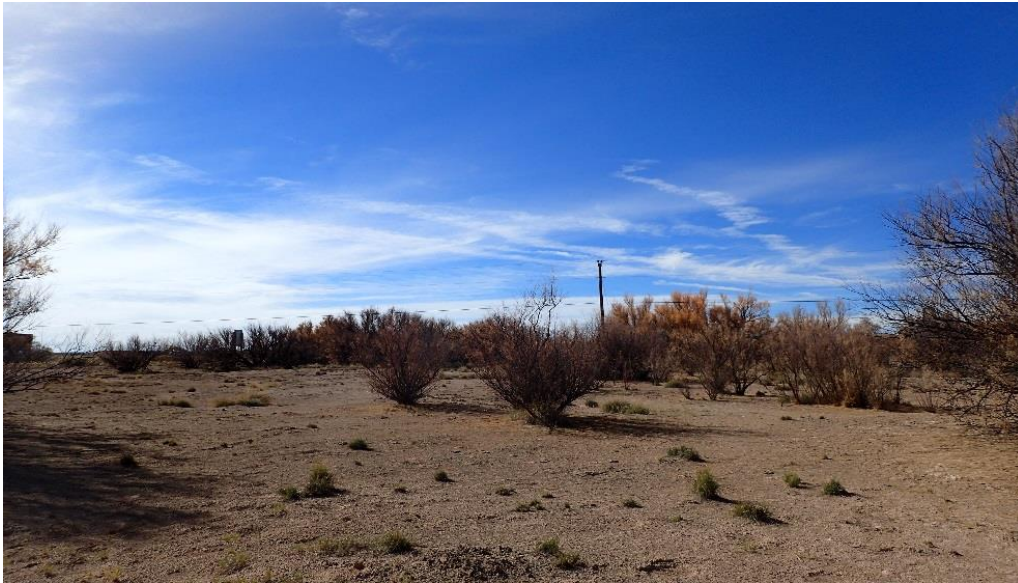
2016: 16.12_1_S.
South view inside of
polygon 1.

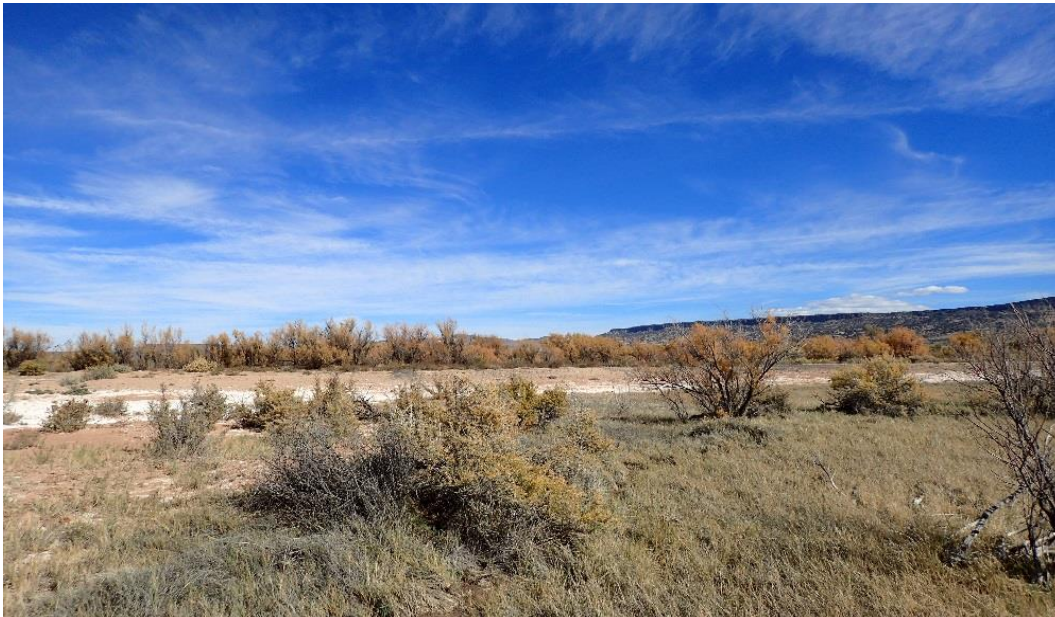
2016:
16.12_2_N
. North
view from
polygon 1,
looking
into
polygon 3.
