# Lagunitas/ Guicu Creek Project 19-04

Pre-treatment Monitoring Report

2020/2021

New Mexico Forest and Watershed Restoration Institute  
for the Greater Rio Grande Watershed Alliance

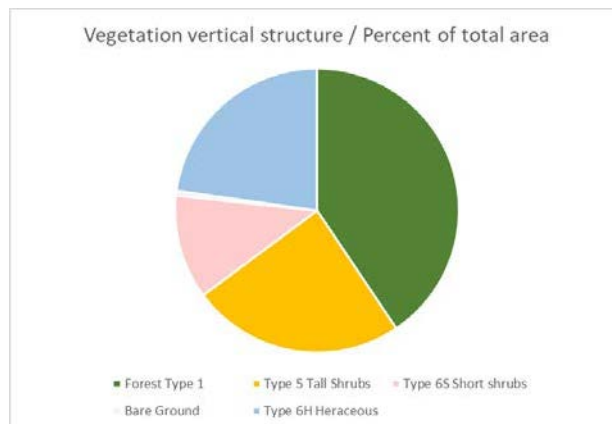
Figure 3. Vegetation Structure Type percents for 19-04.

Vegetation Structure Type	Acres	Percent of Total Area
Forest Type 1	4.02	40.58%
Type 5 Tall Shrubs	2.40	24.25%
Type 6S Short shrubs	1.17	11.85%
Bare Ground	0.05	0.53%
Type 6H Heraceous	2.25	22.79%

19-04 Lagunitas GuicuAcequia was classified according to modified Hink and Ohmart defined classes. The acreage for each cover type are provided below keeping in mind that the total acreage for the treatment acres was 9.89 acres.

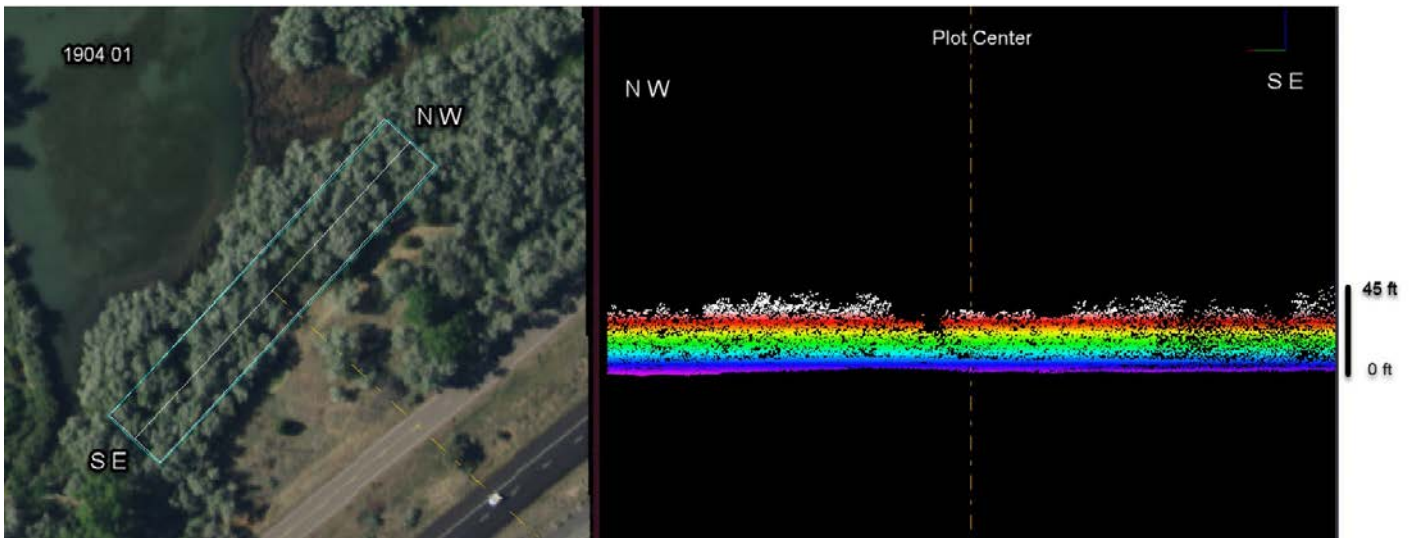
1904 – 1 LiDAR Profile

These LiDAR transects were drawn using the photo point in the center of a 20 x 130 meter window (65 x 426 feet). The transects were drawn north to south, and the aerial view of the areas is on the left in the images below. On the right is the LiDAR profile. The scale on the far right of each image represents the vertical height, and is marked from 0 feet (ground level) to the highest object height recorded in each transect.

These transects provide a visual representation of the canopy cover and vegetation structure present on site.
