San Cristobal Project 20-01

Pre-treatment Monitoring Report

2020/2021

20-01 San Cristobal Creek

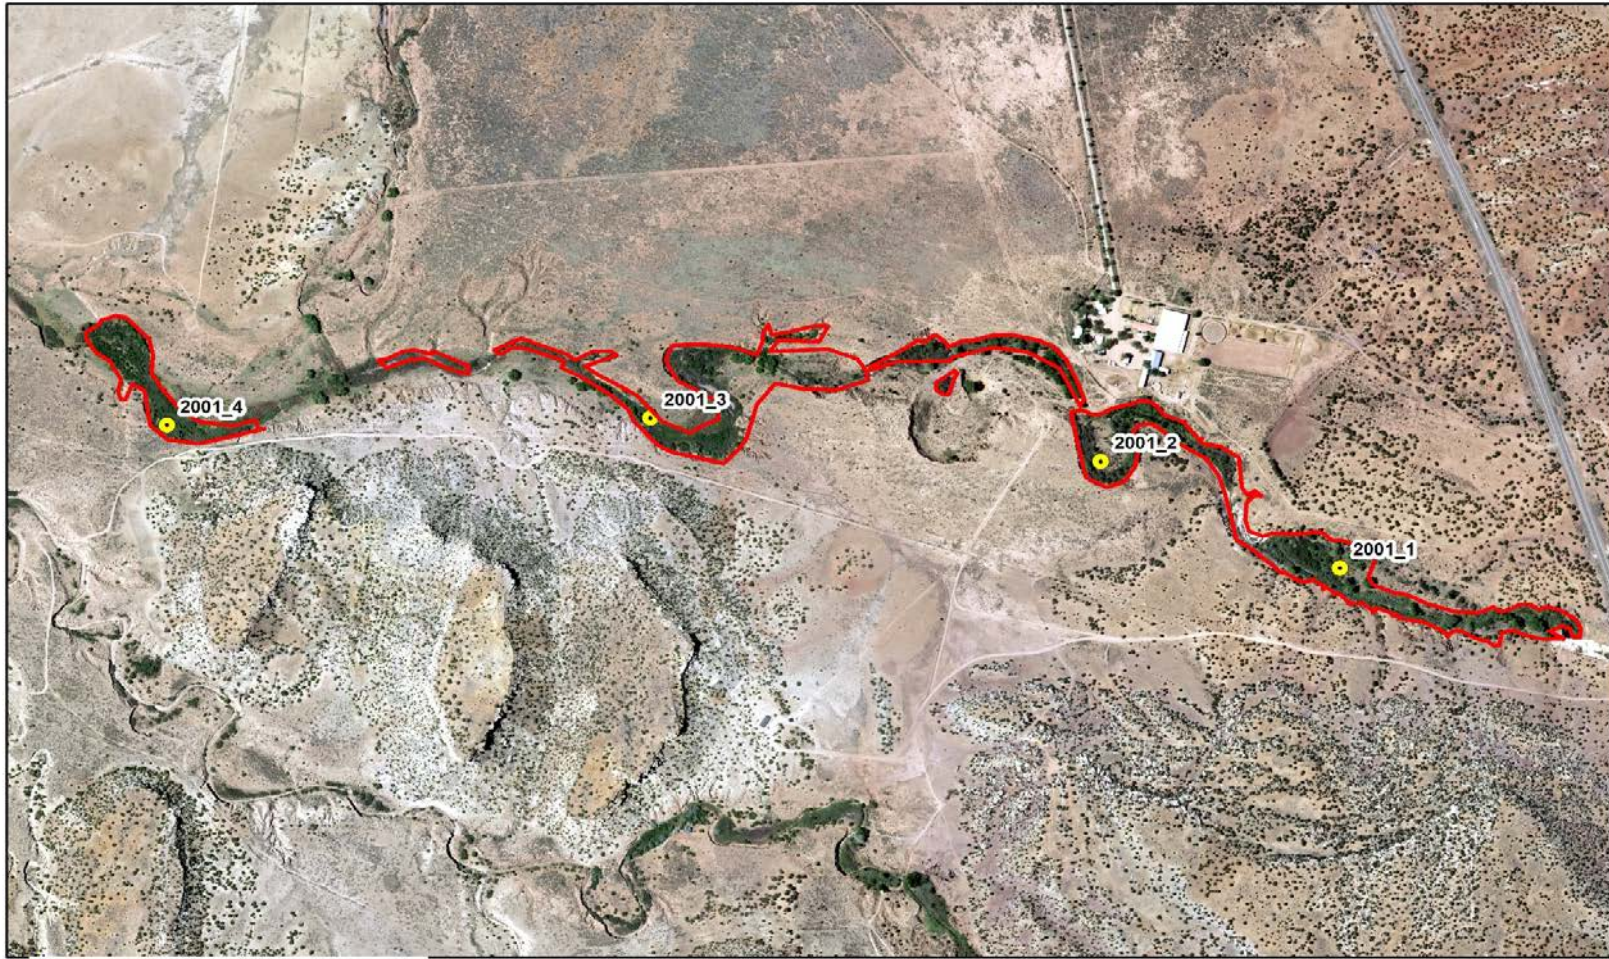
Figure 2. 20-01 San Cristobal project outline.

20_01 San Cristobal Creek 38.5 Acres

Photo Point Location (LiDAR Profiles)

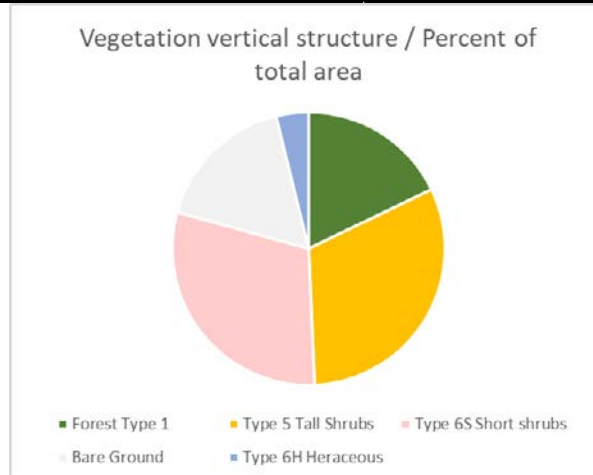
Figure 3. Vegetation Structure Type percents for 20-01.

Vegetation Structure Type	Percent of Total Area
Forest Type 1	17.87%
Type 5 Tall Shrubs	31.43%
Type 6S Short shrubs	30.01%
Bare Ground	16.85%
Type 6H Heraceous	3.84%

20-01 San Cristobal Creek was classified according to modified Hink and Ohmart defined classes. The acreage for each cover type are provided below keeping in mind that the total acreage for the treatment acres was 38.5 acres.

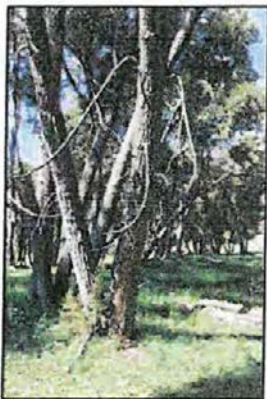
Type 2 –Low Structure Forest with little or no understory.

Tall mature to intermediate-aged trees (>5 m [>15 feet]) with canopy covering >25% of the area of the community (polygon) and understory layer (1-5 m [3-15 feet]) covering <25% of the area of the community (polygon). Majority of foliage is over 5 m (15 feet) above the ground. (This type incorporates Hink and Ohmart structure types 2 and 4.) Photograph on Diamond Creek by Y. Chauvin, 2012.

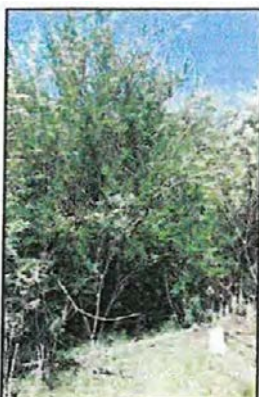
Type 5 –Tall Shrub Stands.

Young tree and shrub layer only (15-5 m [4.5-15 feet]) covering >25% of the area of the community (polygon). Stands dominated by tall shrubs and young trees, may include herbaceous vegetation underneath the woody vegetation. Photograph on San Francisco River by Y. Chauvin, 2012.

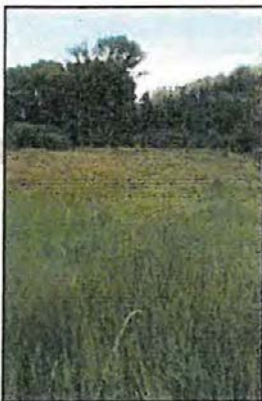
Type 6W- Herbaceous Wetland.

Herbaceous wetland vegetation covering >10% of the area of the community (polygon). Stands dominated by obligate wetland herbaceous species. Woody species absent, or <10% cover. Photograph of *Carex nebrascensis* meadow on upper Rio Santa Barbara by Y. Chauvin, 2009.

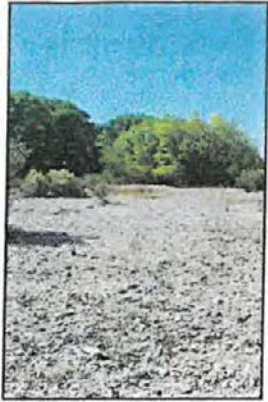
Type 7–Sparse Vegetation/Bare Ground.

Bare ground, may include sparse woody or herbaceous vegetation, but total vegetation cover <10%. May be natural in origin (cobble bars) or anthropogenic in origin (graded or plowed earth) Photograph on Lower Gila River by Y. Chauvin,2012.
