Estancia Basin Watershed Health Restoration Monitoring Study SWCA Progress Report for mid-fall 2008, October 16 – November 14, 2008

Prepared by David Lightfoot, SWCA Environmental Consultants Submitted to the Estancia Basin Watershed Health, Restoration, and Monitoring Steering Committee

November 14, 2008

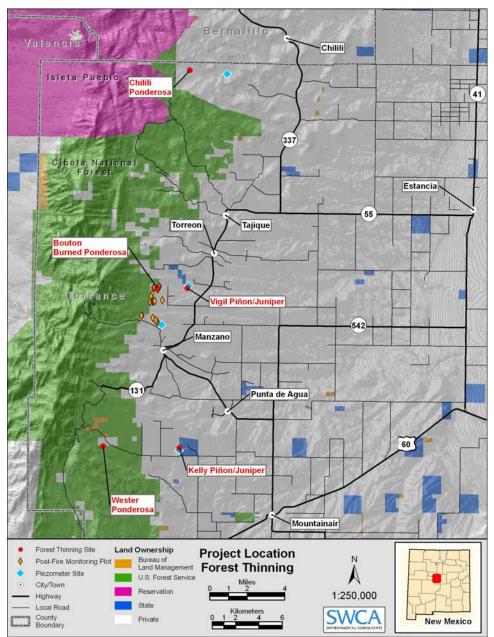
Forest Thinning, Post-Fire Monitoring and Water Resource Monitoring Project Sites

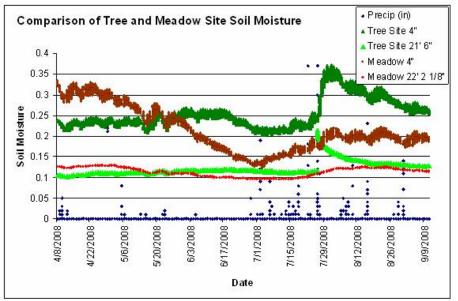
Soil moisture is continually being measured at a variety of depths in both a meadow and in a forested area. We can monitor the soil moisture variations after a rainfall event at both sites.

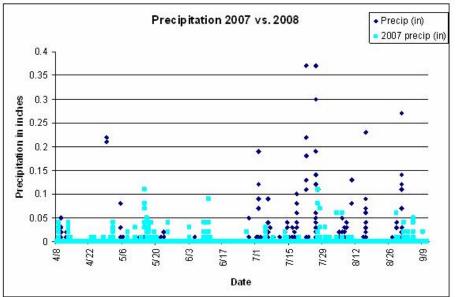
It is now possible to compare atmospheric readings between years, for example, the difference between precipitation in 2007 and 2008. This comparison will be more valuable as multiple years of data are collected.

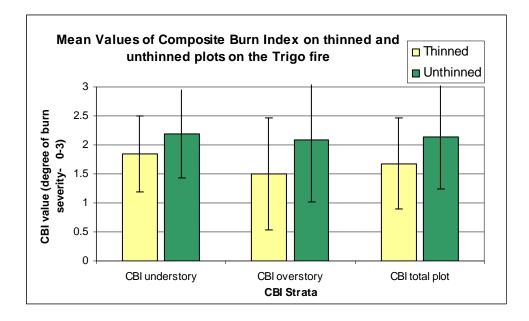
The following chart shows the average CBI values across all plots for understory, overstory and total plot. The data is split into those plots that had been thinned prior to the fire and those that were un-thinned.

It is clear from the chart that plots that were burned in thinned areas had lower CBI values (lower burn severity) than plots in un-thinned areas for both the understory and overstory strata as well as total plot average. On average, plots in thinned areas experienced at most a moderate severity burn (1.5-2.5 CBI), with most overstory strata experiencing only a low severity impact (0.5-1.5) from the fire. Un-thinned plots experienced on average moderate severity (1.5-2.5) burn across all strata based on the strata means. It should be emphasized however that there was significant range in values for all data sets analyzed, as reflected by the standard deviation bars; un-thinned plots extended into the high severity burn class (2.5-3.0) while thinned plots remained within the moderate severity range (1.5-2.5).

When comparing strata amongst thinned areas the charts show that the burn severity was higher for understory parameters than overstory parameters, suggesting the fire remained predominantly on the surface in thinned areas with limited transmission and spread through the canopy due possibly to a lack of ladder fuels and greater crown spacing. Damage to the understory and overstory was relatively uniform in the un-thinned plots showing that the fire transmitted through active crown fire engaging both surface and canopy fuels.

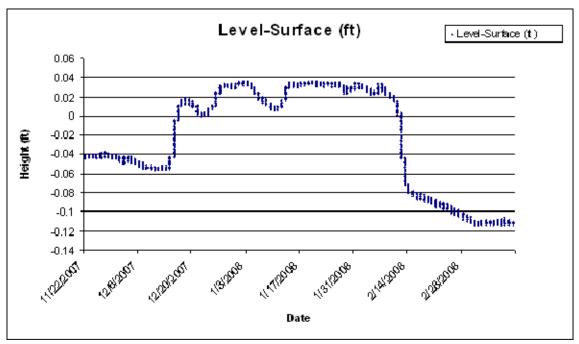
This graph shows changes in height in the Kelly 2 flume. 0 feet is the baseline within the flume, and heights above it indicate flow through the flume.

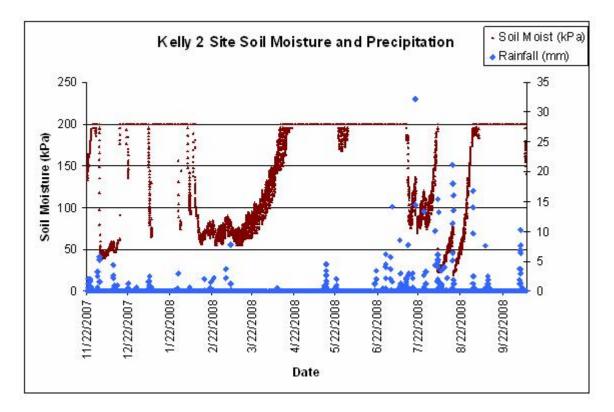
At each thinning site, Watchdog weather stations have been installed allowing monitoring of how soil moisture changes after rainfall events.
