San Cristobal Drainage Project 15.21

Post-treatment Monitoring Report

2021

Prepared by Kathryn R Mahan, Monitoring Program Manager and Alex Makowicki, Ecological Monitoring Technician, New Mexico Forest and Watershed Restoration Institute for the Greater Rio Grande Watershed Alliance

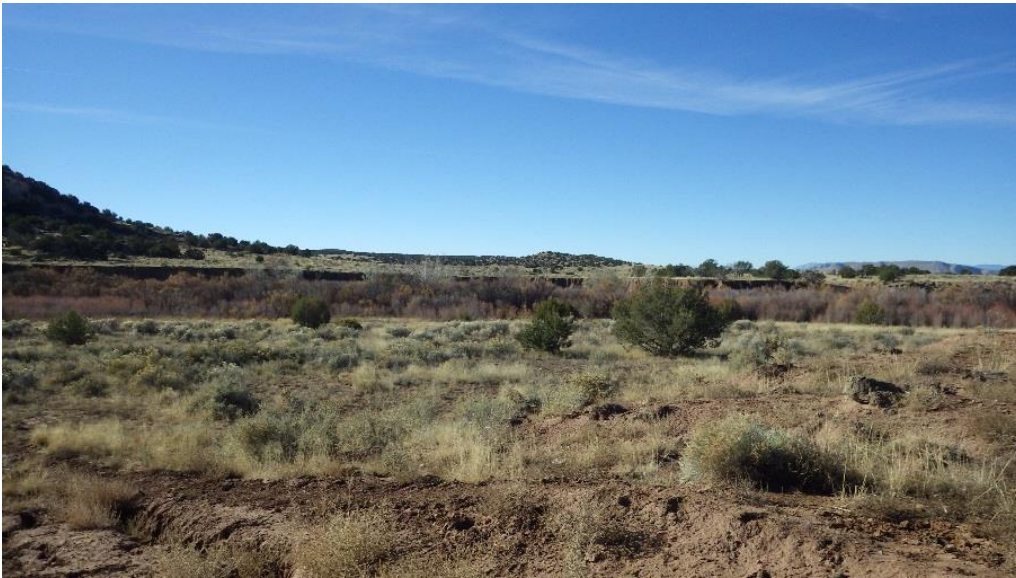
2015: SC1, view of drainage. Taken facing 184 degrees.

2021:
15.21_1_184Deg
_184Deg_S

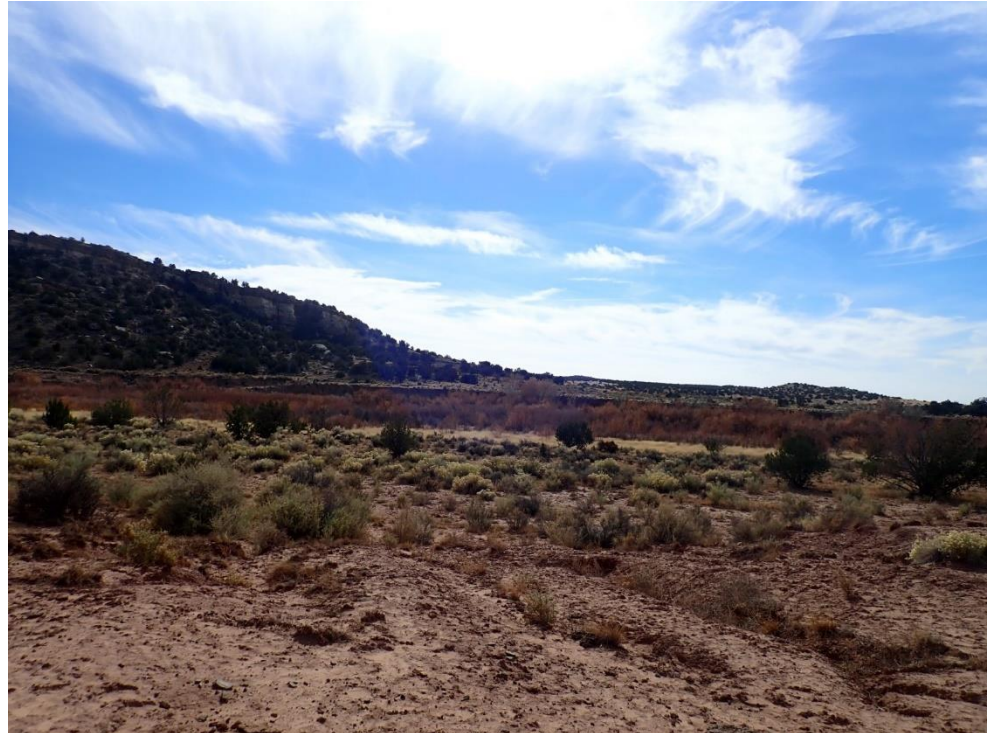
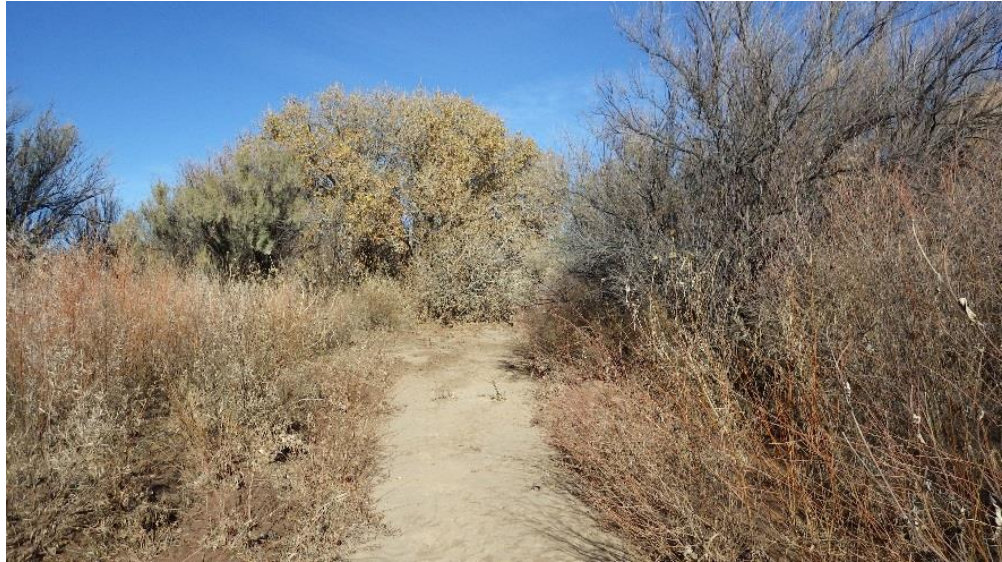
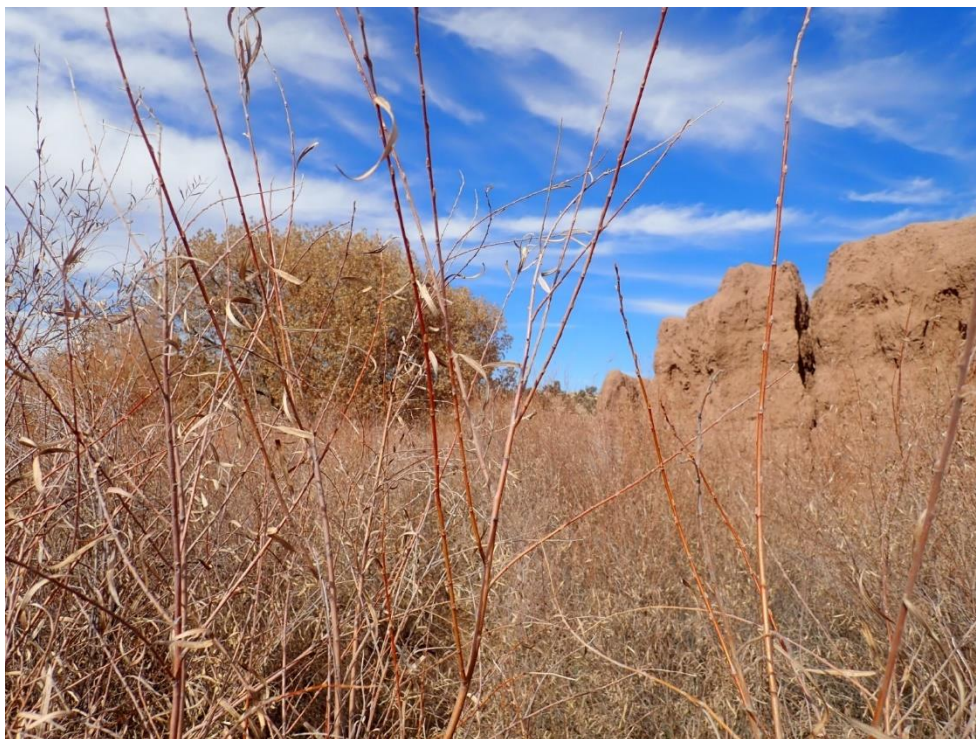
2015: SC2,
view up “arm”
of project.
Taken facing
320 degrees.

2021:
15.21_2_320Deg
_320Deg_N

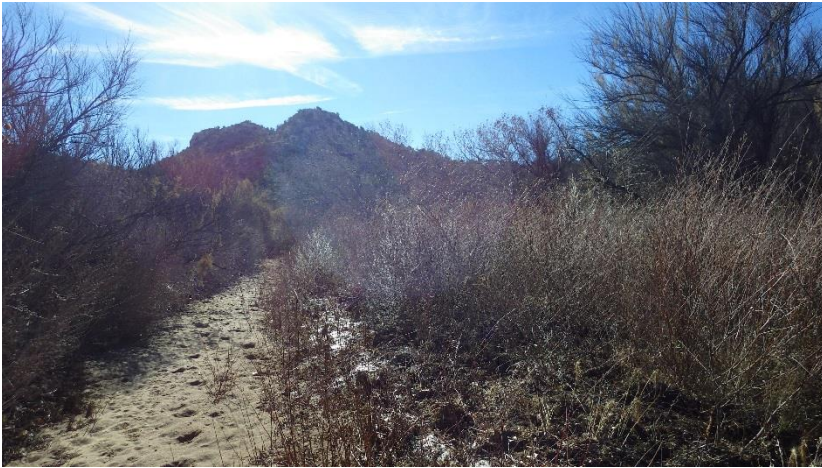
2015: SC2, view toward main body of project. Taken facing 148 degrees.

No matching photo could be found.

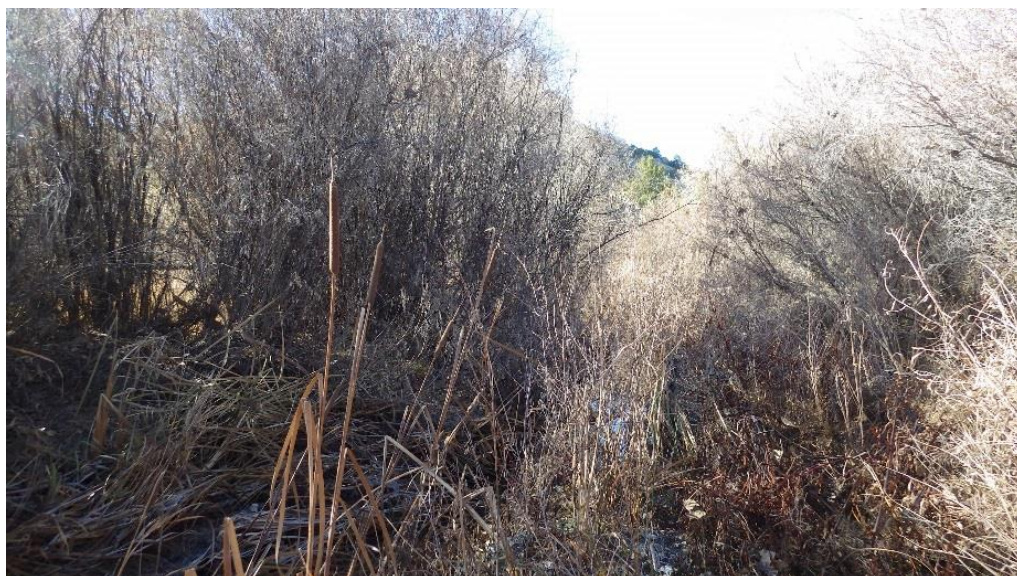
2015: SC3, view of drainage bottom. Taken facing 140 degrees.

2021:
15.21_3
_148De
g_148D
eg_S

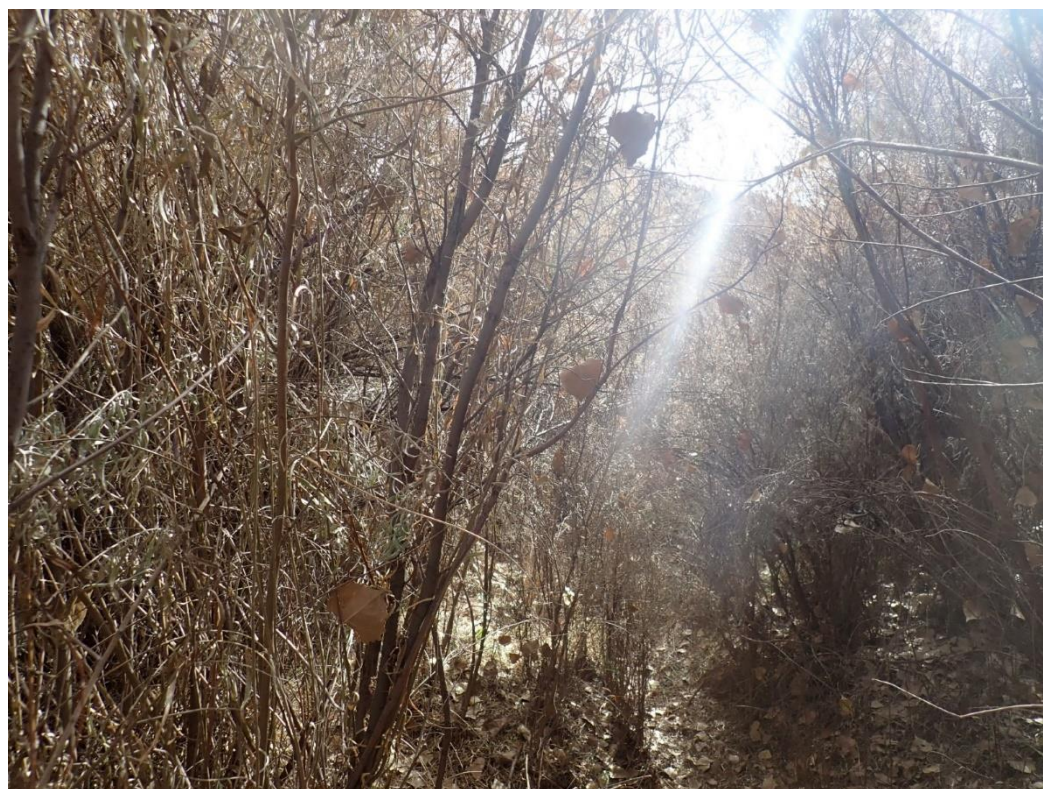
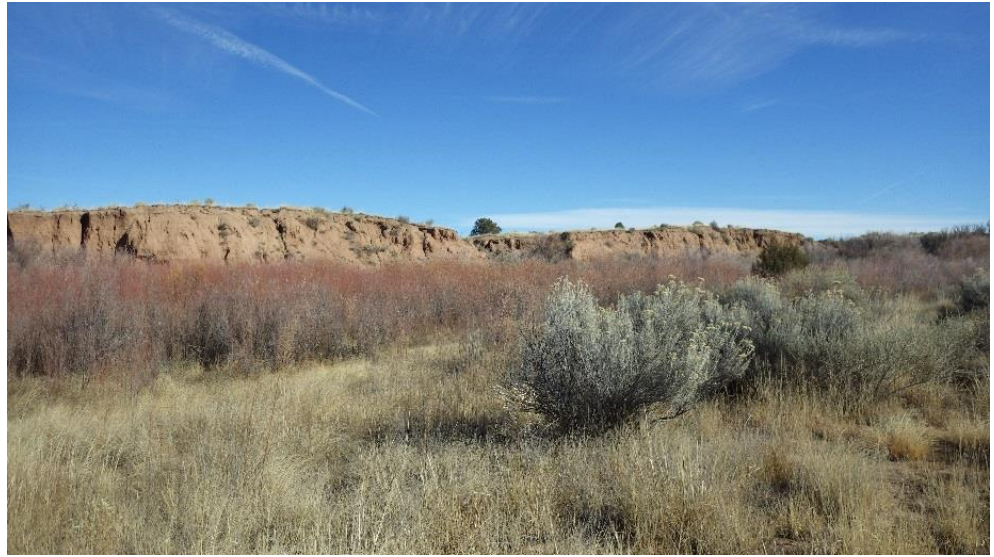
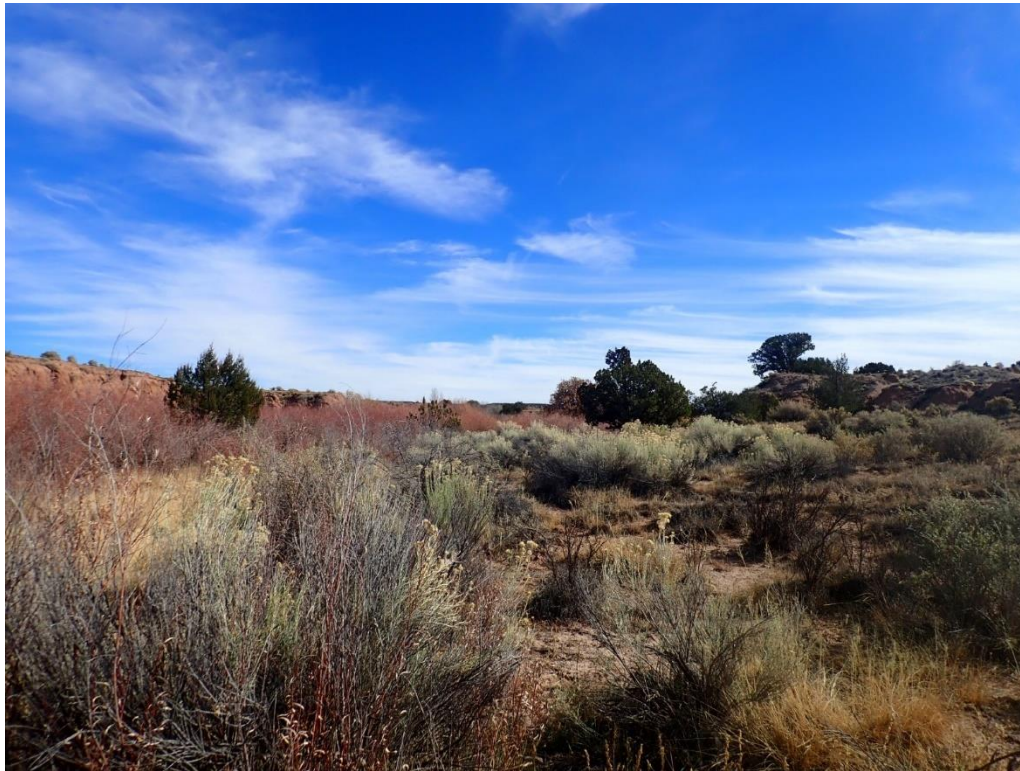
2015: SC4, view of fork. Taken facing 80 degrees.

2021:
15.21_4_80Deg
_80Deg_E

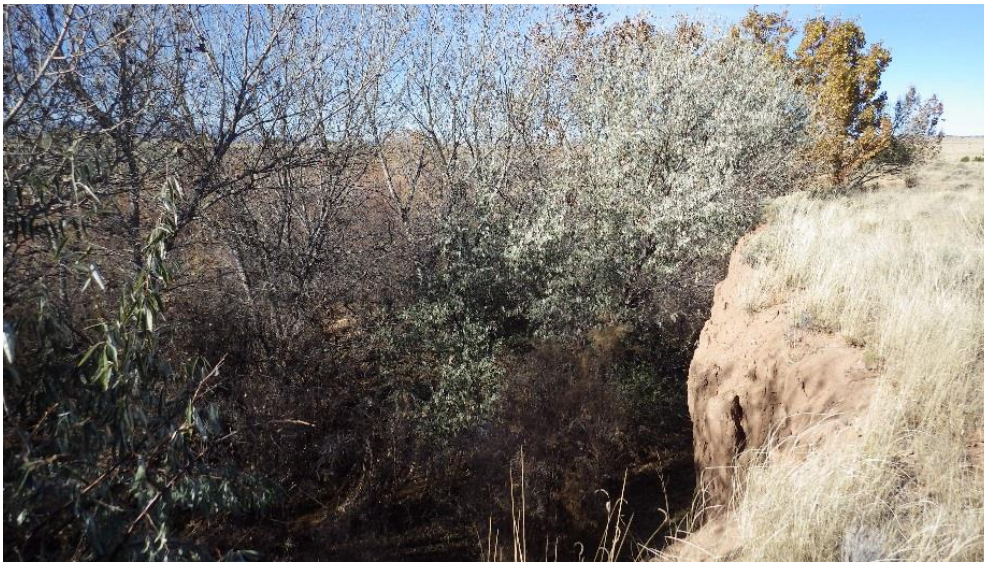
2015: SC5, view of San Cristobal drainage bend – cottonwood, Russian olive, and erosion. Taken facing 285 degrees.

2021:
15.21_5_285Deg
_285Deg_W

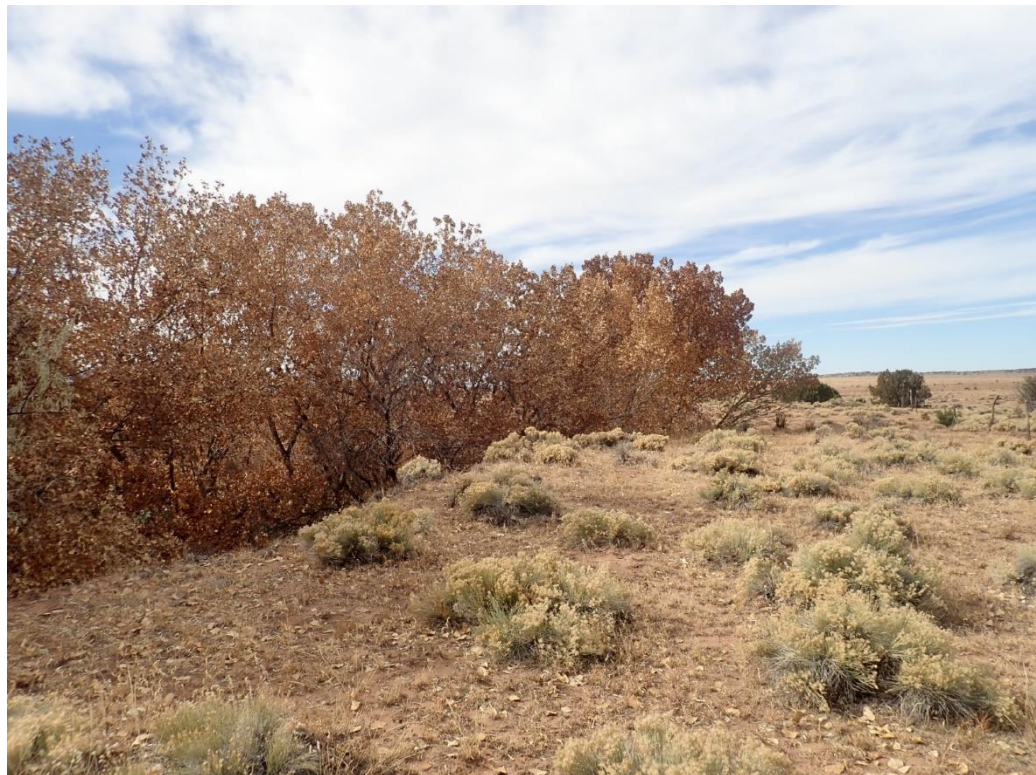
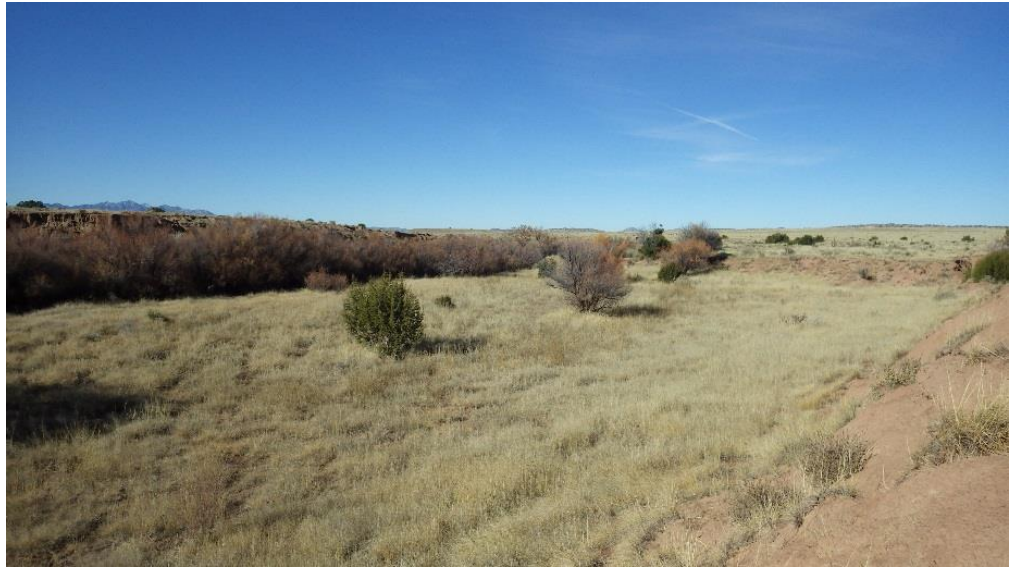
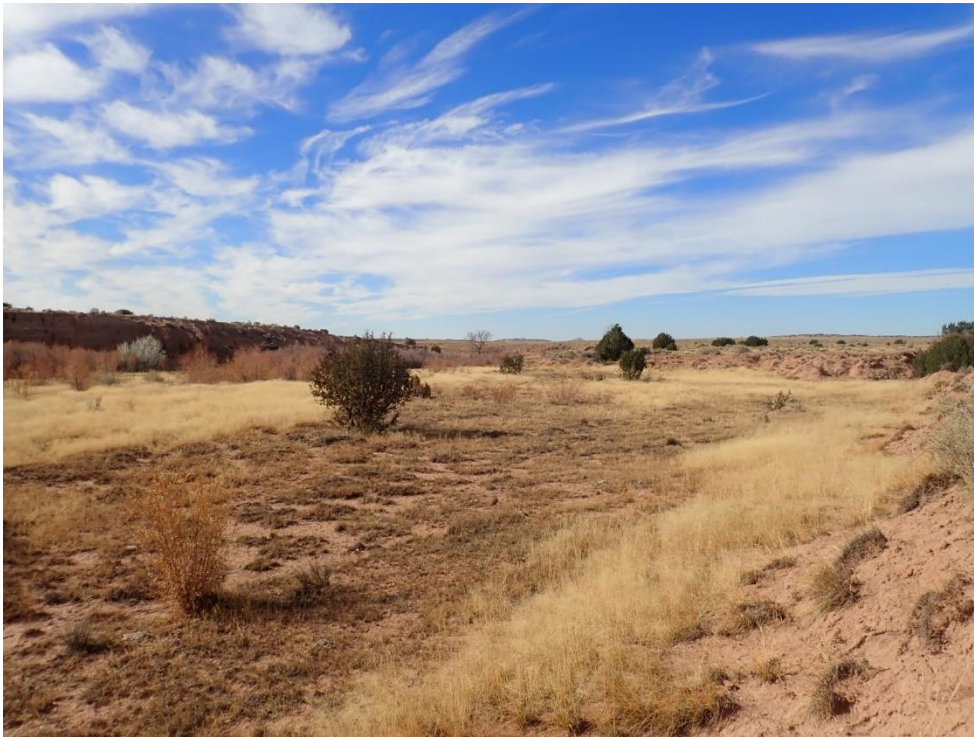
2015: SC6, view of grassy terrace. Taken standing on eroding hill, facing 285 degrees.

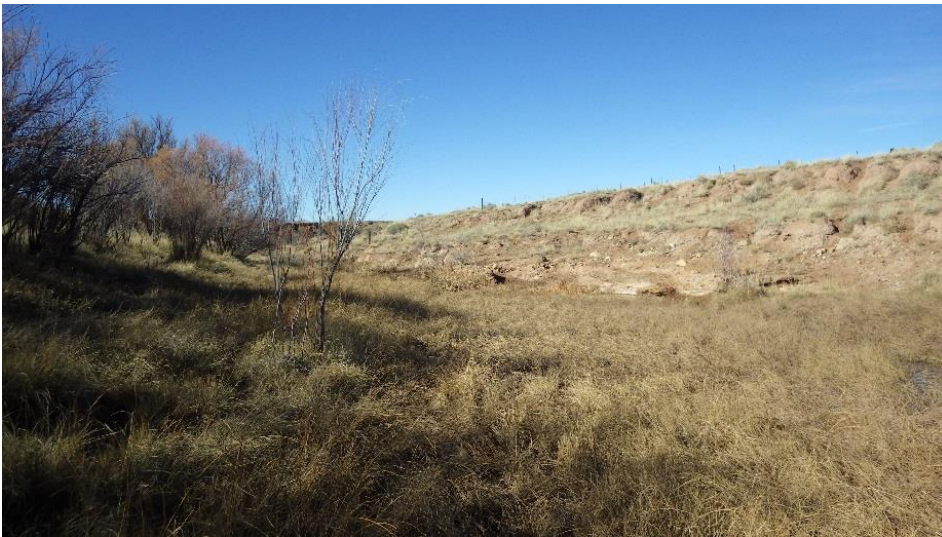
2015: SC7, view of floodplain and erosion; wet area. Taken facing 270 degrees.

2021:
15.21_7_270Deg
_270Deg_W

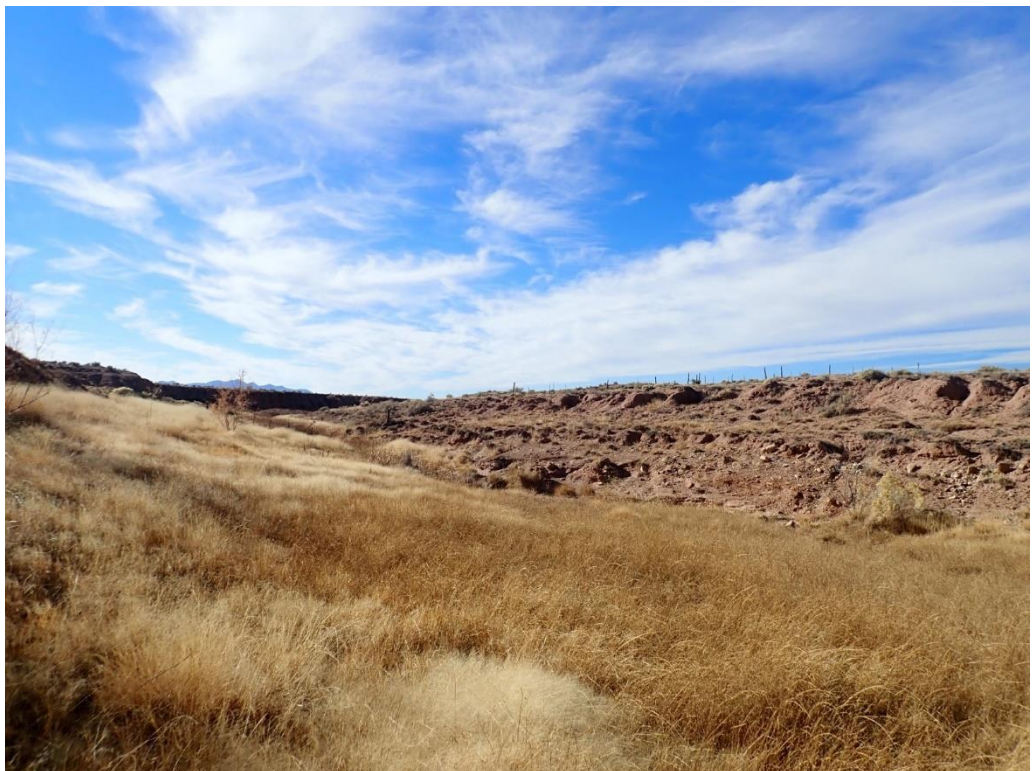
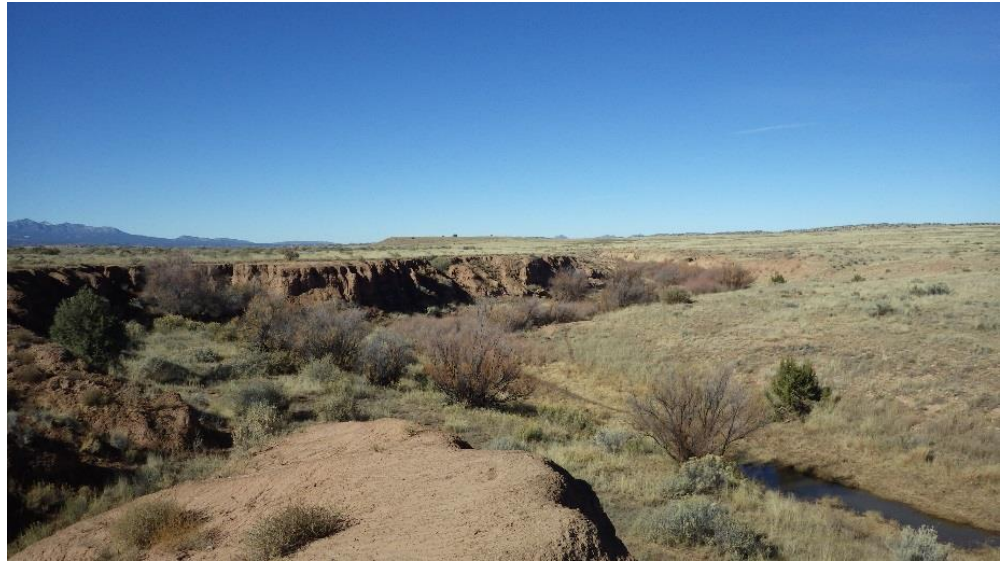
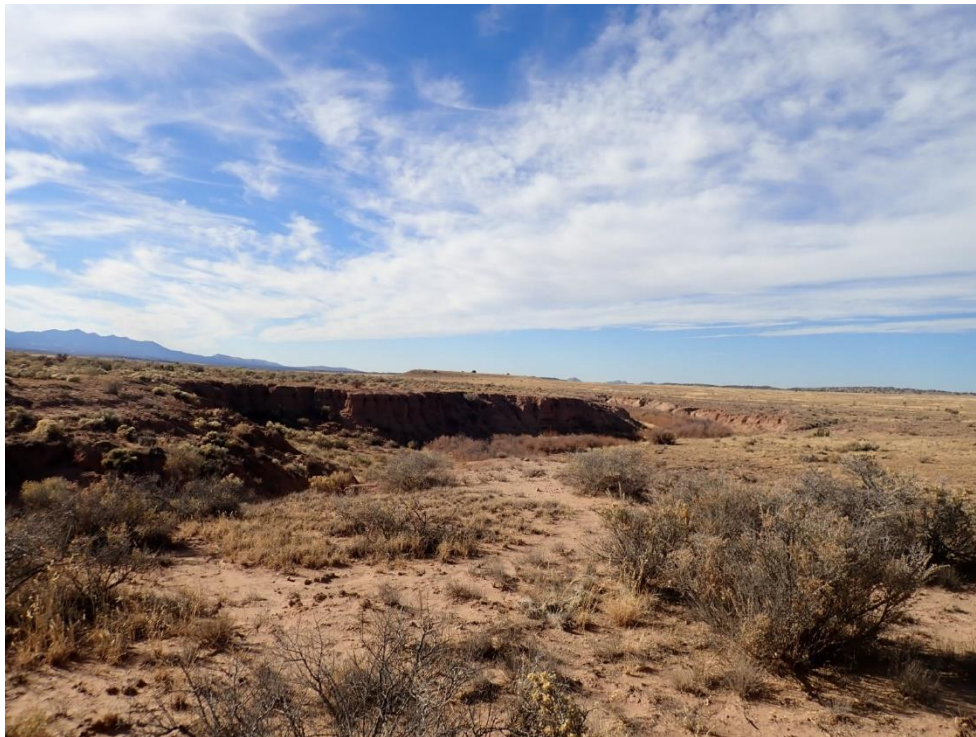
2015: SC8, west end of project. Taken facing 292 degrees.

2021:
15.21_8_292Deg_2
92Deg_W
