## Sandia Wash, 14.05

### 5-year Post-treatment Monitoring Report

2021

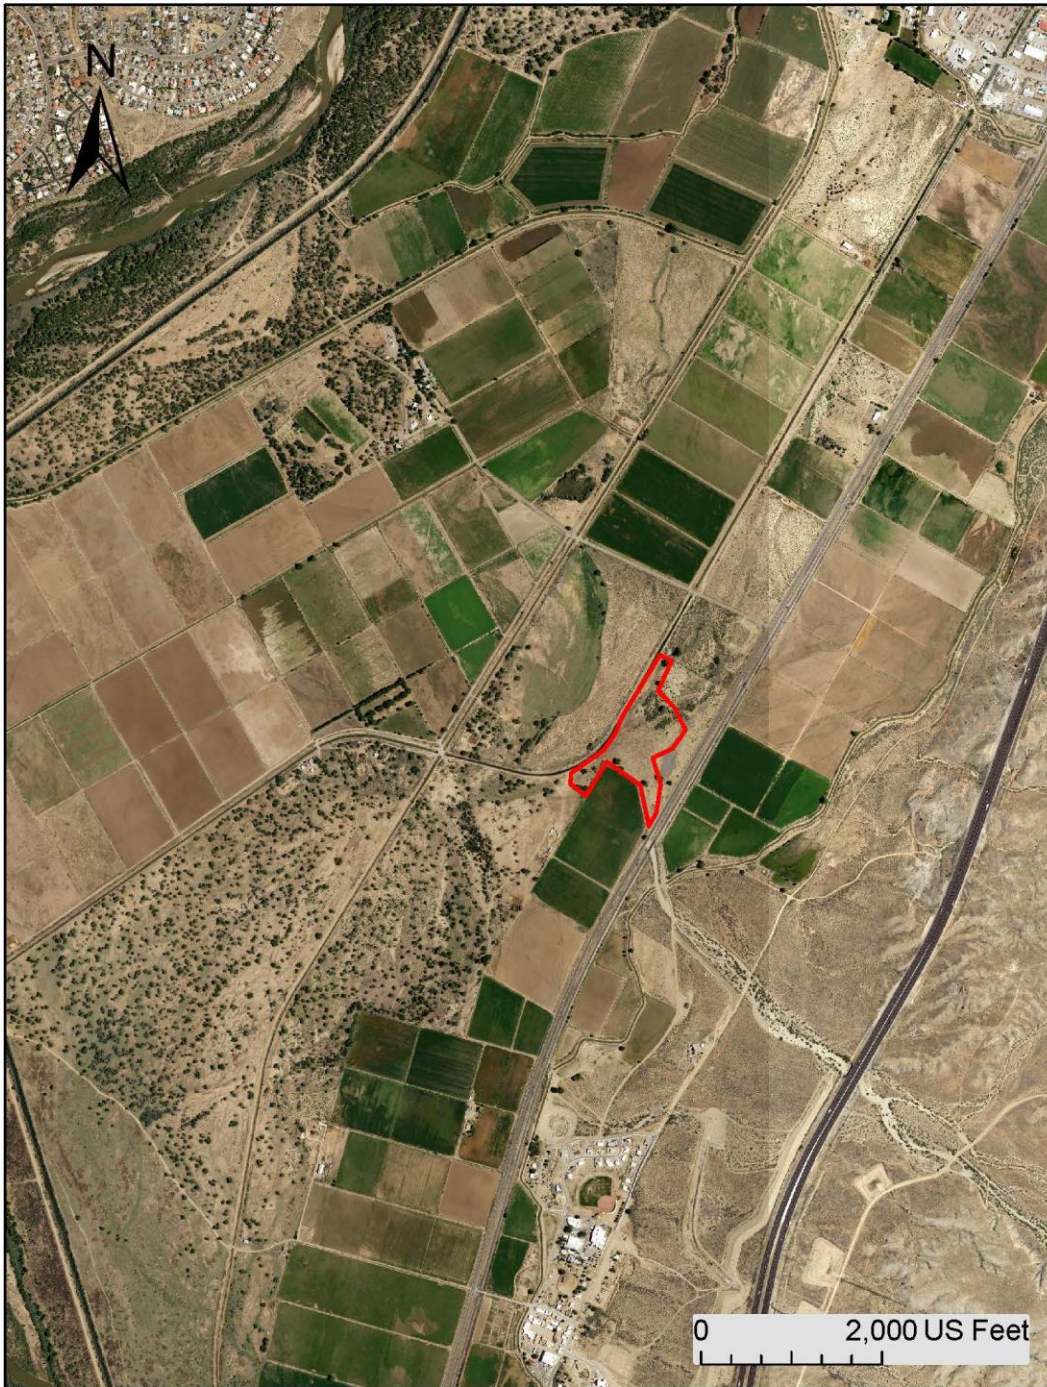
Figure 1. 14.05 Sandia Wash

Pre-treatment monitoring was conducted on this 18.3-acre project was conducted on December 23<sup>rd</sup>, 2014 as part of a restoration project targeting non-native phreatophytes scheduled for 2014-2015. Post-treatment monitoring occurred on December 15<sup>th</sup>, 2021. The project was sponsored by the Ciudad SWCD. The project is designed as an initial treatment on 18.3 acres of upland riparian treatment to remove non-native phreatophytes made up of very large, mature tree sized salt cedars. Treatment and removal was by extraction. Material will be moved off the meadow to an adjoining sandy, upland site where slash will be treated by mastication. Mastication material will be concentrated to minimize the impacted area. Mastication material depths over 6 inches will be allowed.

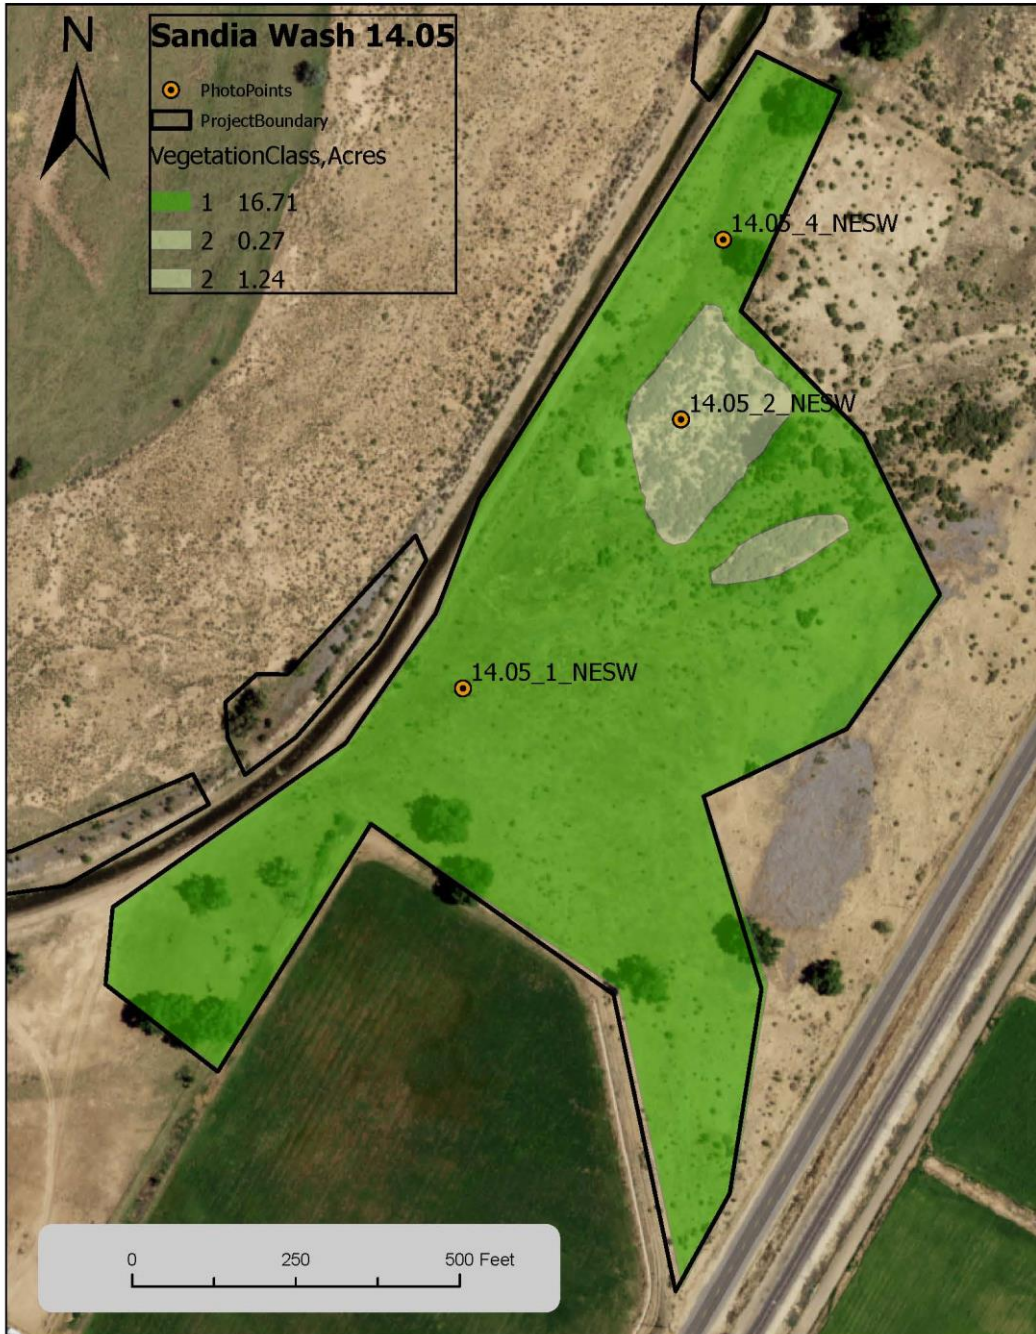
Figure 2. 14.05 Sandia Wash photopoints.

Low scores came in Vegetation Vertical Structure. The original NMRAM could not be located, but observing maps from the time of pre-treatment monitoring it can be seen there are patches of taller vegetation such as trees and shrubs. In 2021 herbaceous vegetation was observed to dominate the sample area, covering 90%, while short shrubs covered only 10% of the area. The loss of taller vegetation is a result of the treatment which targeted large phreatophytes, leaving behind the short vegetation. The site scored well in Soil Surface Condition. Initial post-treatment monitoring (2/17/2015) observed many livestock trails in the area, these were not as present in 2021.

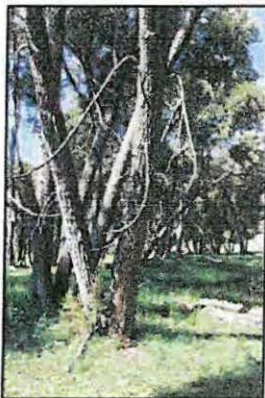
#### **Type 2 –Low Structure Forest with little or no understory.**

Tall mature to intermediate-aged trees (>5 m [>15 feet]) with canopy covering >25% of the area of the community (polygon) and understory layer (1-5 m [3-15 feet]) covering <25% of the area of the community (polygon). Majority of foliage is over 5 m (15 feet) above the ground. (This type incorporates Hink and Ohmart structure types 2 and 4.) Photograph on Diamond Creek by Y. Chauvin, 2012.

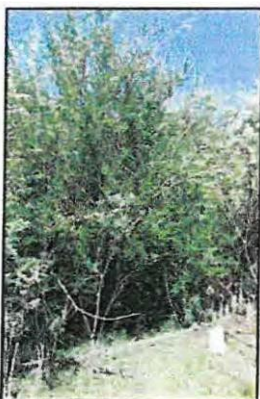
#### **Type 5 –Tall Shrub Stands.**

Young tree and shrub layer only (15-5 m [4.5-15 feet]) covering >25% of the area of the community (polygon). Stands dominated by tall shrubs and young trees, may include herbaceous vegetation

underneath the woody vegetation. Photograph on San Francisco River by Y. Chauvin, 2012.

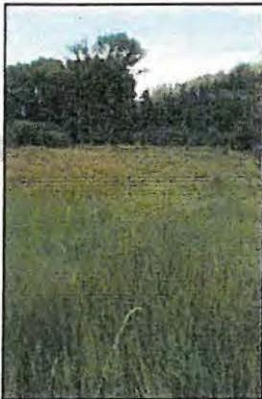
**Type 6W- Herbaceous Wetland.**

Herbaceous wetland vegetation covering >10% of the area of the community (polygon). Stands dominated by obligate wetland herbaceous species. Woody species absent, or <10% cover. Photograph of *Carex nebrascensis* meadow on upper Rio Santa Barbara by Y. Chauvin, 2009.
