Santa Fe-Pojoaque SWCD SFP1 (Puerta del Cañon) Project

5-year Monitoring Report

2016

SFP1 Puerta del Cañon Project

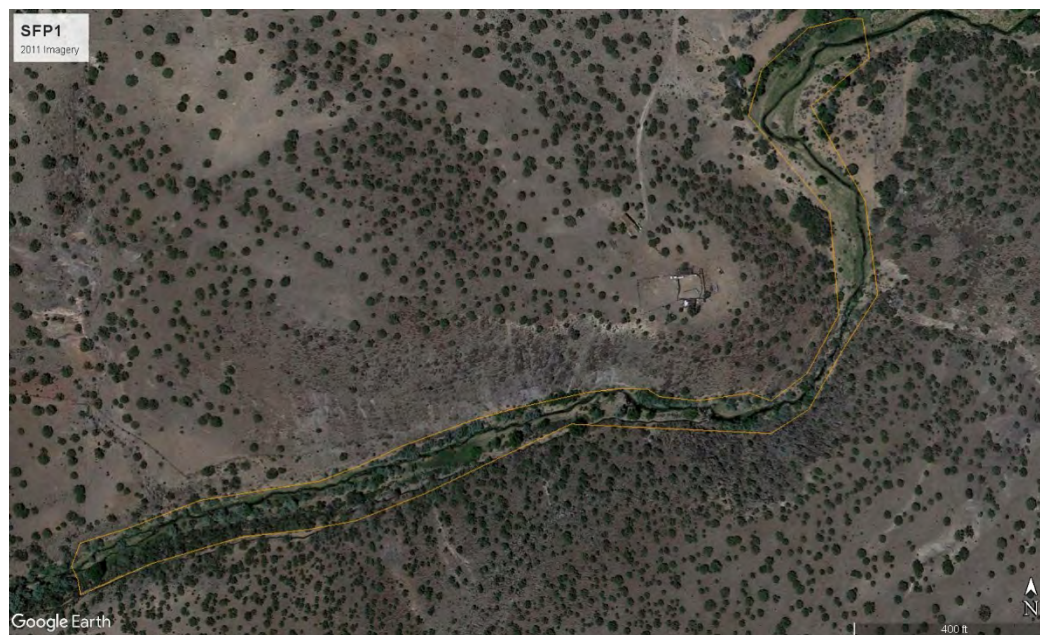
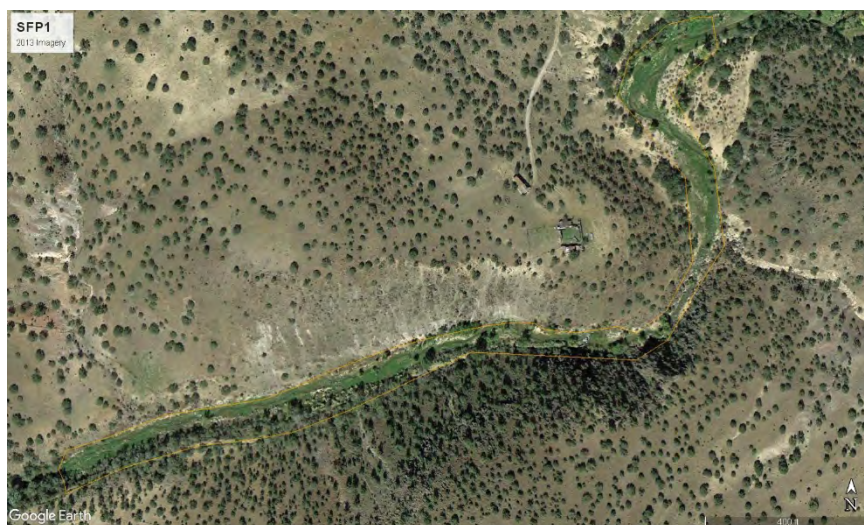
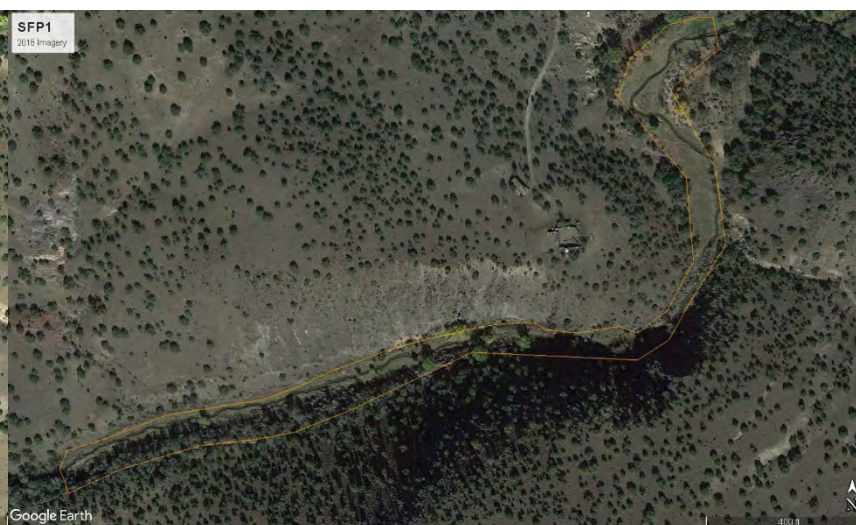
Figure 4. Google Earth imagery for SFP1 pre- and post-treatment. 2011 pre-treatment imagery is top; 2013 and 2016 post-treatment imagery on bottom.

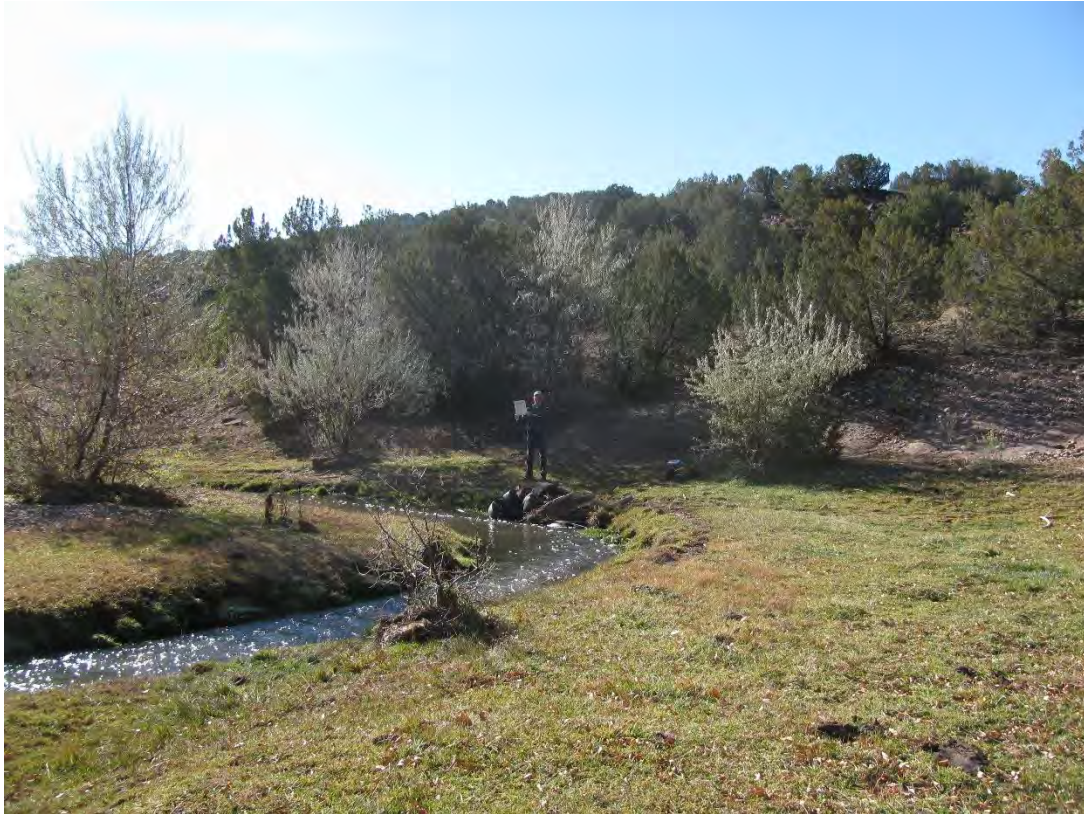
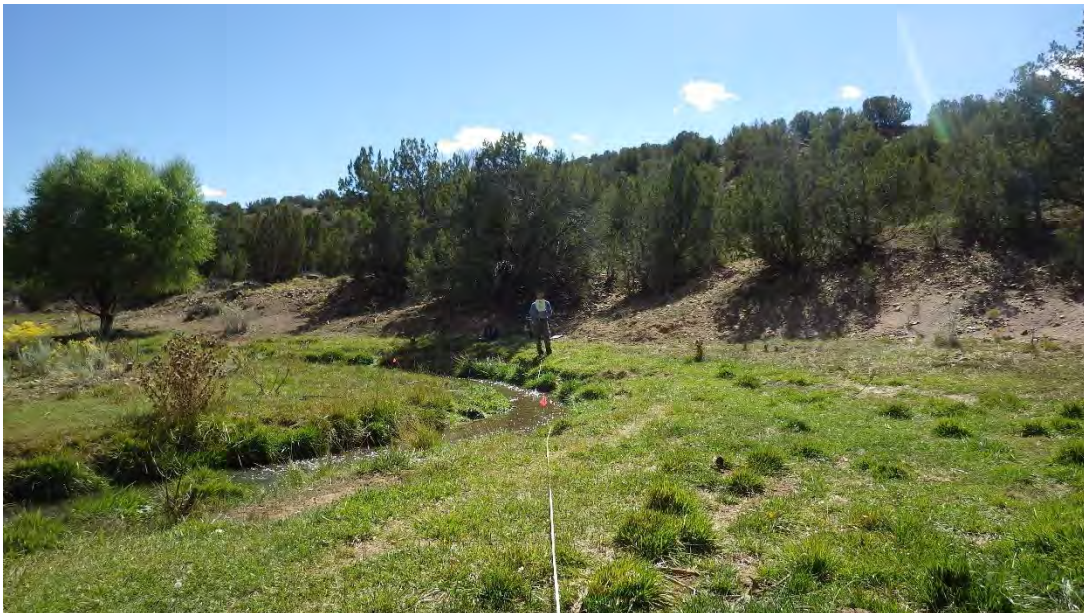
SFP1_1C, facing center from as close to 66 feet as visually possible (2011 above, 2016 below)

2016 Hink & Ohmart Type: 6**2016 Modified Hink & Ohmart Type: 7 (rock)****2011 Comments:** None.**2016 Comments:** Plot crosses river; cattle appear to have continuous river access. There is no stream shade and active bank undercutting on plot.

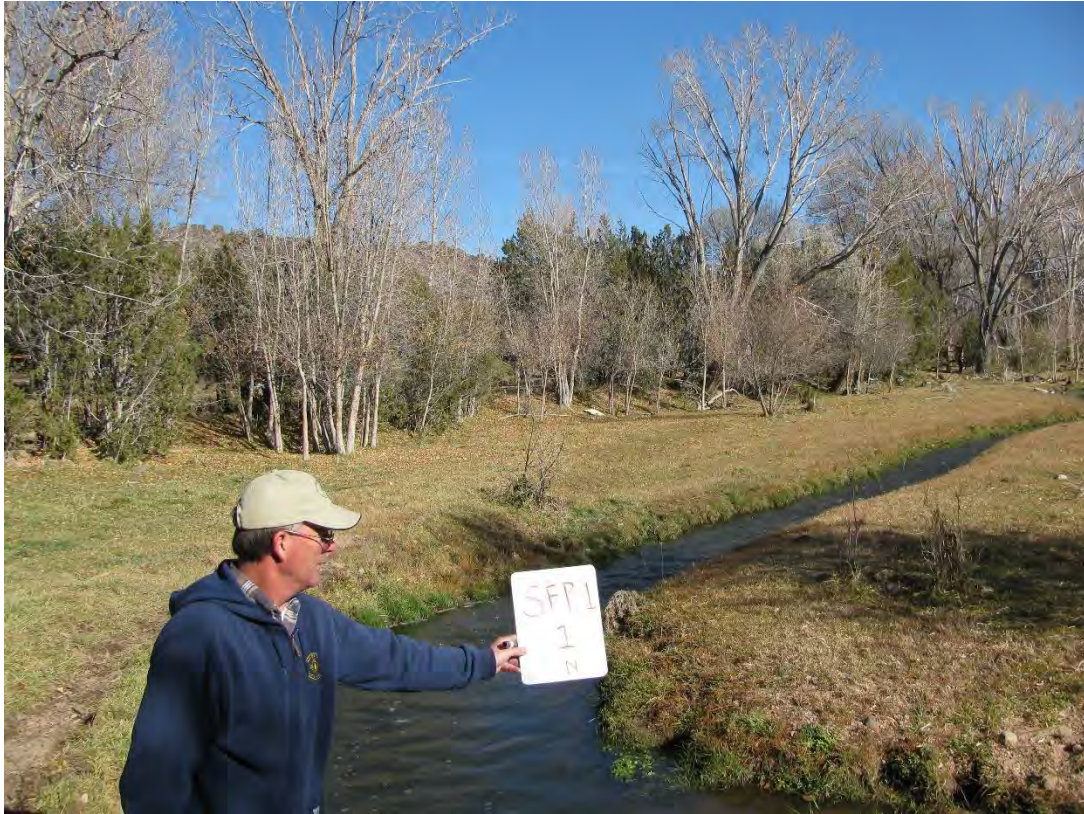
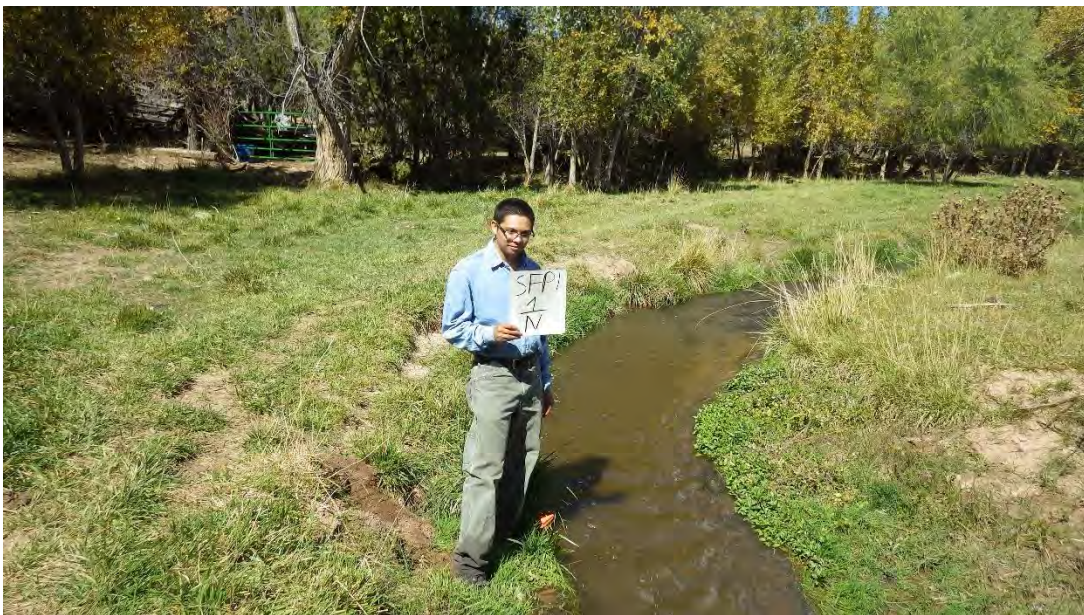
SFP1_1N, facing north from center (2011 above, 2016 below)

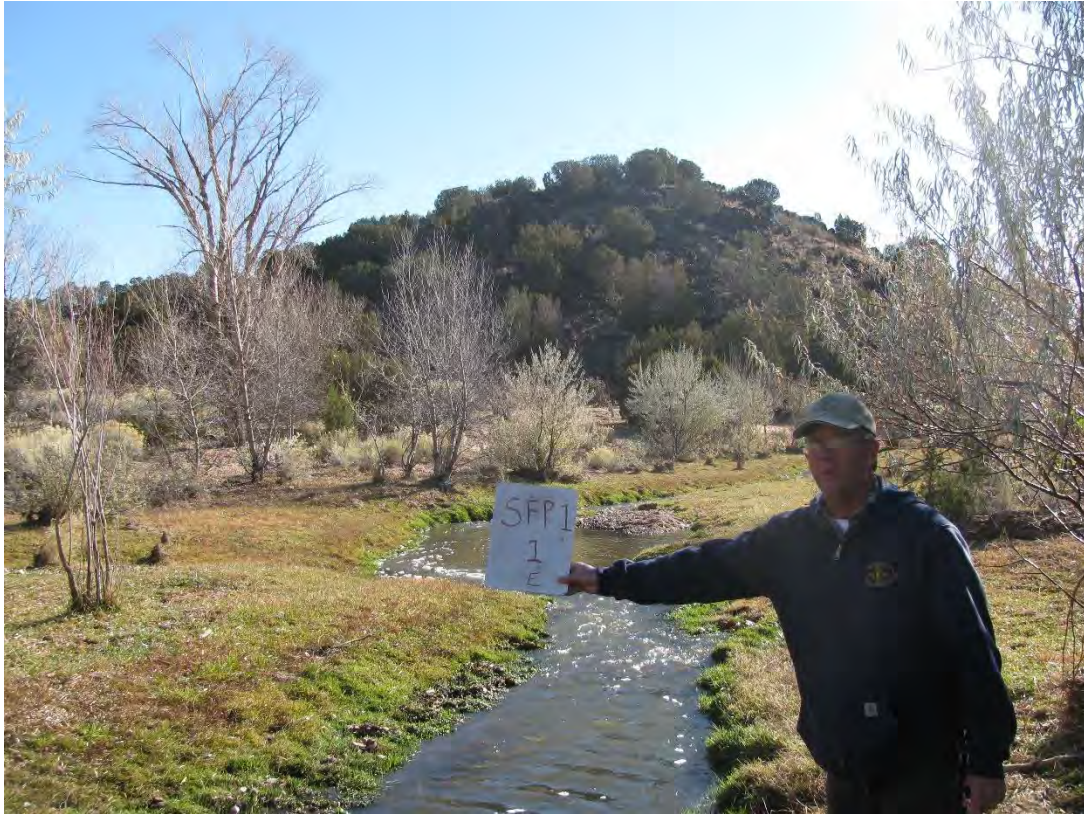
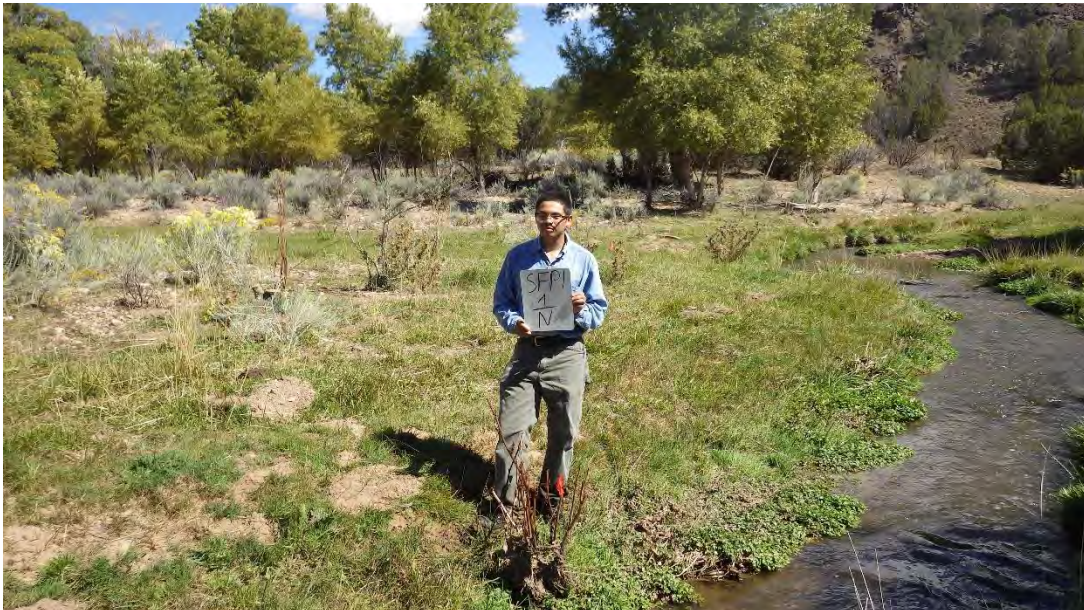
SFP1_1E, facing east from plot center (2011 above, 2016 below)

**** Whiteboard is incorrectly labeled in 2016 photos for this plot.****

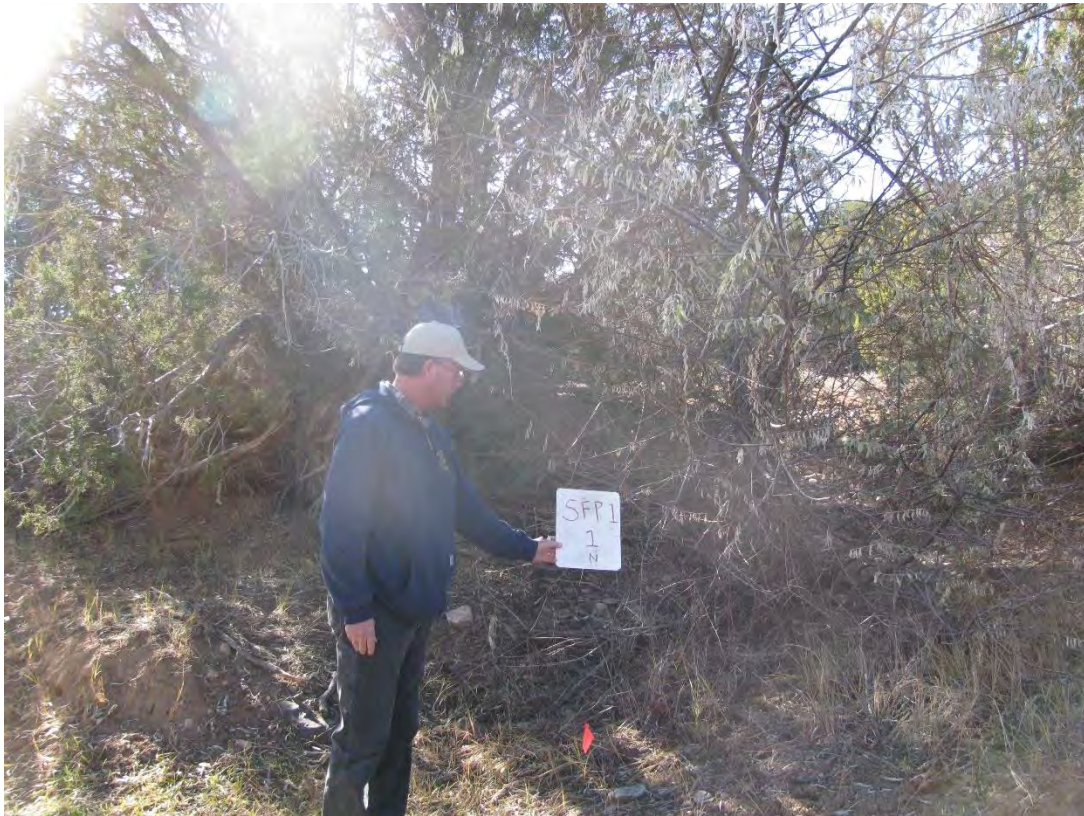
SFP1_1S, facing south from center (2011 above, 2016 below)

**** Whiteboard is incorrectly labeled in 2016 photos for this plot.****

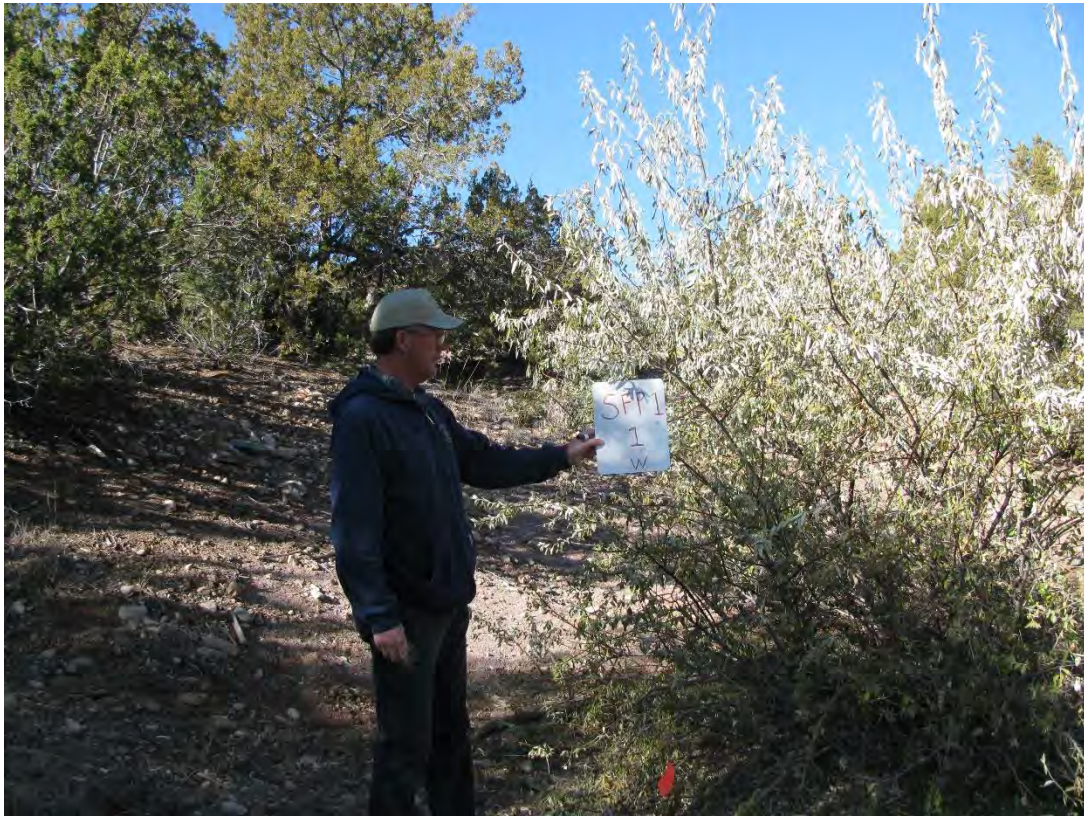
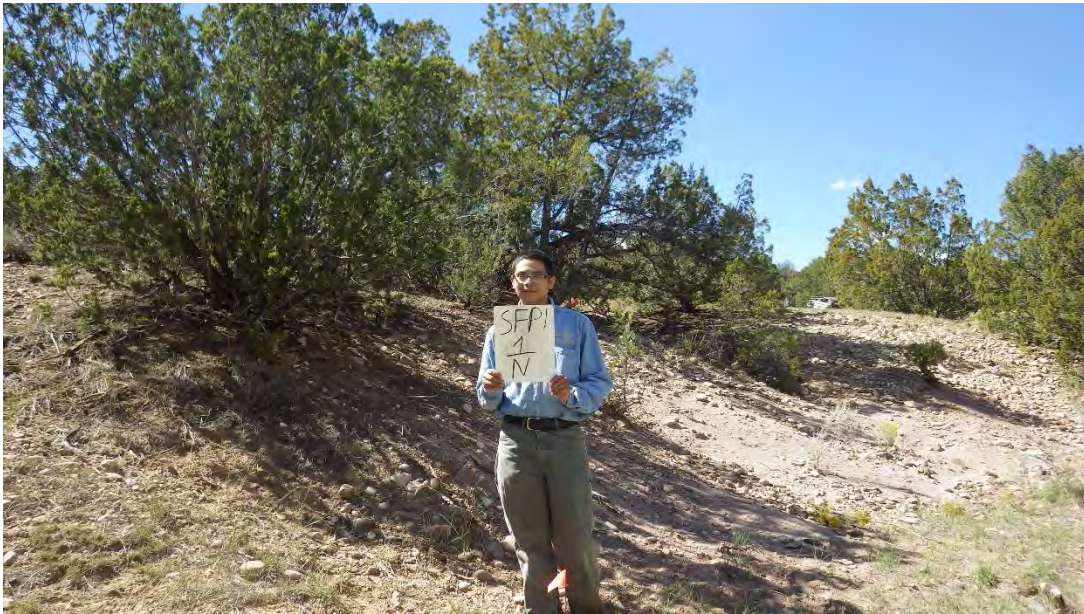
SFP1_1W, facing west from center (2011 above, 2016 below)

** Whiteboard is incorrectly labeled in 2016 photos for this plot.**

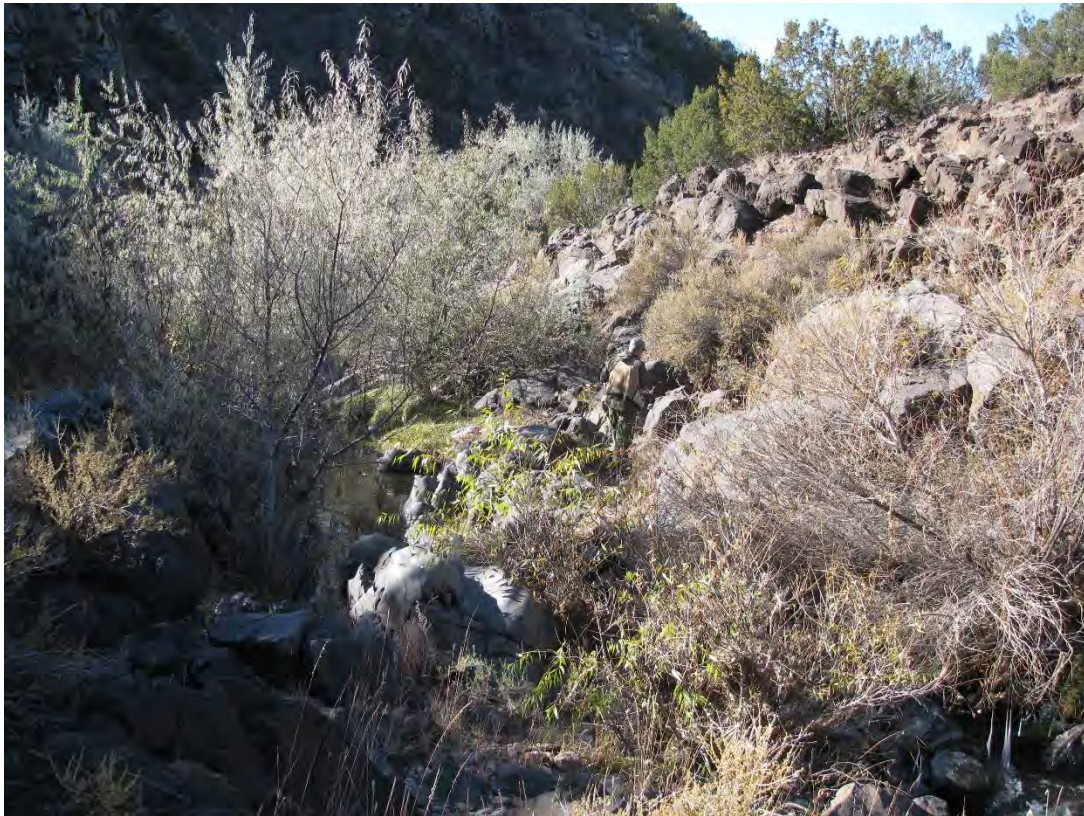
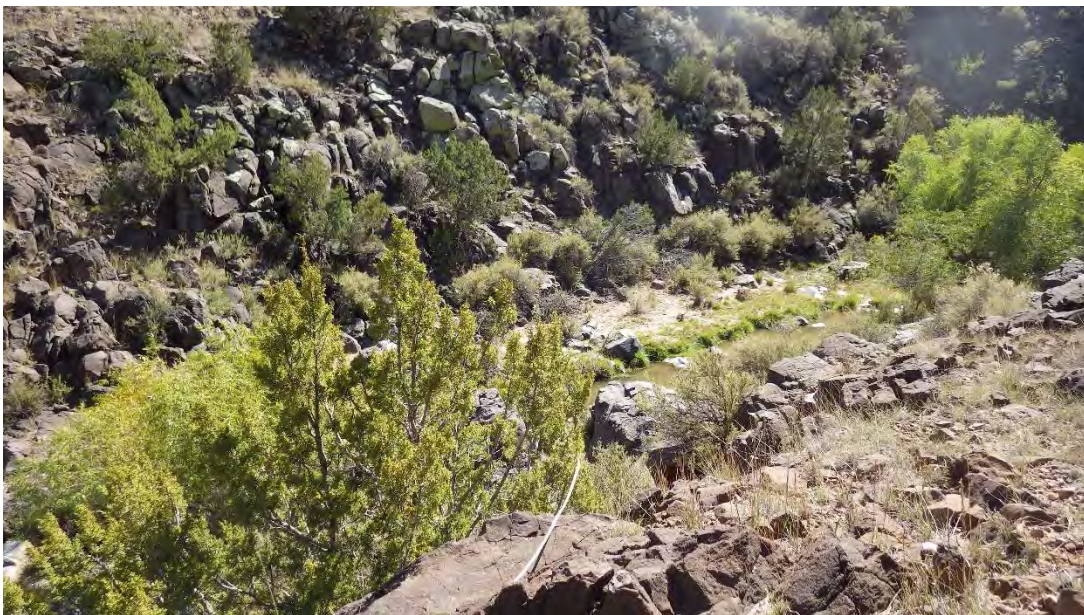
SFP1_2C, facing center from as close to 66 feet as visually possible (2011 above, 2016 below)

2016 Hink & Ohmart Type: 3**2016 Modified Hink & Ohmart Type: 2/6H****2011 Comments:** None.**2016 Comments:** This plot is especially cliffy and rocky. The river crossing includes a deep pool.

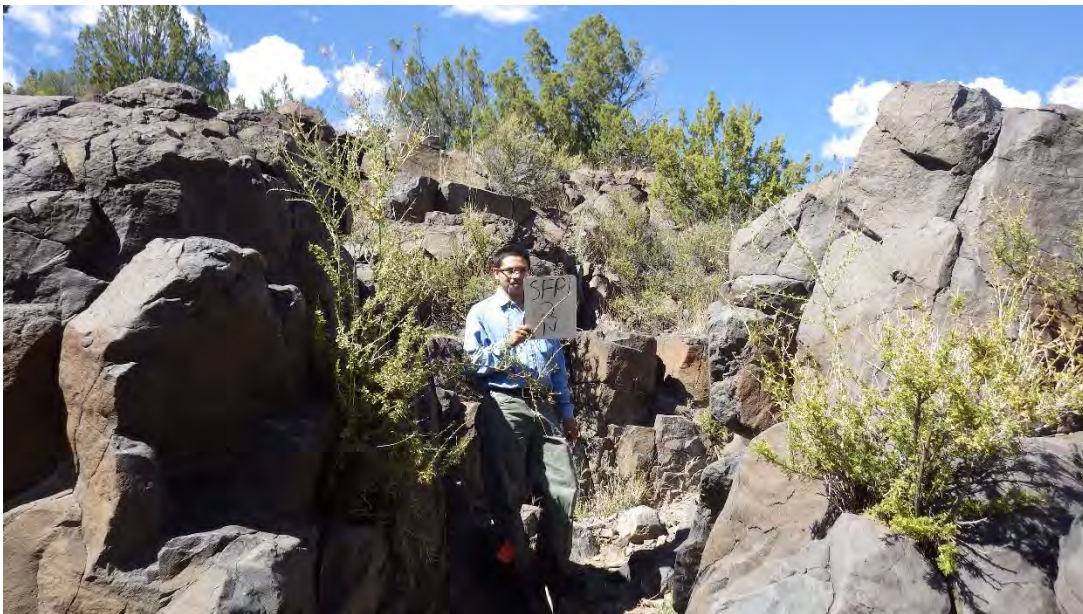
****Whiteboard is incorrectly labeled in 2011 photos for this plot.****

SFP1_2N, facing north from plot center (2011 above, 2016 below)

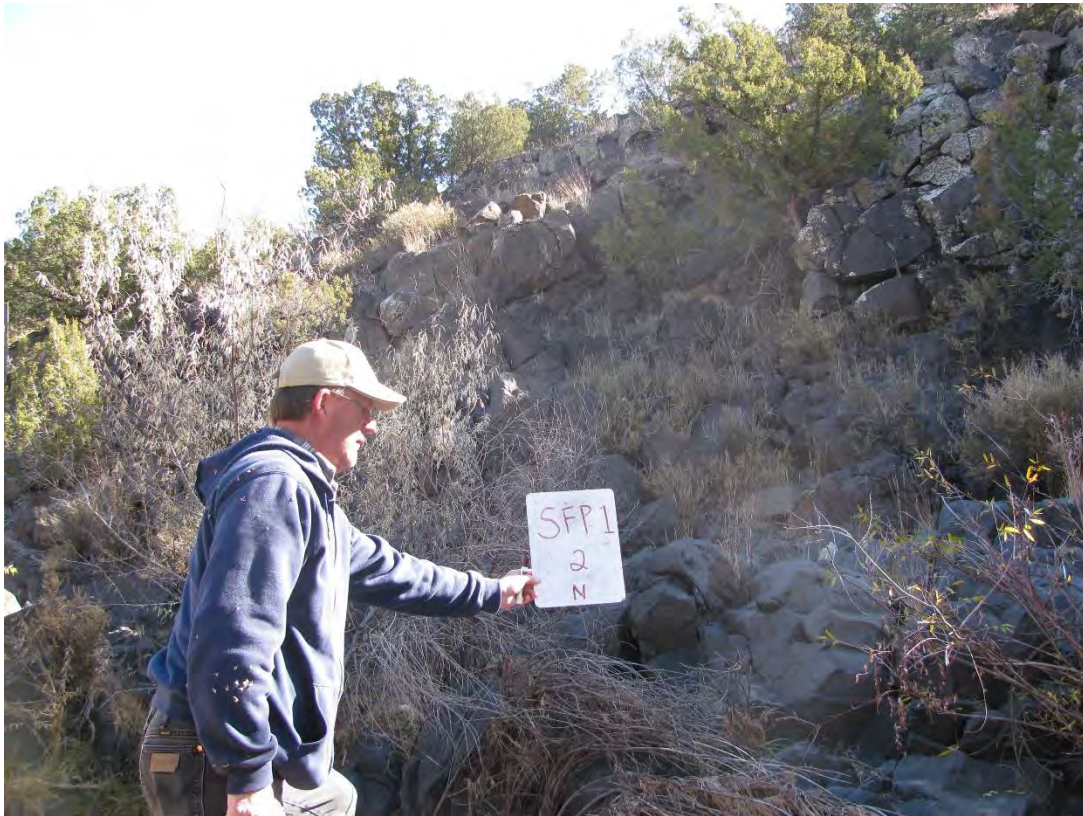
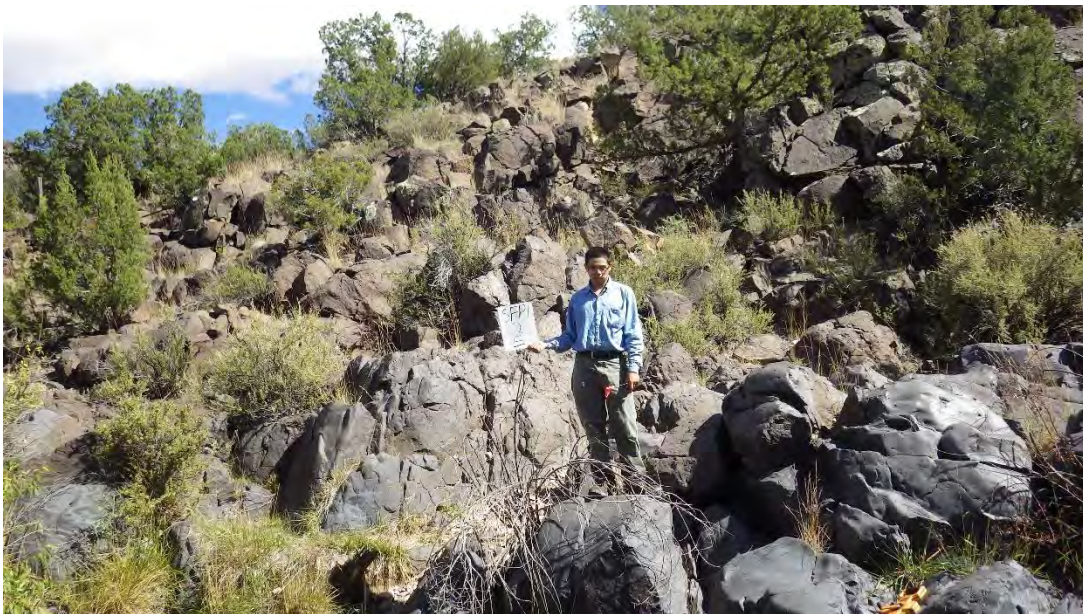
****Whiteboard is incorrectly labeled in 2011 photos for this plot.****

SFP1_2E, facing east from center (2011 above, 2016 below)

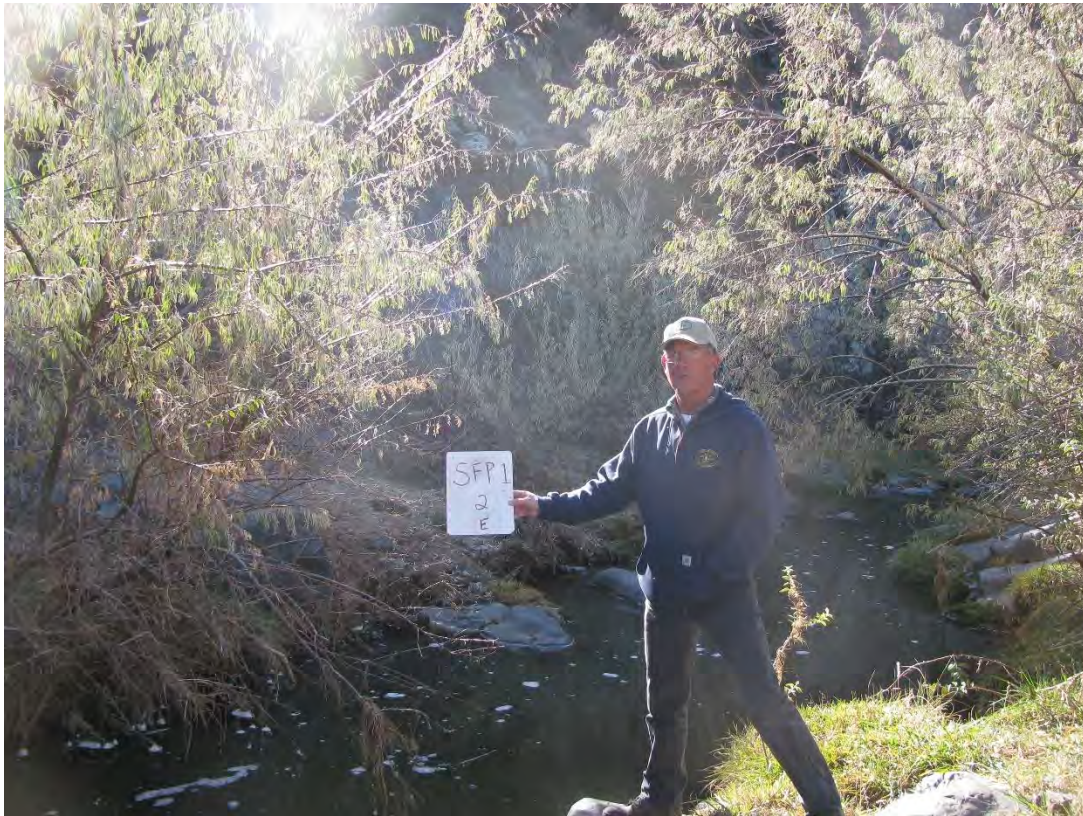
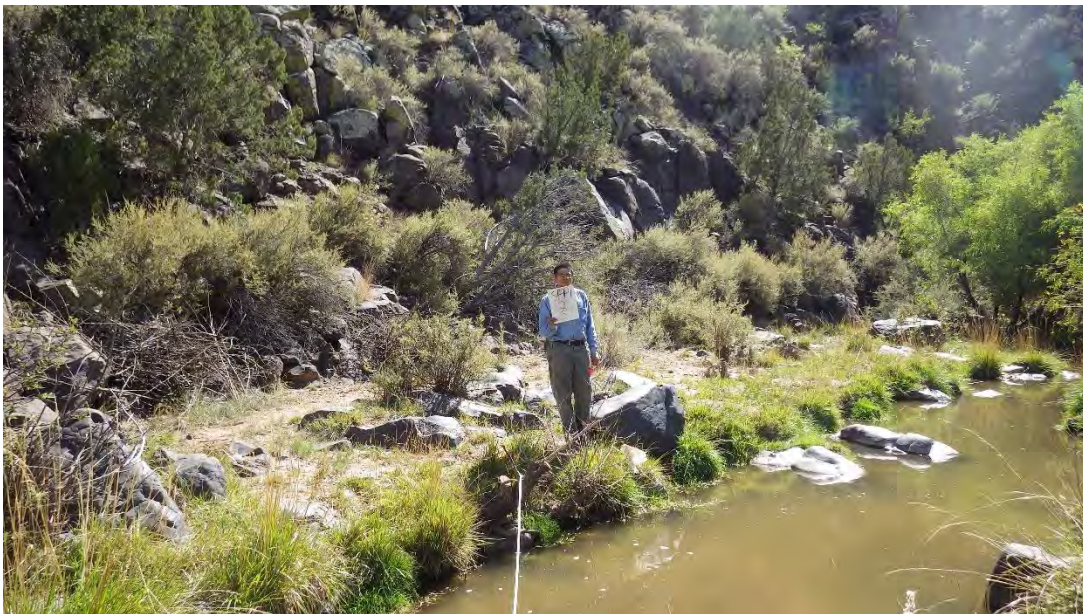
****Whiteboard is incorrectly labeled in 2011 photos for this plot.****

SFP1_2S, facing south from plot center (2011 above, 2016 below)

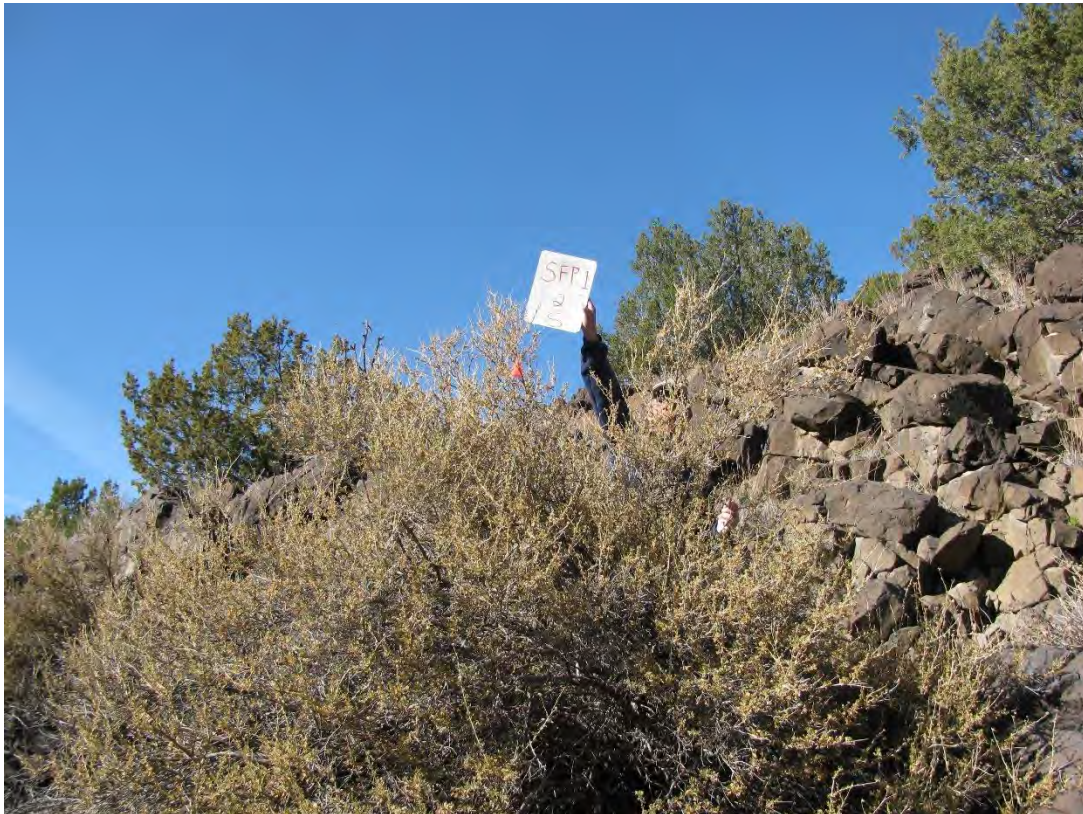
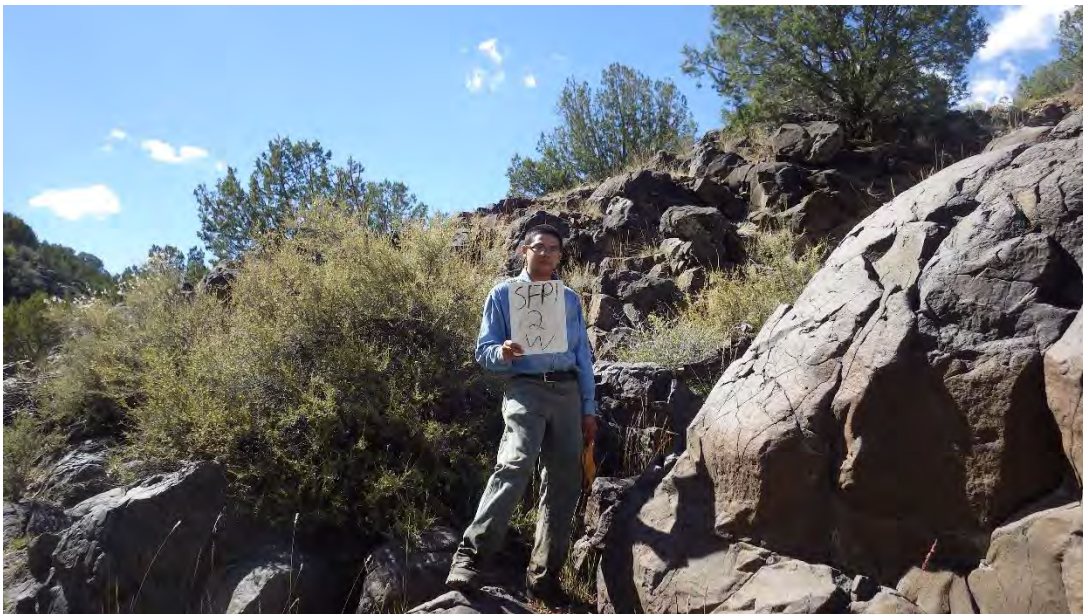
****Whiteboard is incorrectly labeled in 2011 photos for this plot.****

SFP1_2W, facing west from center (2011 above, 2016 below)

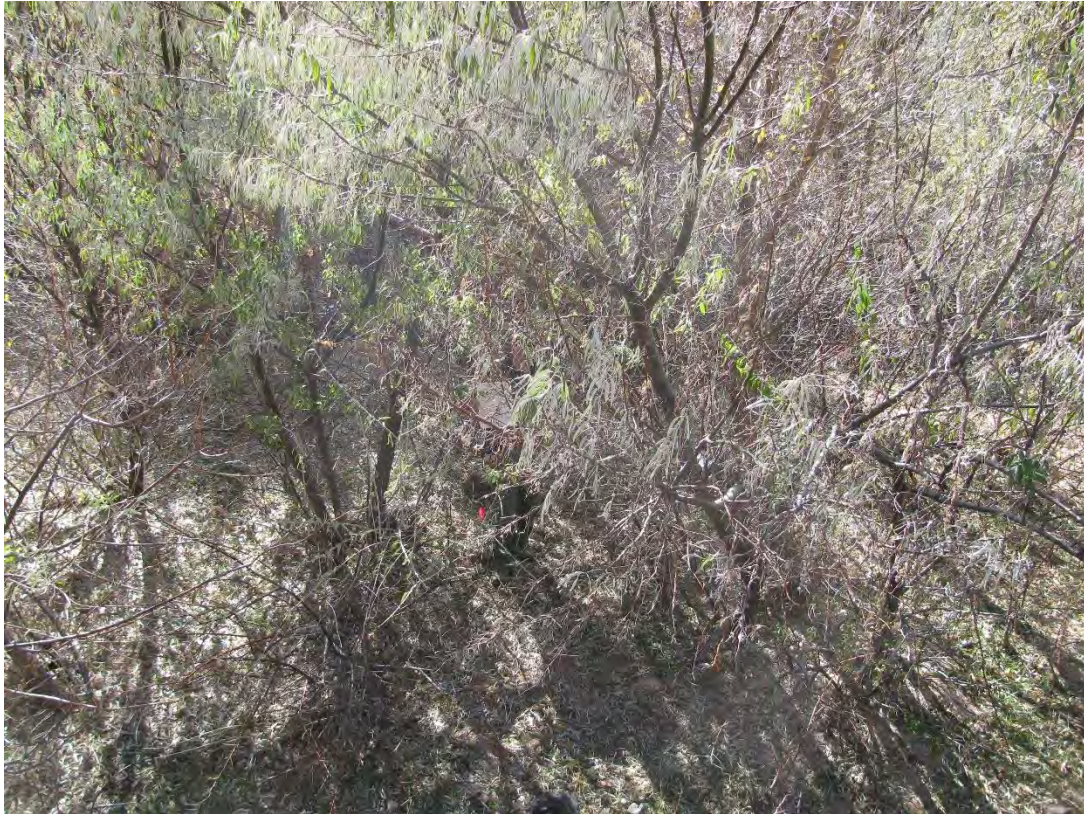
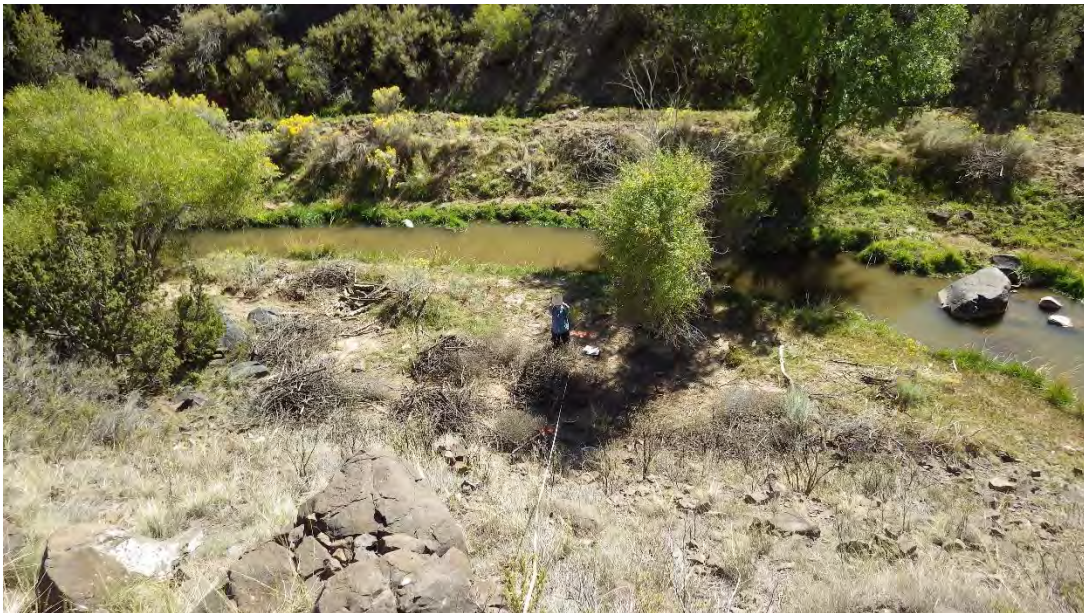
SFP1_3C, facing center from as close to 66 feet as visually possible (2011 above, 2016 below)

2016 Comments: This plot is downstream of the acequia diversion. It is steep, rocky with abundant slash on site. Salt is visible on the soil surface. Tires, glass and other debris were noted. Plot center stake was in tumbleweeds.

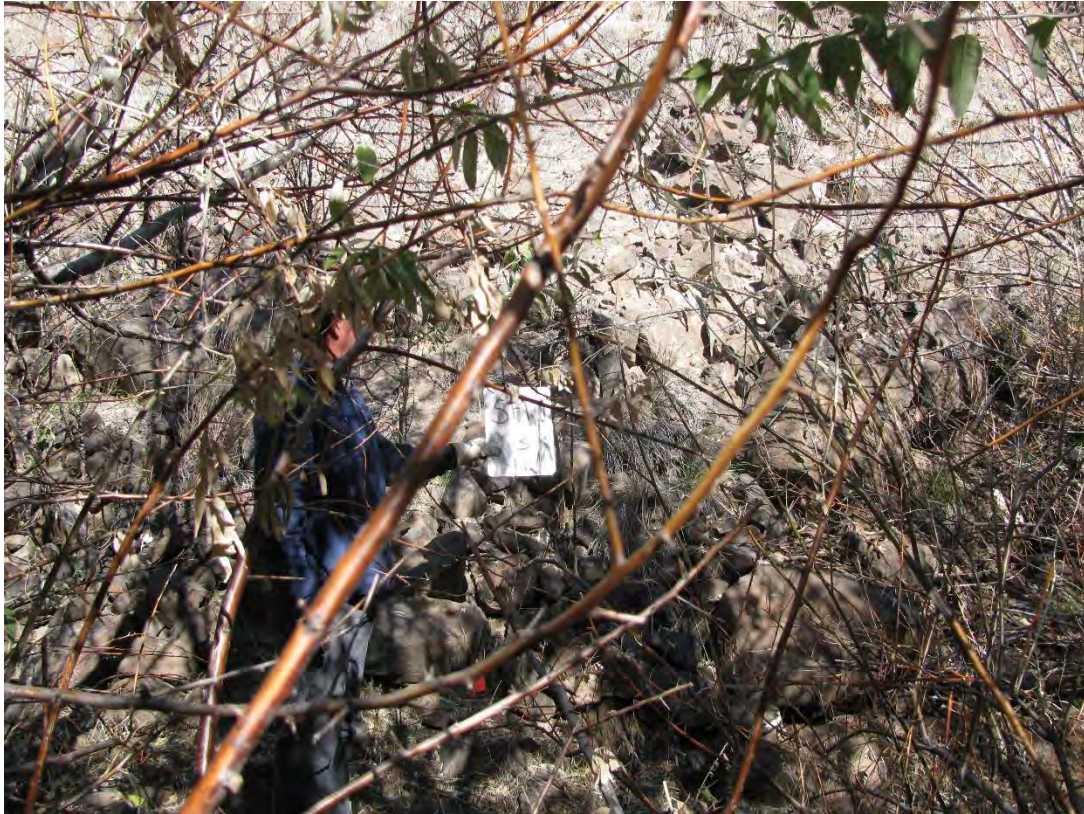
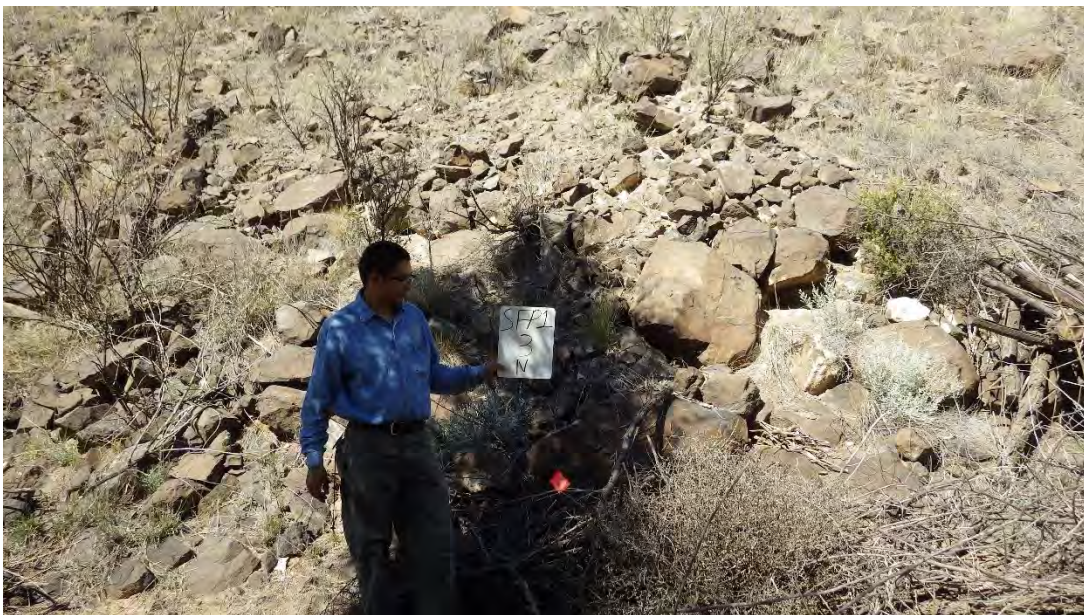
SFP1_3N, facing north from center (2011 above, 2016 below)

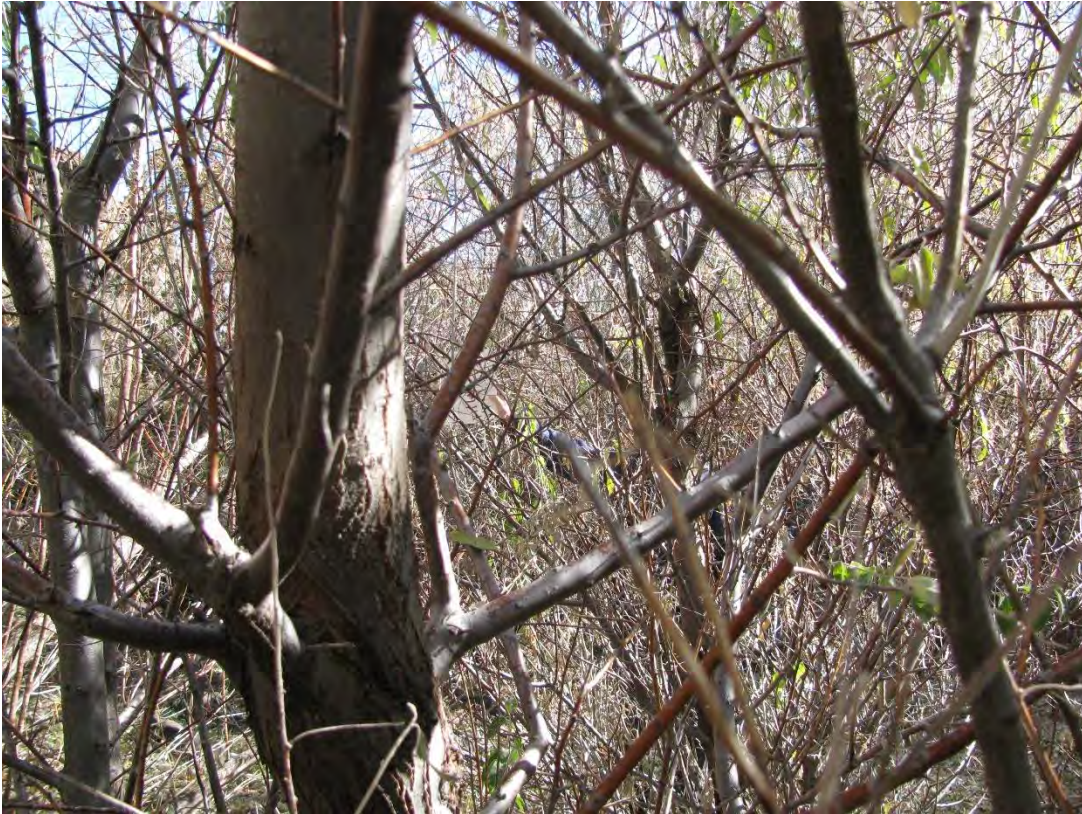
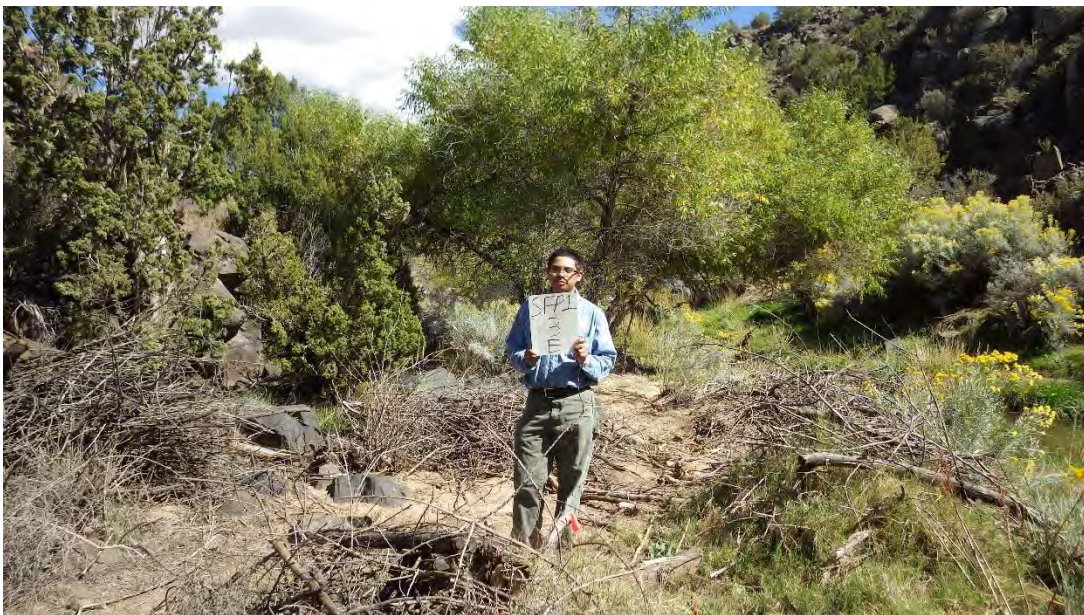
SFP1_3E, facing east from center (2011 above, 2016 below)

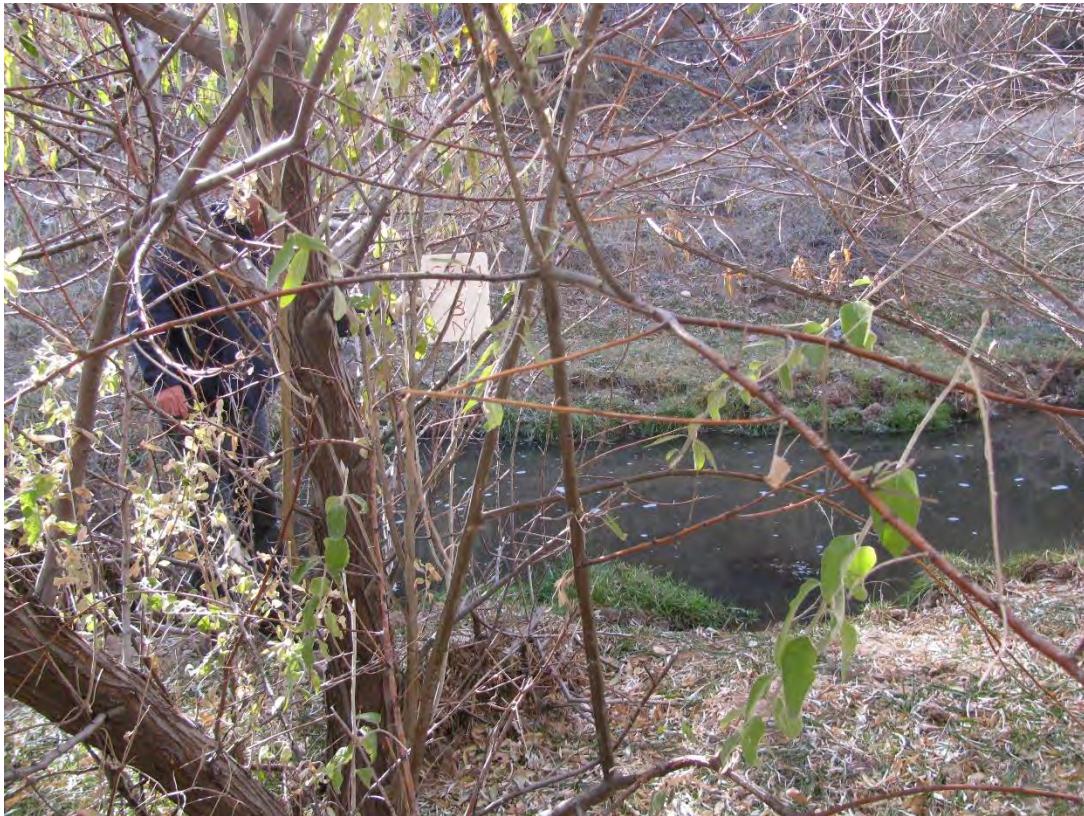
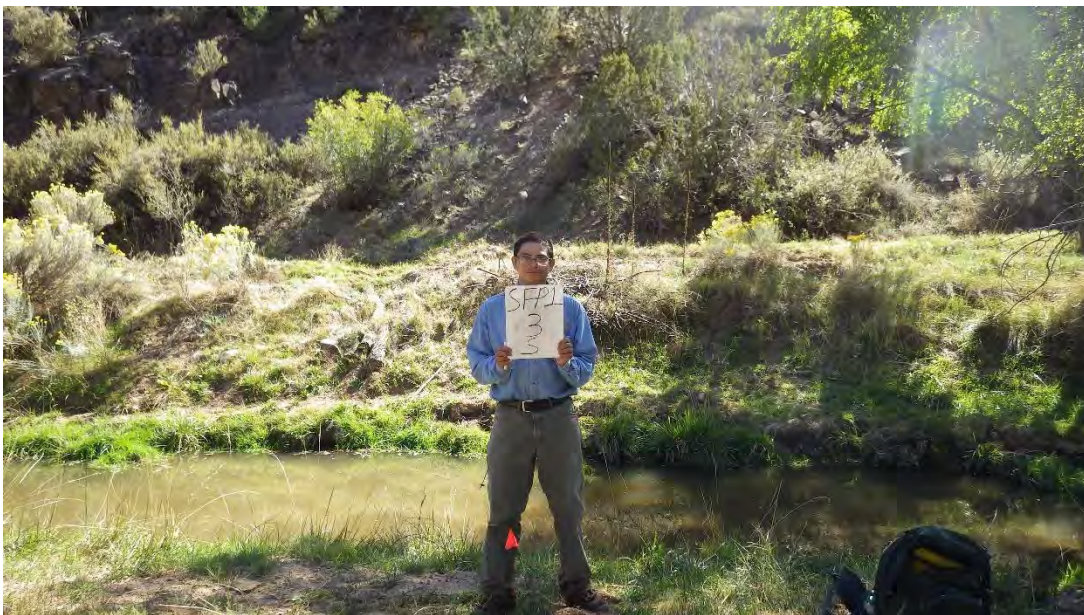
SFP1_3S, facing south from center (2011 above, 2016 below)
