Santa Fe-Pojoaque SWCD SFP1 (Puerta del Cañon) Project

5-year Monitoring Report

2016

SFP1 Puerta del Cañon Project

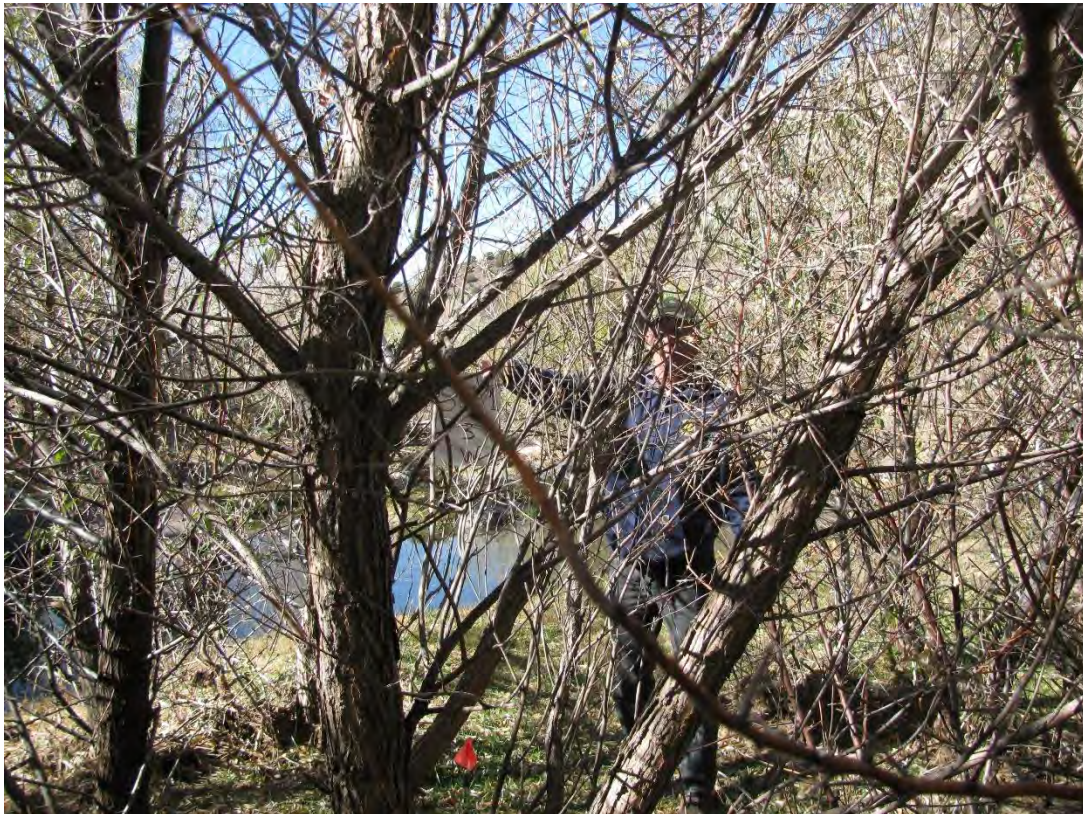
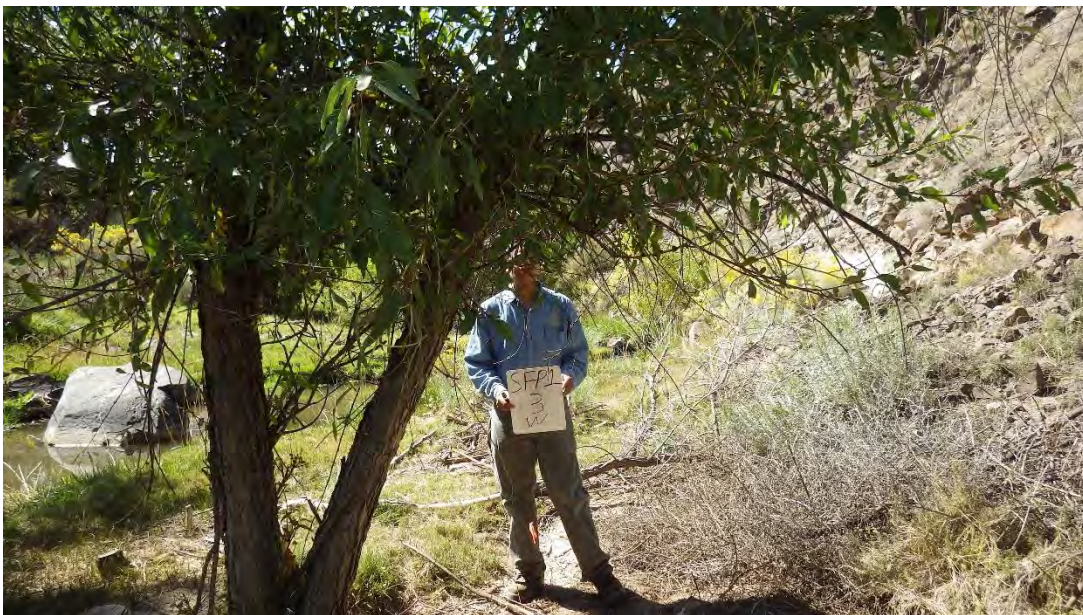
SFP1_3W, facing west from center (2011 above, 2016 below)

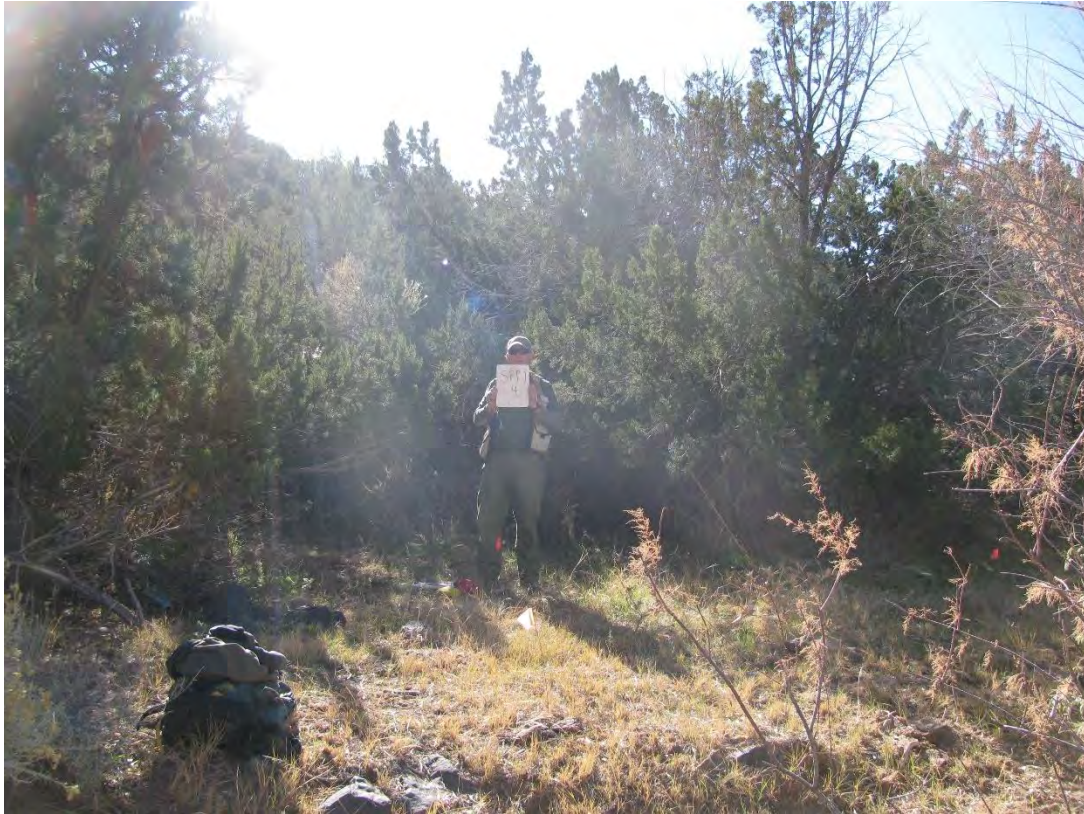
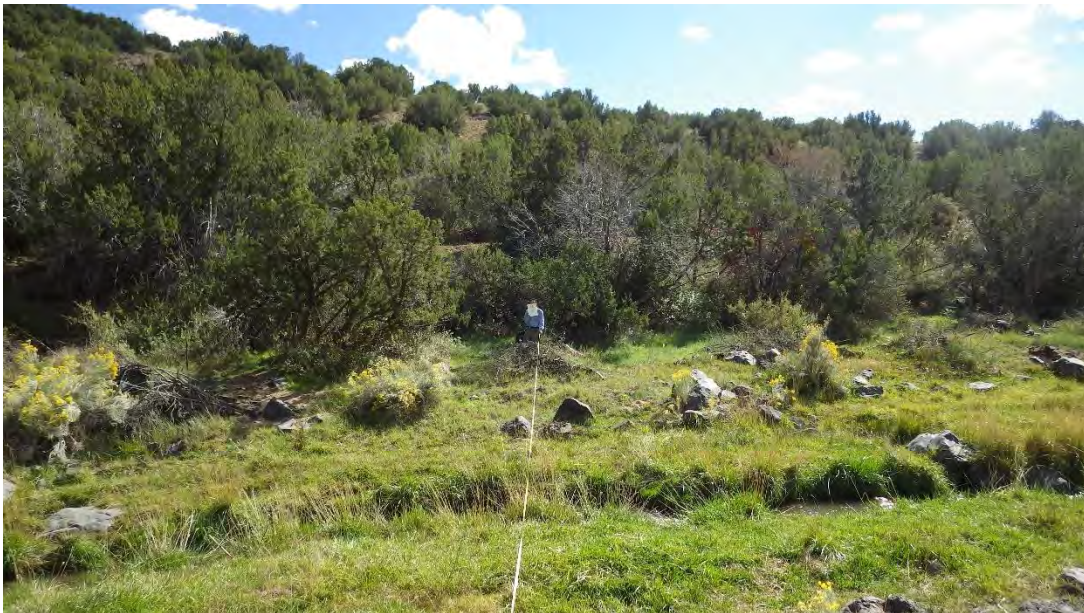
SFP1_4C, facing center from as close to 66 feet as visually possible (2011 above, 2016 below)

2016 Hink & Ohmart Type: 6**2016 Modified Hink & Ohmart Type: 6H****2011 Comments:** None.**2016 Comments:** Plot center was in a brush pile.

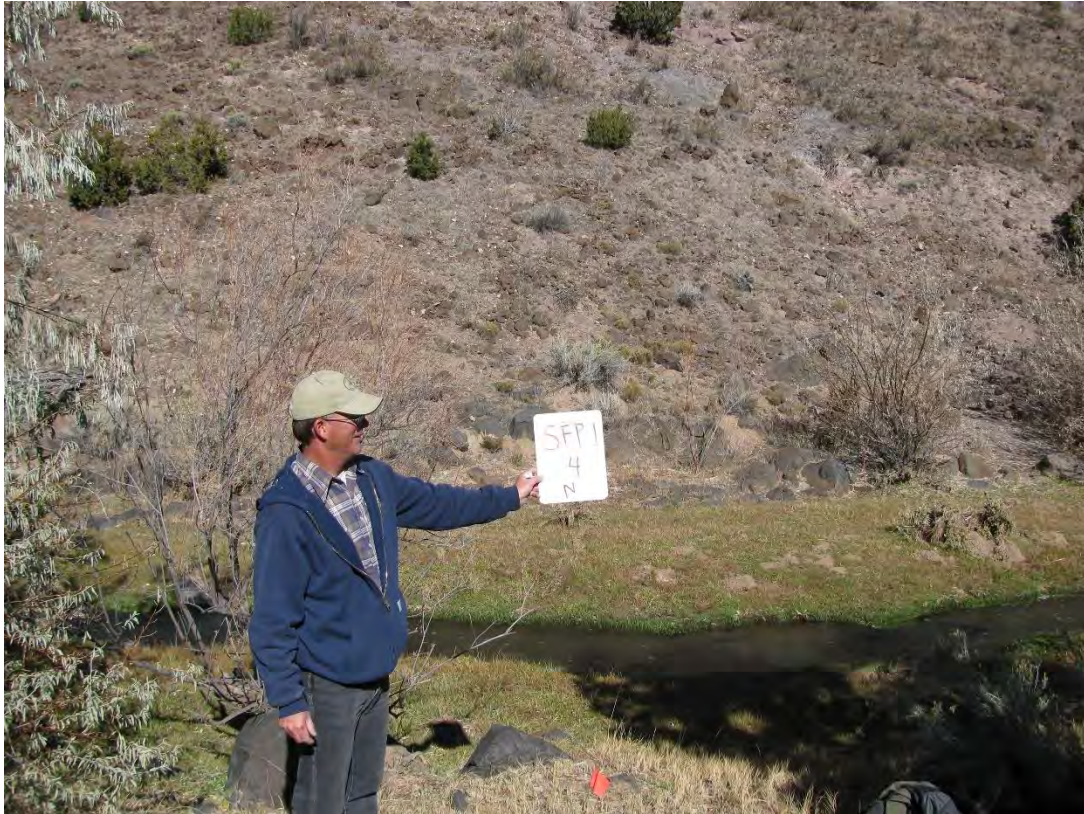
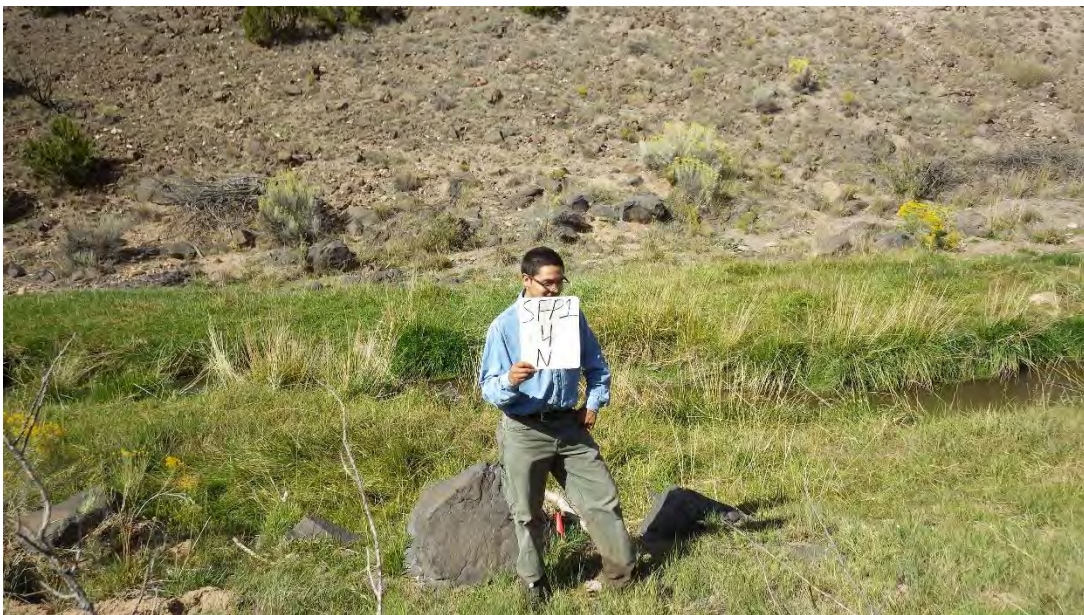
SFP1_4N, facing north from center (2011 above, 2016 below)

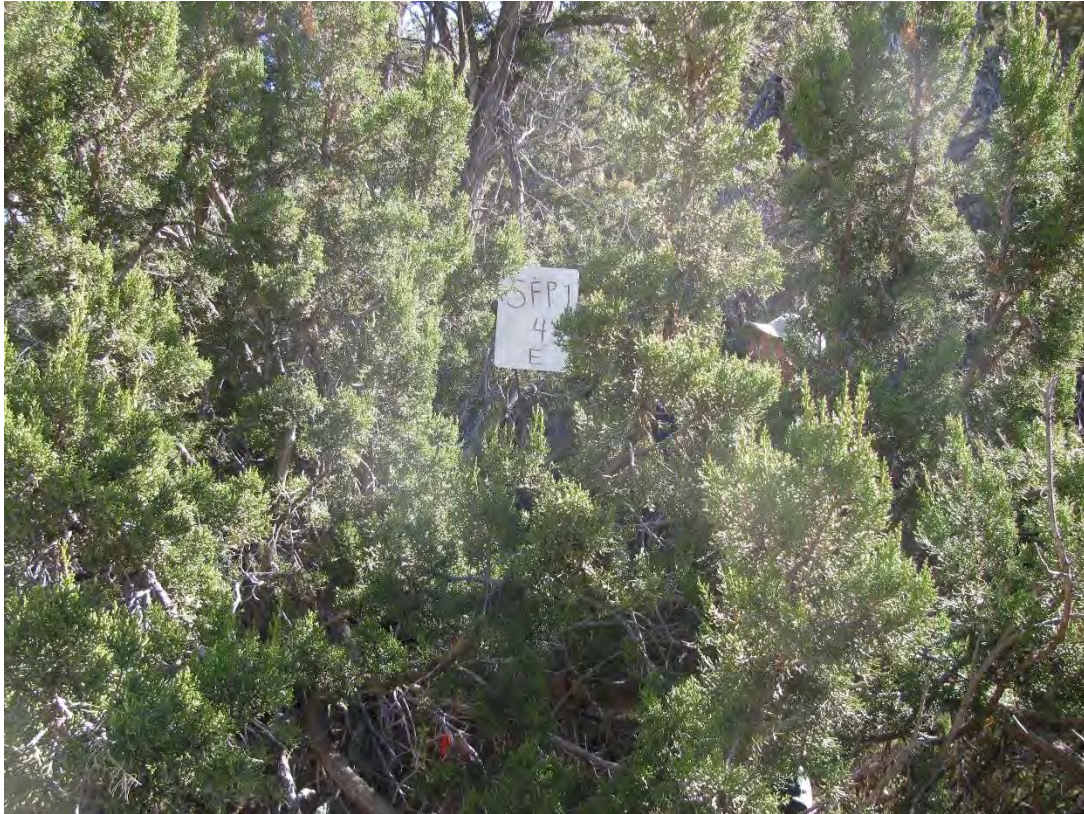
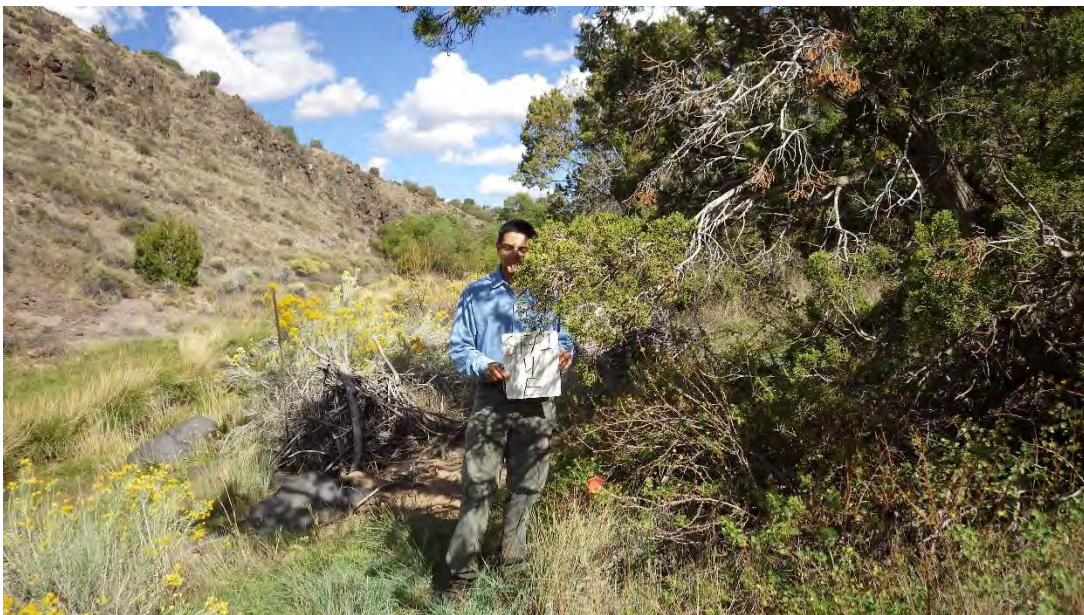
SFP1_4E, facing east from center (2011 above, 2016 below)

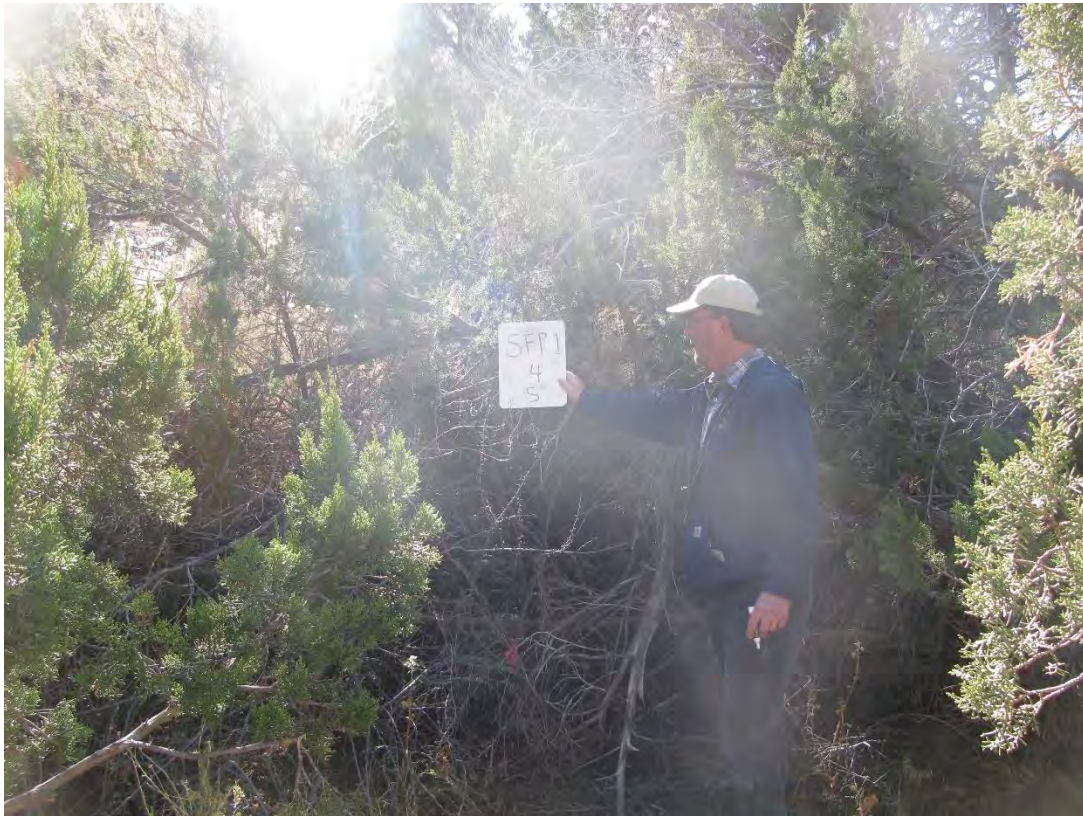
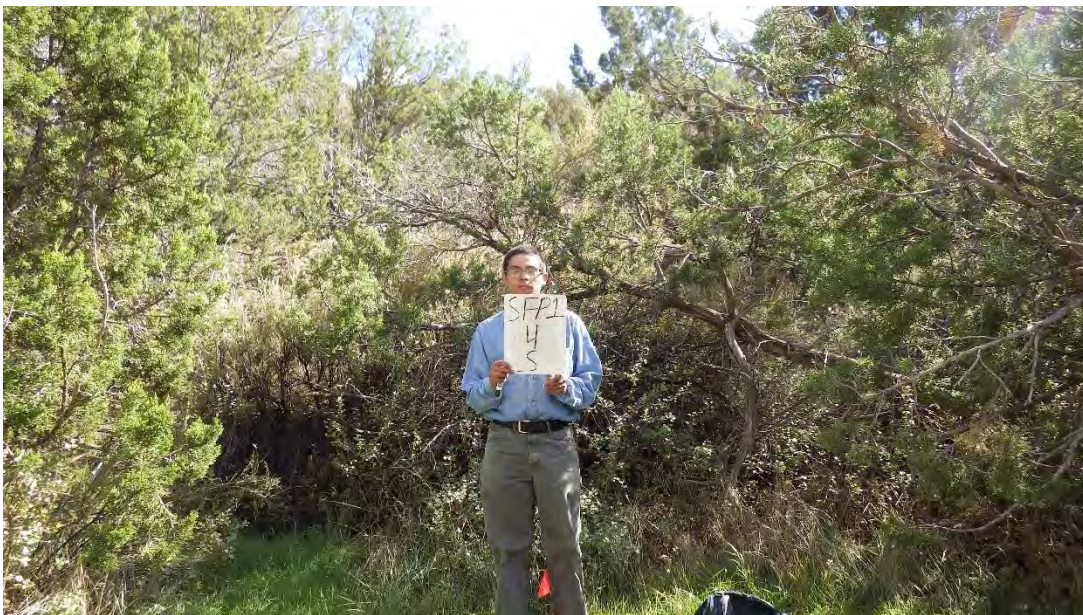
SFP1_4S, facing south from center (2011 above, 2016 below)

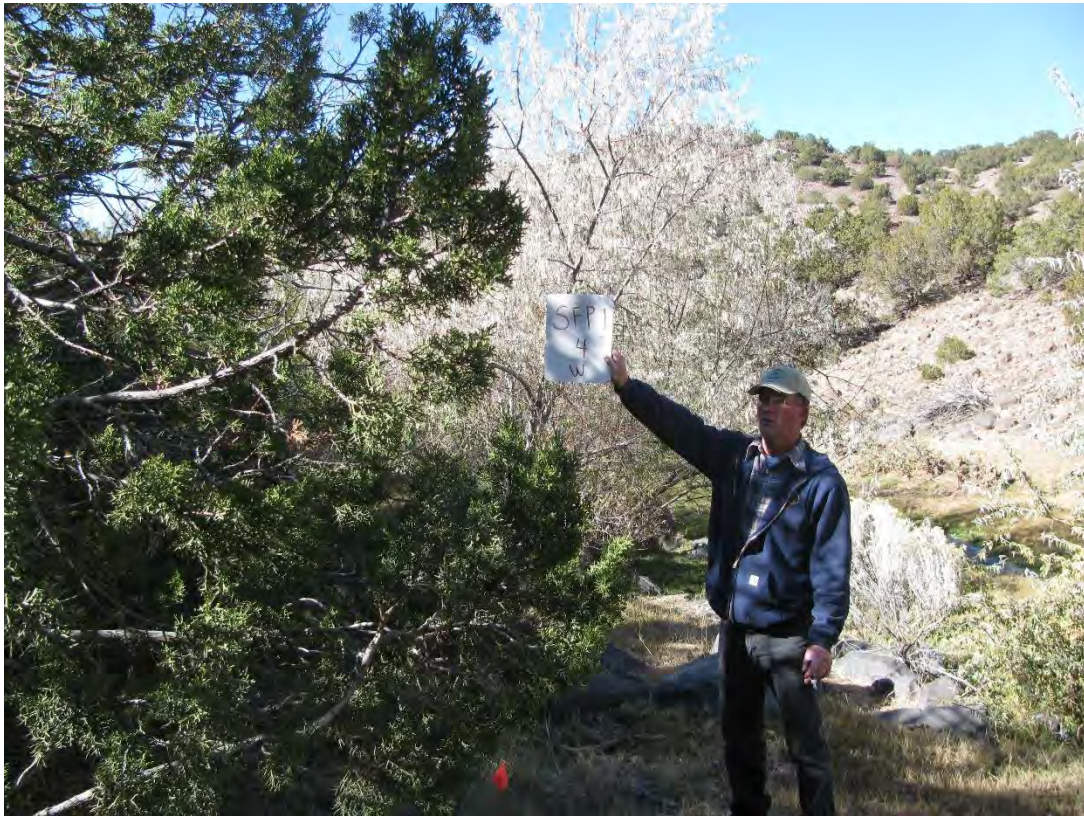
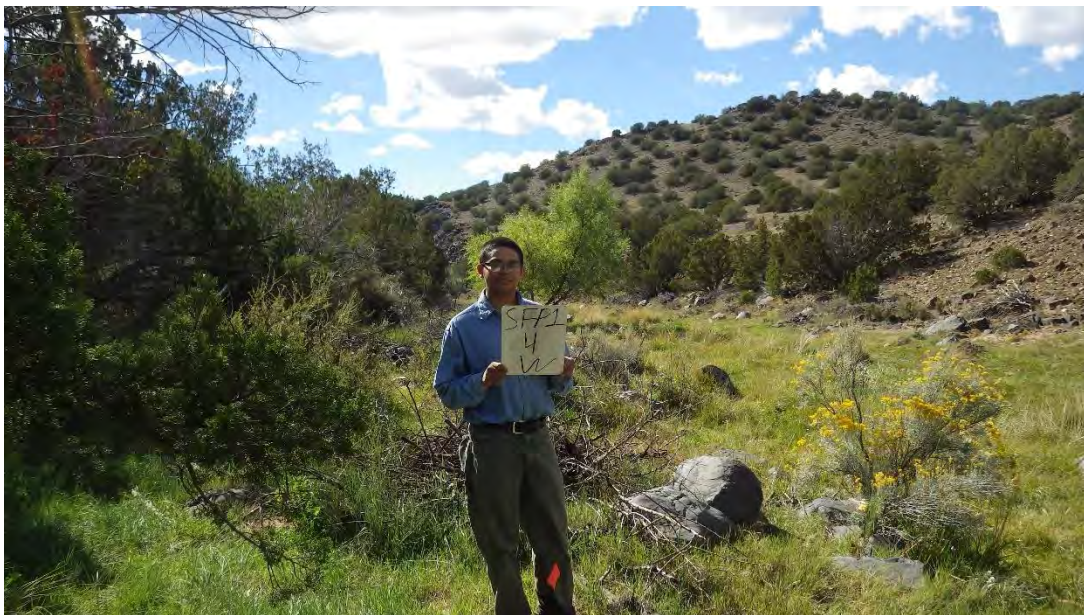
SFP1_4W, facing west from center (2011 above, 2016 below)
