Vegetation Monitoring Report – Pre-treatment

Greater Rio Grande Watershed Alliance

Valencia SWCD Project Site

Willie Chavez Park South - Belen

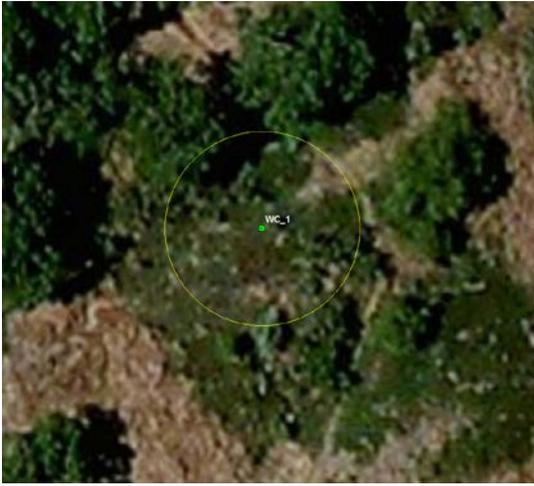
May 2011 Aerial View, Circle = 1/10 acre

Cover (%)											
Tree canopy	Seedlings/saplings		Shrubs <5'/5 - 15'		Gramanoid	Forbs	Litter	Bare Soil	Rock	Gravel	Water or wet soil
0	0	0	3	10	0	90	10	0	0	0	0

Hink & Ohmart Class: 5

Grasses	Forbs	Shrubs	Trees
	<i>Anemopsis californica</i>	<i>Salix exigua</i> Nutt	<i>Populus deltoides</i>
			<i>Elaeagnus angustifolia</i>

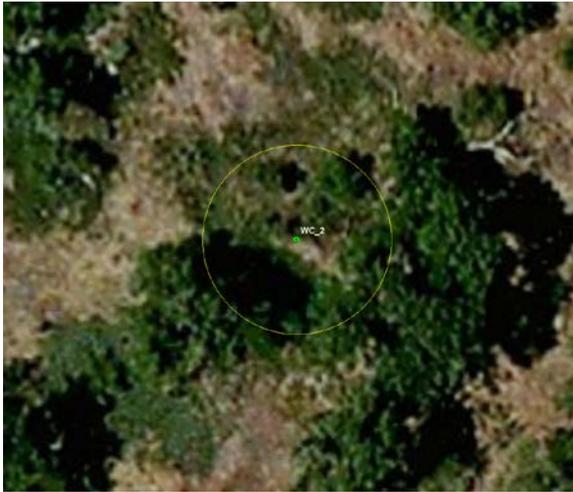
May 2011 Aerial View, Circle = 1/10 acre

Cover (%)											
Tree canopy	Seedlings/saplings		Shrubs <5'/5 - 15'		Gramanoid	Forbs	Litter	Bare Soil	Rock	Gravel	Water or wet soil
25	0	0	0	1	4	25	70	1	0	0	0

Hink & Ohmart Class: 1

Grasses	Forbs	Shrubs	Trees
	<i>Anemopsis californica</i>	<i>Salix exigua Nutt</i>	<i>Populus deltoides</i>
			<i>Elaeagnus angustifolia</i>
			<i>Salix gooddingii</i>
