Pino Fire Restoration Project 14-16

Pre-treatment Monitoring Report

2015

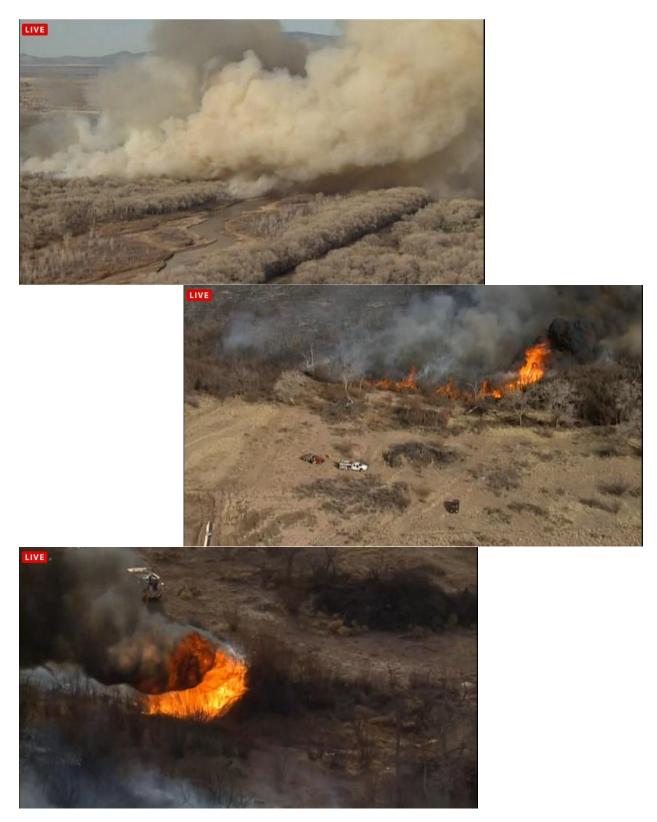
Figure 2. KRQE News 13 SkyNews photos of the Pino Fire. (Chelo Rivera, KRQE News 13, 2014)

Local news reported the fire's primary fuel source was the dense salt cedar stands along the river (Chelo Rivera, KRQE News 13, 2014). GRGWA's 2014 RFP noted the presence of dead sapling- and pole-sized salt cedar and Russian olives in the project area but suggested that much of the damaged vegetation was beginning to re-sprout, with heights at 2 to 4 feet by August 2014, just 5 months post-fire (Claunch-Pinto Soil and Water Conservation District on behalf of The Greater Rio Grande Watershed Alliance, 2014). Our contractor's photographs and notes from February 2016 (11 months post-fire; see Appendix II) suggest a patchy burn pattern where some areas experienced significant mortality in all canopy strata.
